Re: **Closure Report**
N-Line Leak 3
GPS: Latitude 32.734912 Longitude -103.772112
UL "F", Sec. 21, T18S, R32E
Lea County, NM
NMOCD Ref. No.

Tasman Geosciences (Tasman), on behalf of DCP Midstream (DCP), has prepared this Closure Report for the historical Release Site known as the N-Line Leak 3. Details of the release are summarized below:

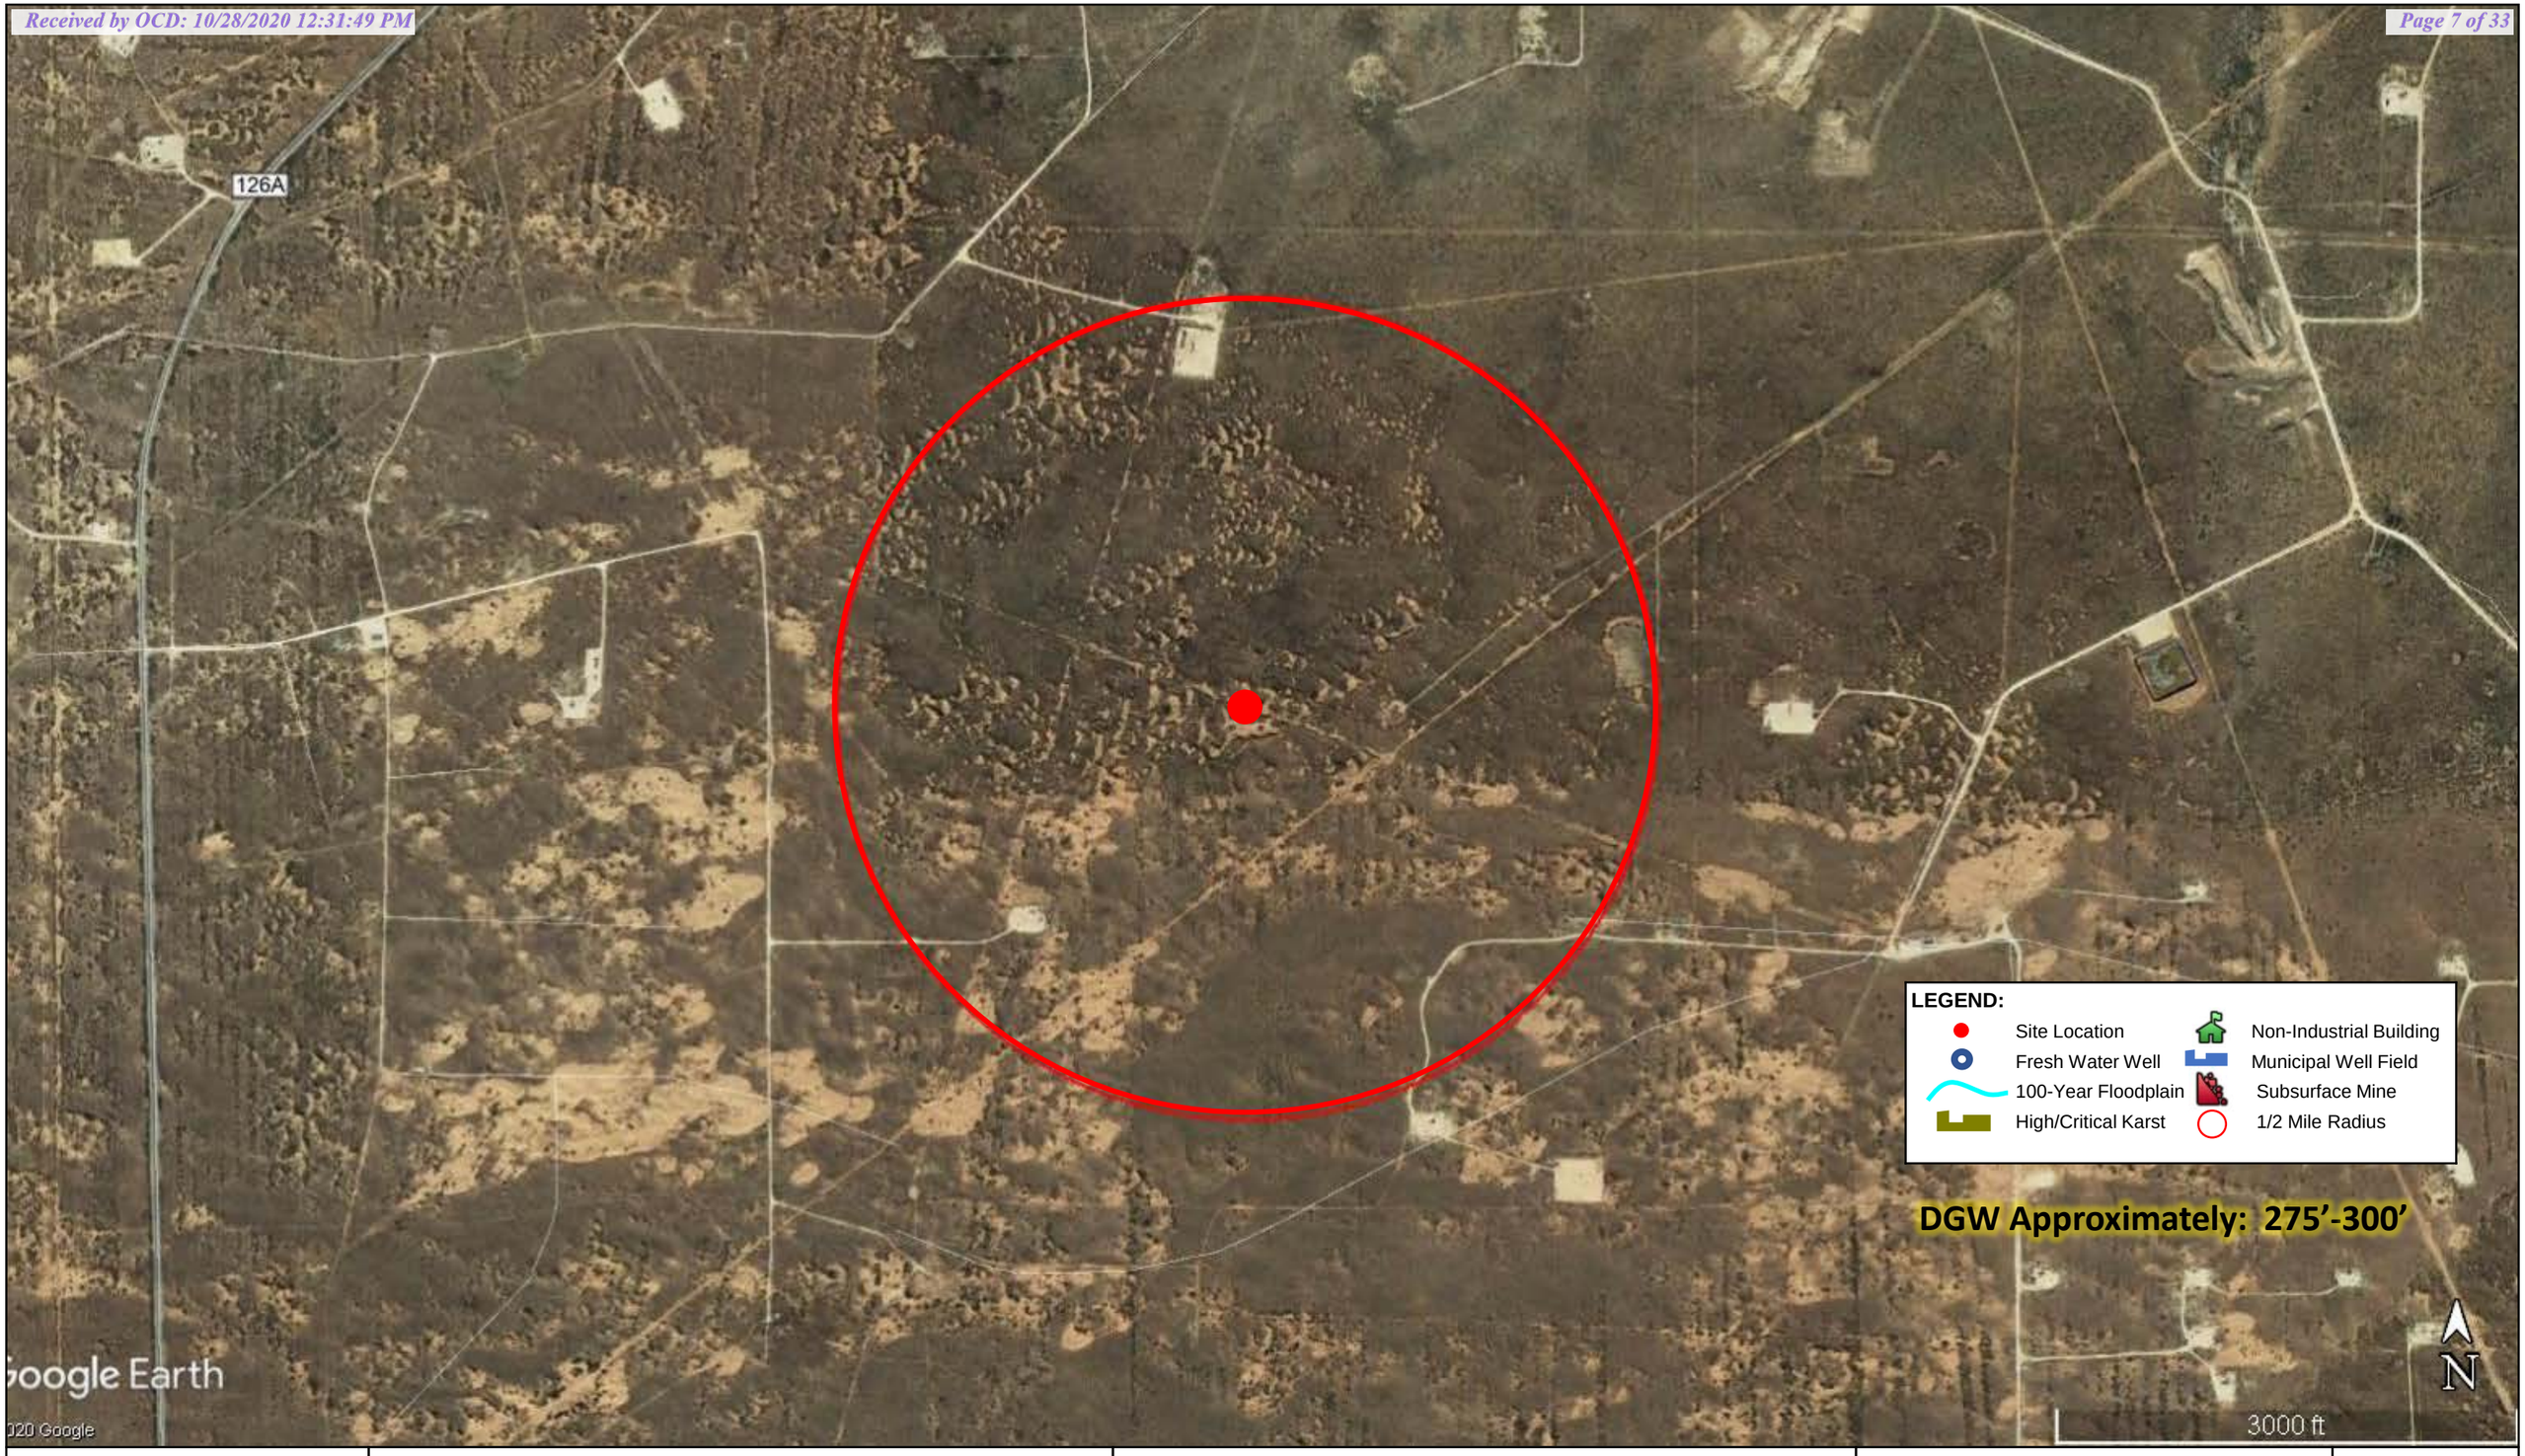
Attachment #1- Figure 1 – Site Characteristics Map

Site Characteristics Map is provided as Attachment #1. General Site Photographs are provided as Attachment #4. A Copy of the Initial Release Notification and Corrective Action (NMOCD Form C-141) is provided as Attachment #6

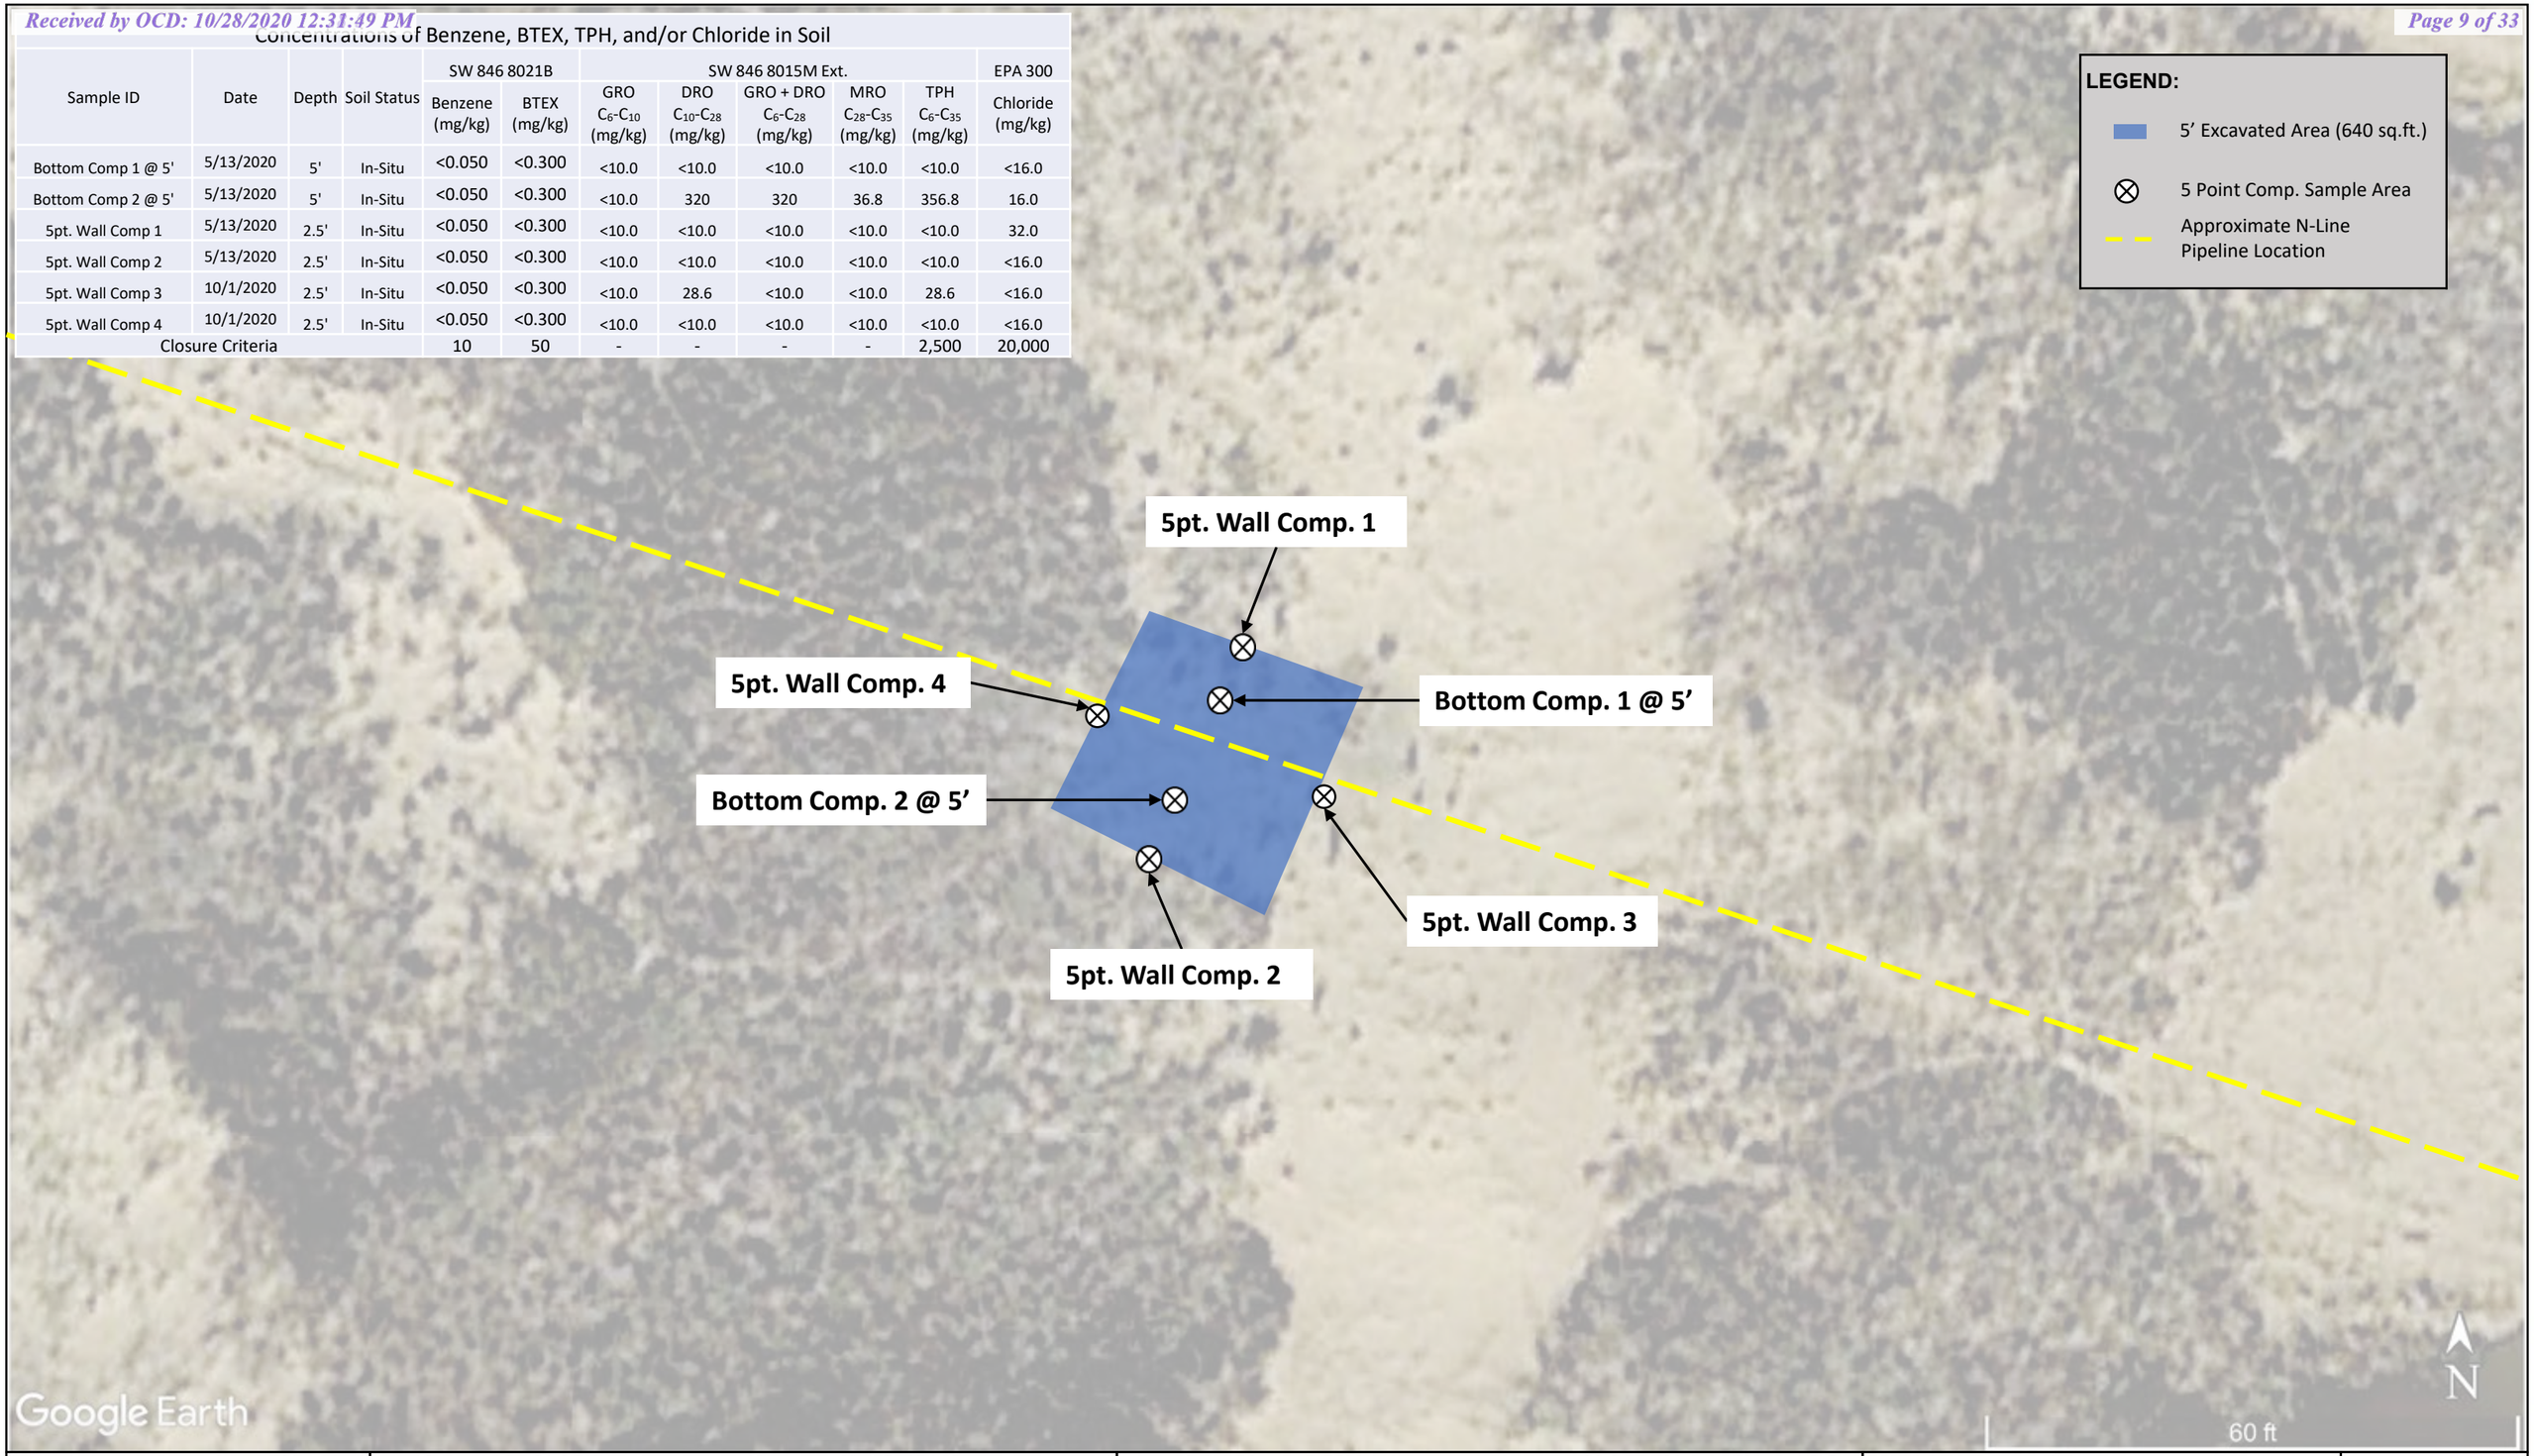
Attachment #2- Figure 2 - Site Sample Location Map

Impacted soil within the release margins was excavated and temporarily stockpiled on-site, atop an impermeable liner, pending final disposition. The floor and sidewalls of the excavated area were advanced until laboratory analytical results from confirmation soil samples indicated TPH concentrations were below the NMOCD Closure Criteria. Upon excavating impacted soil from within the release margins, six (6) confirmation soil samples were collected from the floor and sidewalls of the excavated area representing no more than 200 Sq. Ft. The collected soil samples were submitted to an NMOCD-approved laboratory for analysis of TPH, BTEX, and chloride concentrations. Upon receiving laboratory analytical data showing samples were below NMOCD Closure Criteria, impacted soil was transported under manifest to a NMOCD-approved disposal facility and the excavated area was backfilled with locally sourced, non-impacted "like" material. A table summarizing laboratory analytical results from confirmation soil samples is provided below:

Sample ID	Date	Depth	Soil Status	SW 846 8021B		SW 846 8015M Ext.					EPA 300
				Benzene (mg/kg)	BTEX (mg/kg)	GRO C_6-C_{10} (mg/kg)	DRO C_{10}-C_{28} (mg/kg)	GRO + DRO C_6-C_{28} (mg/kg)	MRO C_{28}-C_{35} (mg/kg)	TPH C_6-C_{35} (mg/kg)	Chloride (mg/kg)
Bottom Comp 1 @ 5'	5/13/2020	5'	In-Situ	<0.050	<0.300	<10.0	<10.0	<10.0	<10.0	<10.0	<16.0
Bottom Comp 2 @ 5'	5/13/2020	5'	In-Situ	<0.050	<0.300	<10.0	320	320	36.8	356.8	16.0
5pt. Wall Comp 1	5/13/2020	2.5'	In-Situ	<0.050	<0.300	<10.0	<10.0	<10.0	<10.0	<10.0	32.0
5pt. Wall Comp 2	5/13/2020	2.5'	In-Situ	<0.050	<0.300	<10.0	<10.0	<10.0	<10.0	<10.0	<16.0
5pt. Wall Comp 3	10/1/2020	2.5'	In-Situ	<0.050	<0.300	<10.0	28.6	<10.0	<10.0	28.6	<16.0
5pt. Wall Comp 4	10/1/2020	2.5'	In-Situ	<0.050	<0.300	<10.0	<10.0	<10.0	<10.0	<10.0	<16.0
Closure Criteria				10	50	-	-	-	-	2,500	20,000

Based on laboratory analytical results from soil samples collected during the final site assessment, impacted soil within the release margins has been determined to be remediated below the Table I of 19.15.29.12 NMAC Closure Criteria for Soils Impacted by a Release. Tasman on behalf of DCP Midstream, respectfully requests the NMOCD grant closure approval for the historical release site known as N-Line Leak 3.
