Re: Vacuum Grayburg San Andres Unit Satellite #4
Site Assessment Report
Case No. 1RP-3258 & 1RP-3257
Lea County, New Mexico

- Vacuum Grayburg San Andres Unit Satellite #4 – Site Assessment Report

VACUUM/LOVINGTON FUNCTIONAL MANAGEMENT TEAM UNITS
LEA COUNTY, NEW MEXICO
SITE ASSESSMENT REPORT

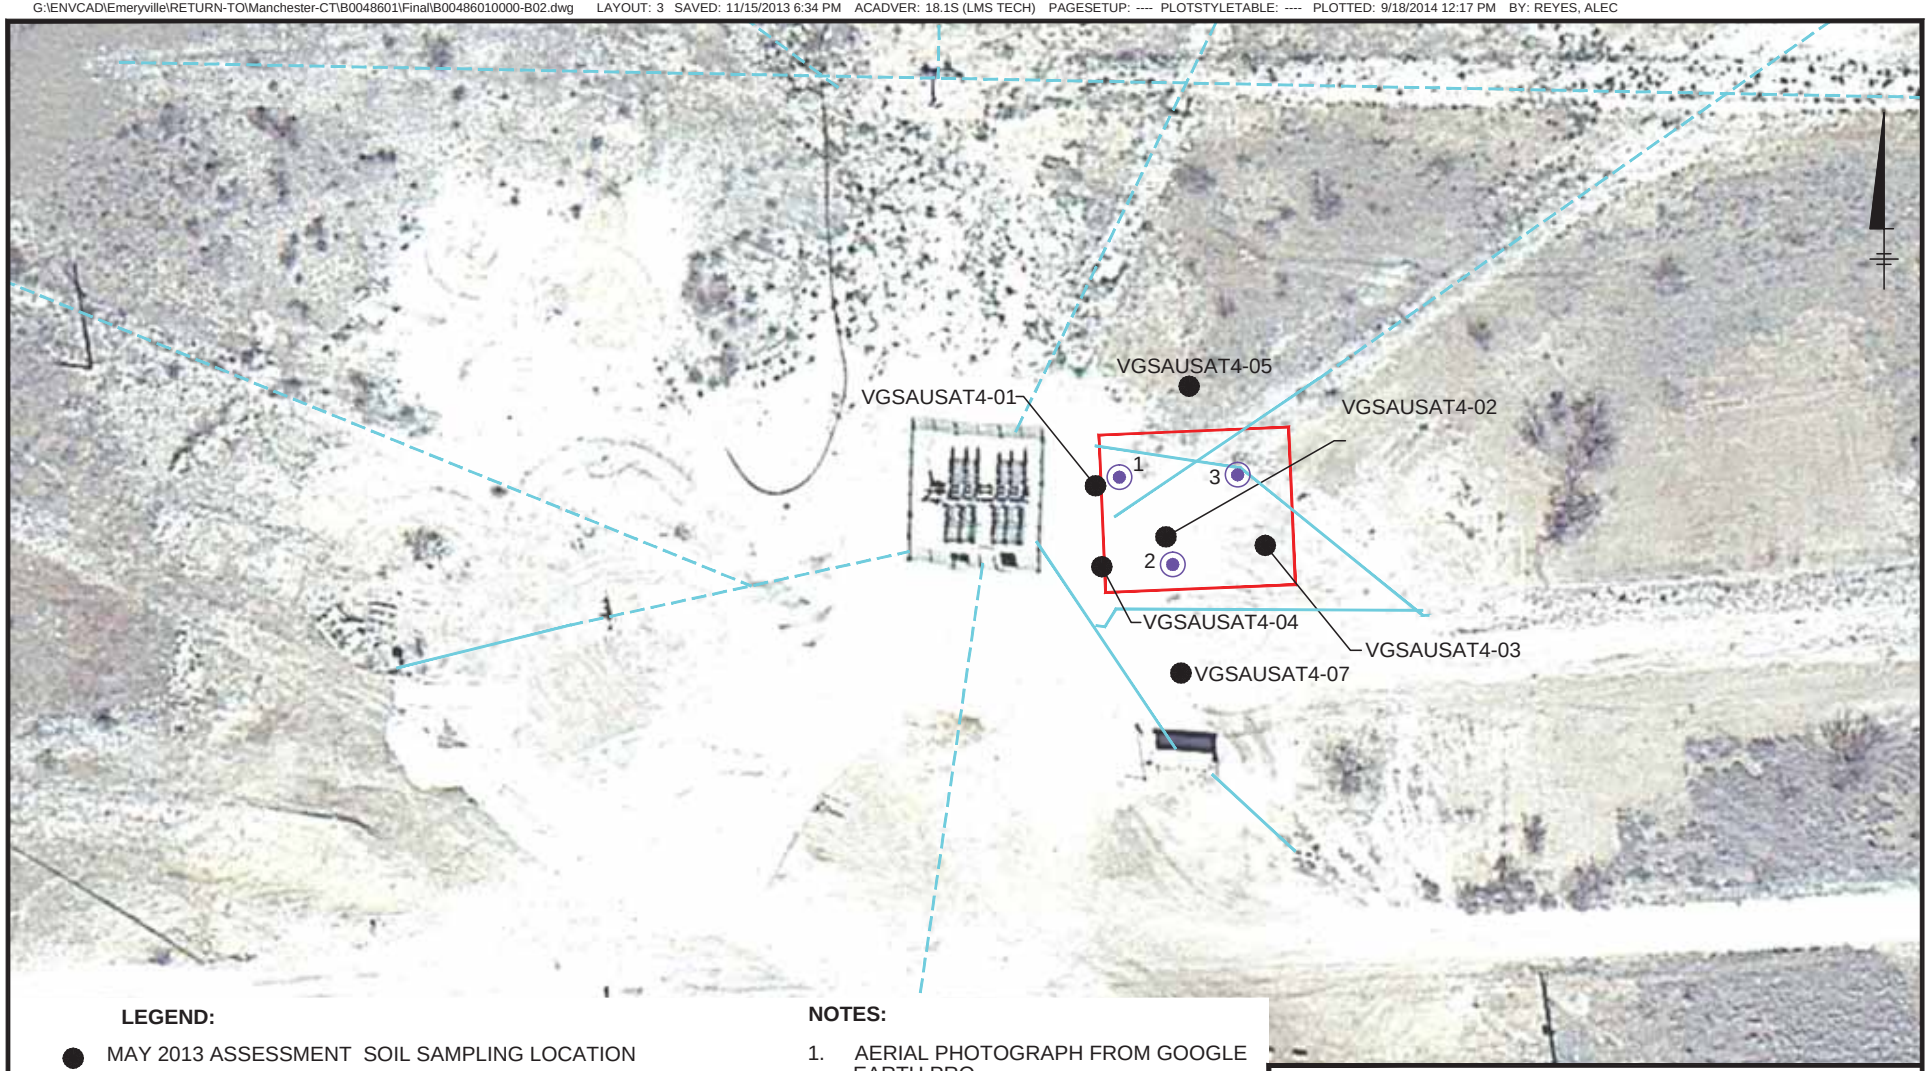
- MAY 2013 ASSESSMENT SOIL SAMPLING LOCATION
- 1 OCTOBER 2011 CONFIRMATION SOIL SAMPLING LOCATION
- UNDERGROUND UTILITY LINE
- ABOVE GROUND UTILITY LINE
- APPROXIMATE EXTENT OF SPILL

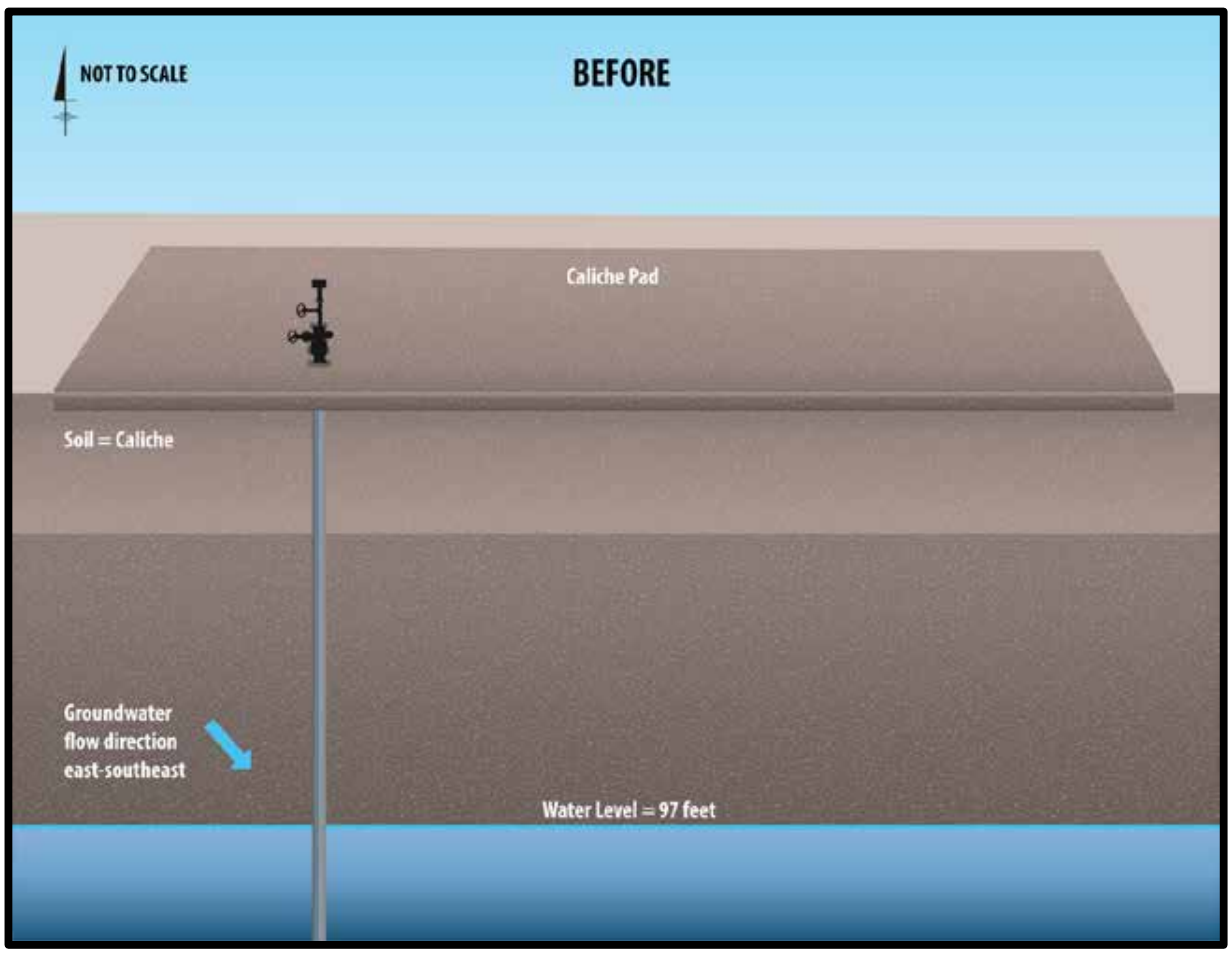
The site is located in the western edge of the Permian Basin with Lovington (the closest town) located approximately 13 miles northeast of the site. Due to the arid climate, the site experiences low precipitation and high evapotranspiration rates. According to information obtained from the NMOSE online database, groundwater near the site is encountered at a depth of approximately 97 feet bgs.

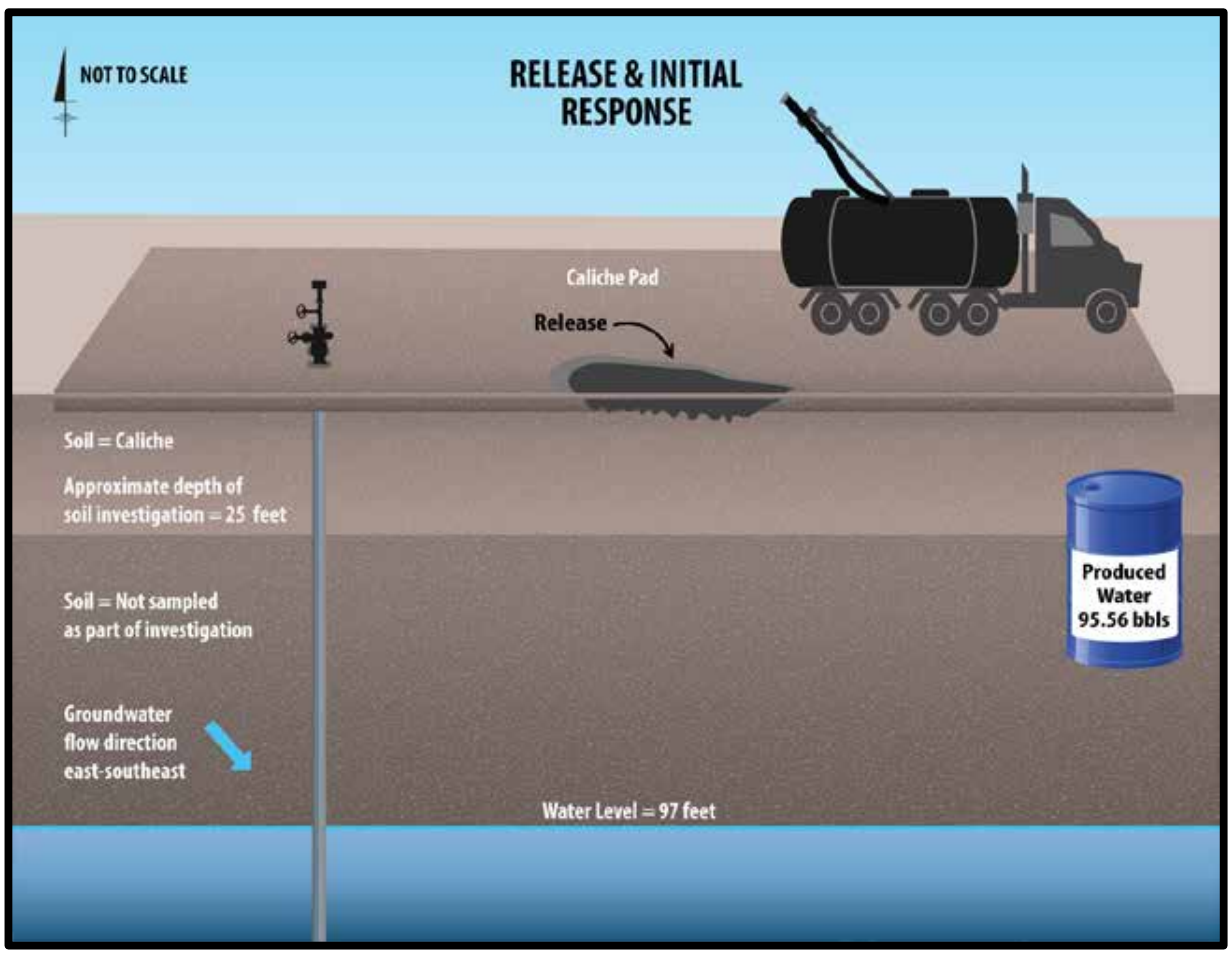
A release of approximately 95.56 bbls of produced water occurred at the site on August 17, 2011 due to the failure of a water injection station pump. Chevron personnel from the Mid-Continent Business Unit (MCBU) stopped the release and recovered approximately 80 bbls of fluids using a vacuum truck. Chevron MCBU personnel excavated visually impacted soil in the area to a depth of approximately 2 feet bgs and collected three discrete confirmation soil samples from the base of the excavation on October 13, 2011. After collecting the soil samples, the excavated area was reportedly backfilled with imported soil. Analyte concentrations in one or more confirmation soil samples were above regulatory criteria, which prompted additional site assessment activities.

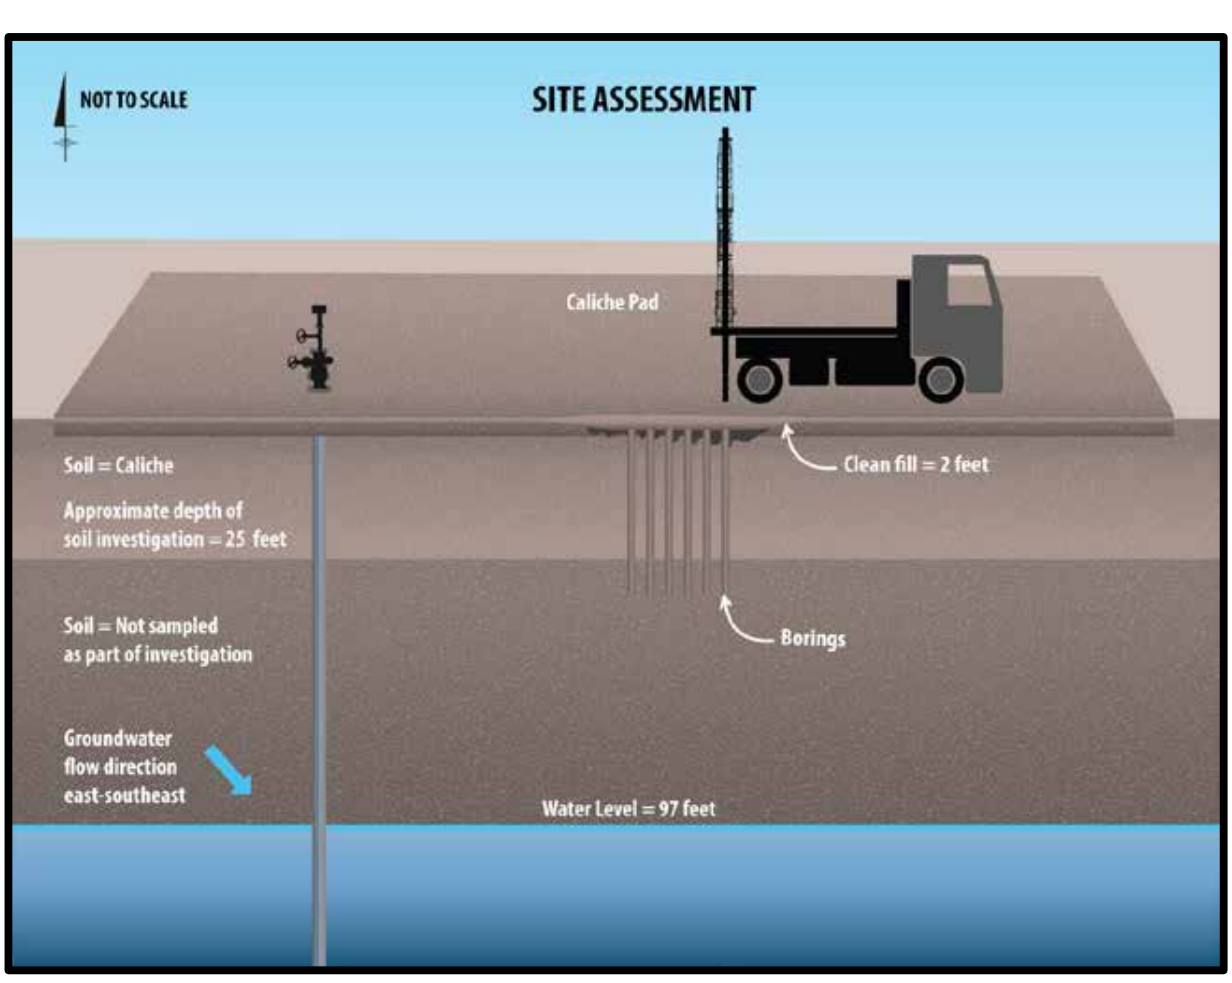
In May 2013, ARCADIS conducted site assessment activities to characterize the lateral and vertical extents of soil impacts at the site. Soil boring locations were selected based on the results of confirmation soil sampling completed at the site in October 2011, locations of pipelines and other equipment at the site, and the extent of the release as documented by Chevron MCBU personnel during the initial response activities. Analyte concentrations in samples collected during the 2013 assessment were reported below site-specific criteria. Site assessment activities demonstrate that remaining soil concentrations associated with the release do not pose significant risk to groundwater resources or other receptors.

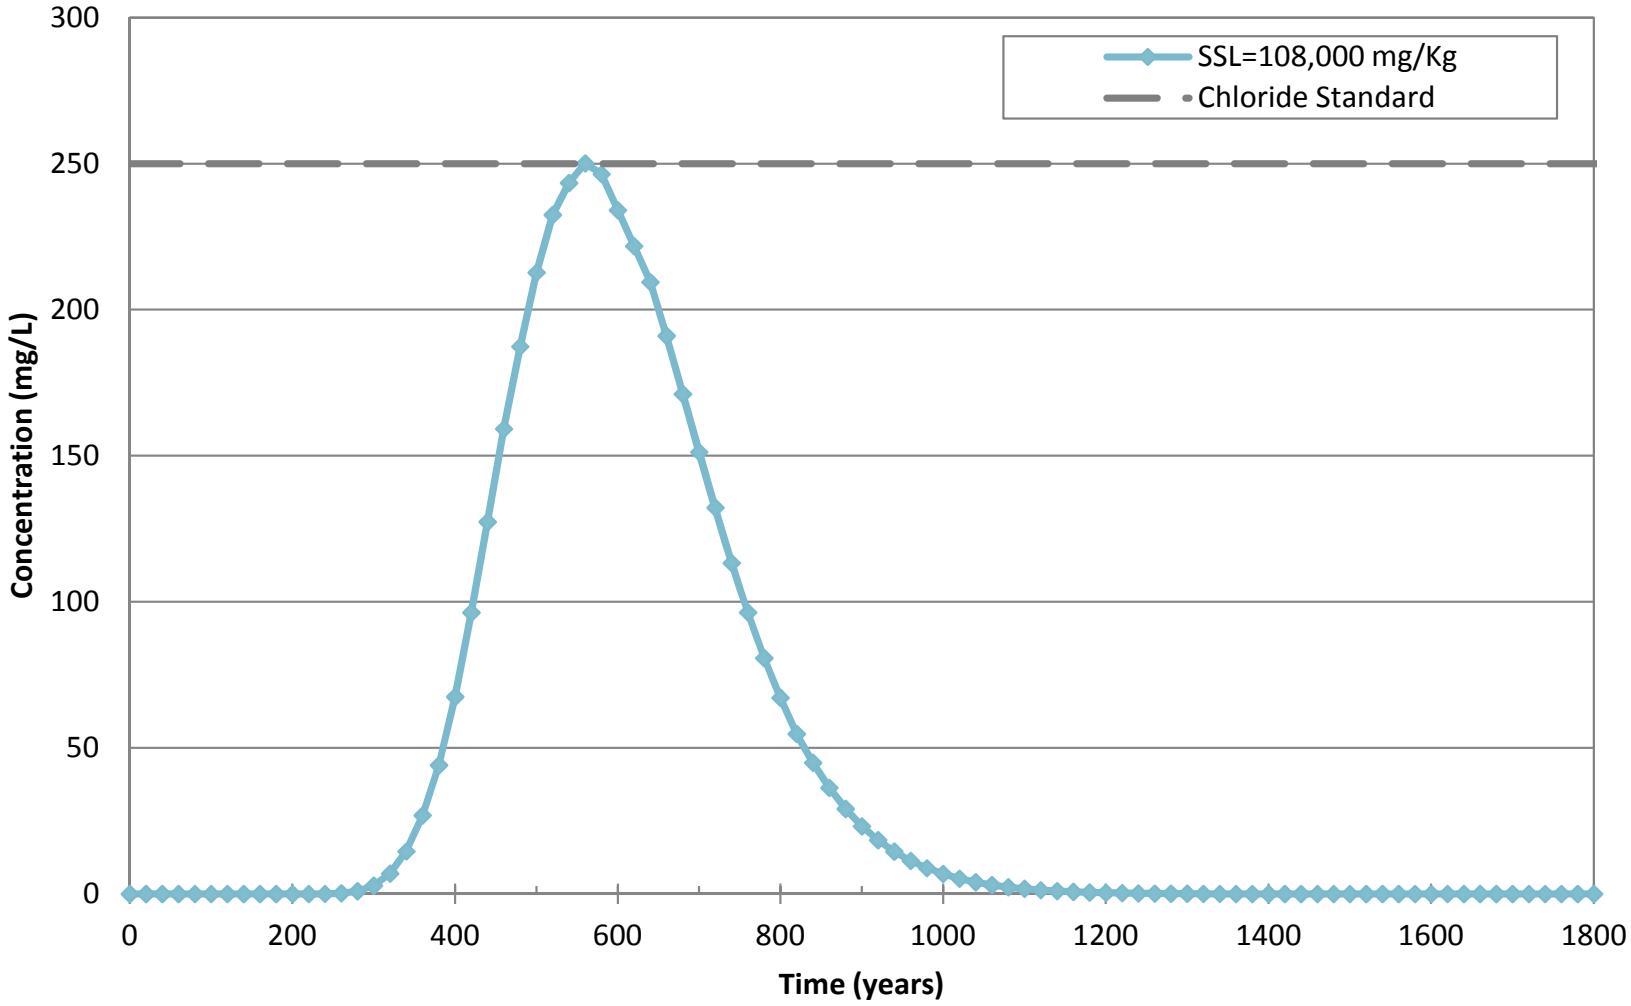
Figure 1
MULTIMED Simulated Chloride Concentration Vs Time in Groundwater
(Source = 20m, Chloride 0-1m, & Depth to Groundwater = 20m)

The predicted groundwater concentrations versus time are illustrated on Figures 1 through 8. The peak arrival times varied between 540 and 860 years. The simulations indicate the site SSLs for the protection of groundwater ranged from 8,525 to 266,100 mg/kg (Table 2) depending on the scenario and are protective of the New Mexico chloride groundwater standard of 250 mg/L.
