CLOSURE REPORT

Contango Resources, LLC.
Karlsbad Corral 11 SWD 1
Eddy, New Mexico
Unit Letter "J", Section 11, Township 25 South, Range 29 East
Latitude 32.143476, Longitude -103.955108

30-01535341, nAPP1728633177

2RP-4436

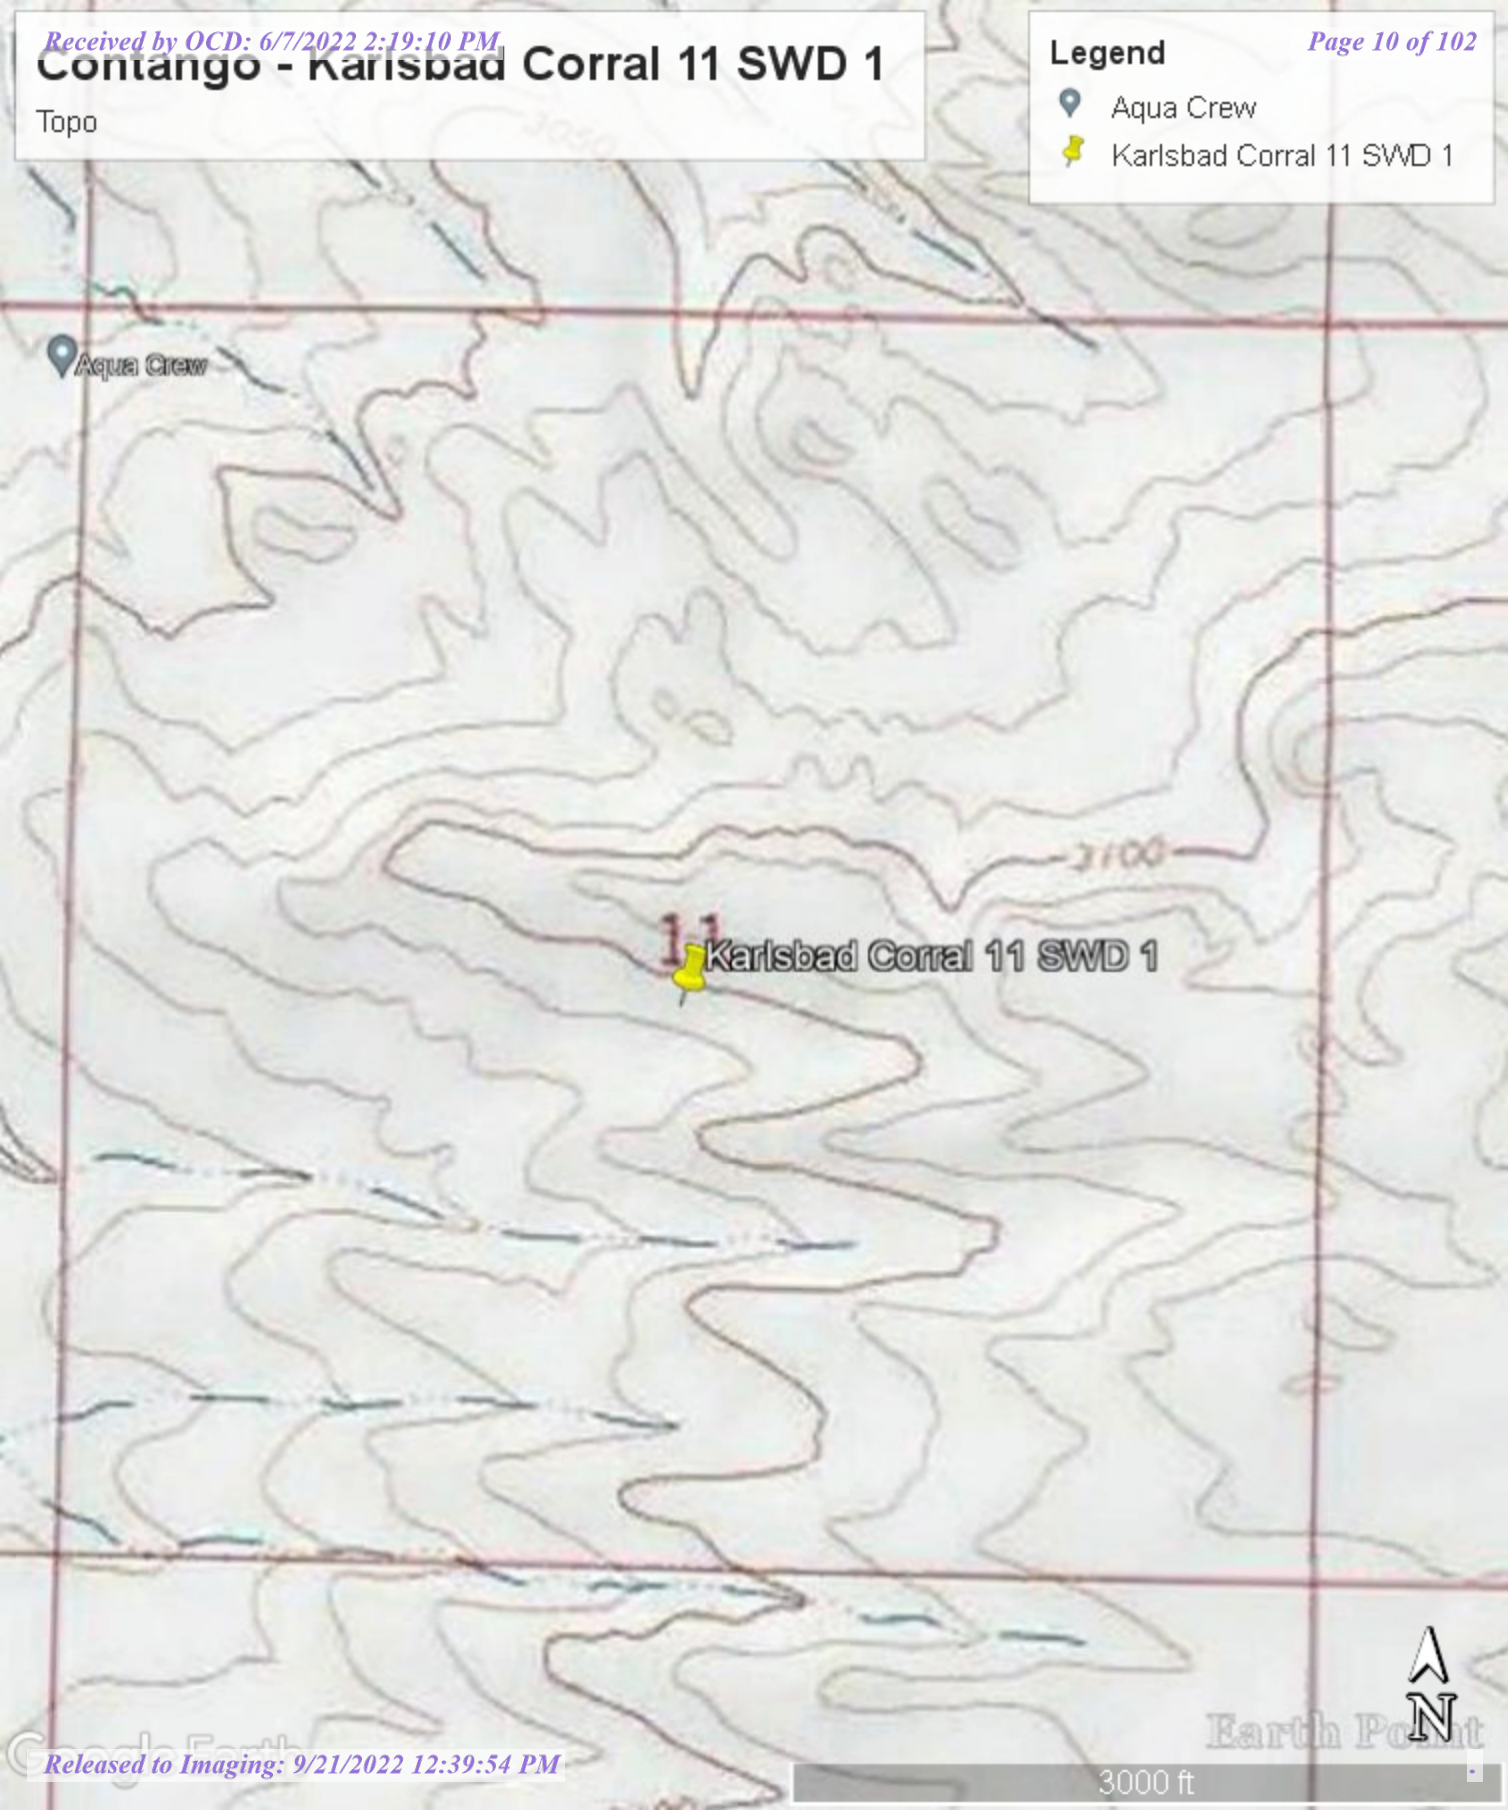
Initial sampling activities were conducted on May 12th by ASSI personnel, using a stainless-steel hand auger to determine the vertical extent of the impact throughout the release footprint. Sixteen (16) samples were collected from eight (8) sample locations at discrete intervals within the release footprint to a depth between one-half (0.5) and two (2) foot below ground surface (bgs). Table 1 in Appendix B presents analytical results. Figure 3 in Appendix A shows sampling locations inside the release footprint during the May 12th sampling event.

Figures 3 and 4 in Appendix A show the approximate position of the sample locations installed within the release footprint and the relation to pertinent land features respectively.

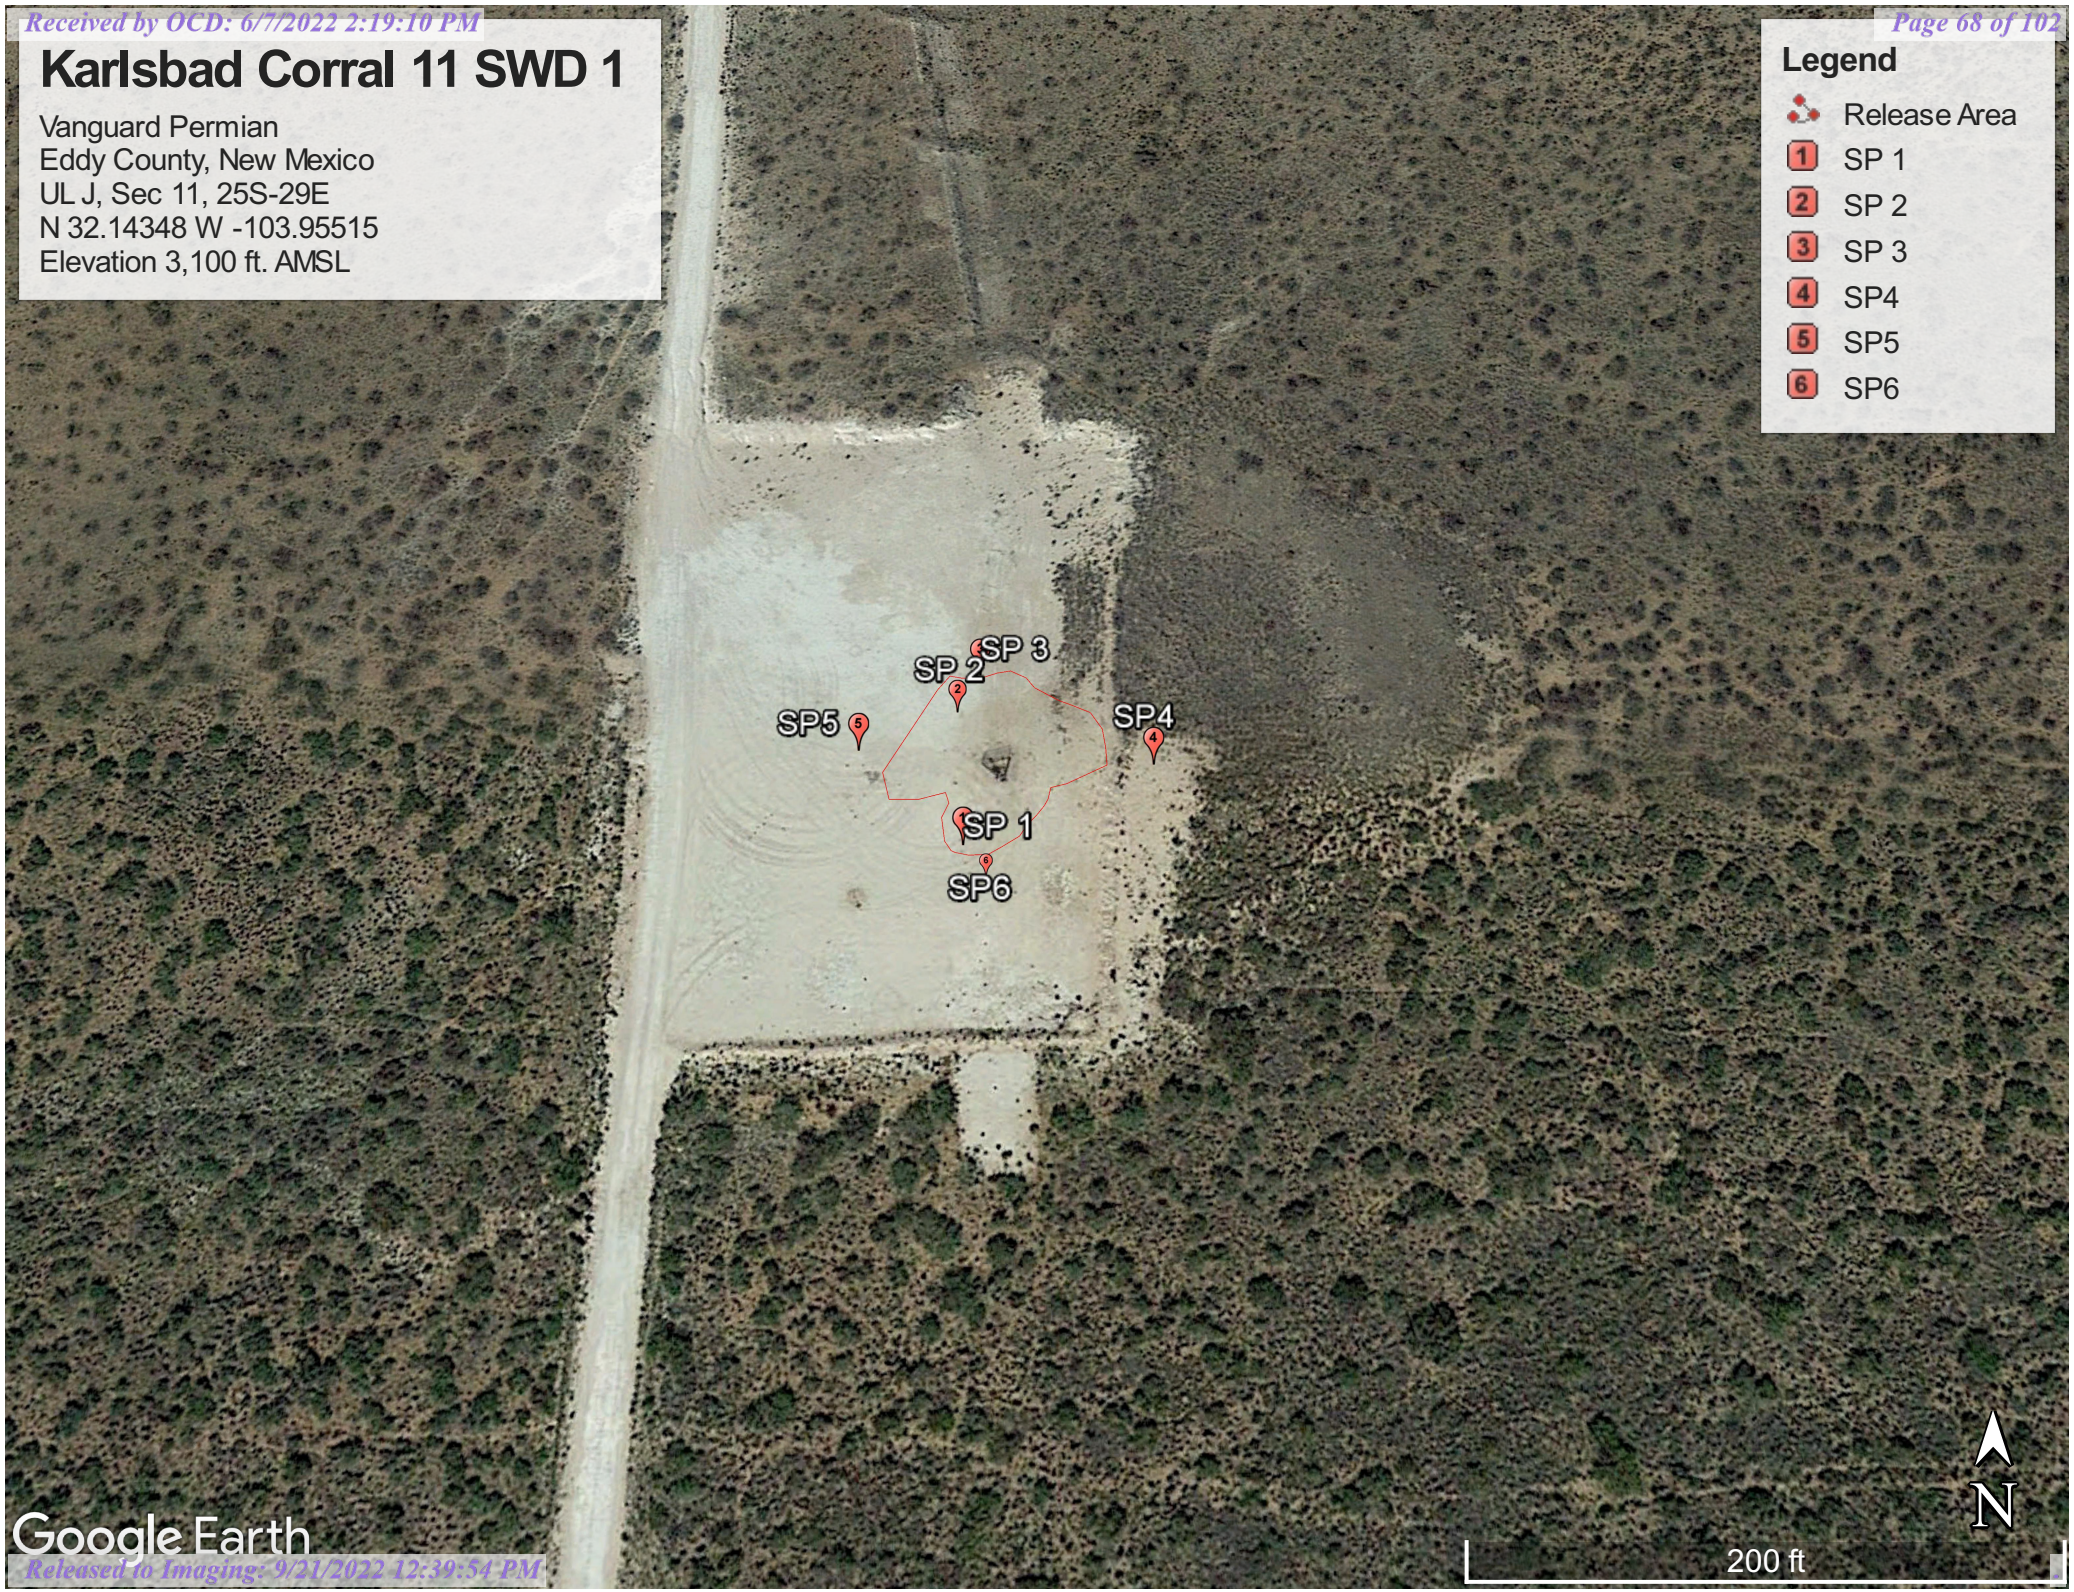
The visually stained area totals an area of approximately 3,800 square feet. The area is caliche approximately two feet thick on the pad.
