REMEDIATION SUMMARY

SITE CLOSURE REQUEST

COG Operating, LLC
SRO State Com #002H
Eddy County, New Mexico
Unit Letter "P", Section 32, Township 25 South, Range 28 East
Latitude 32.080101° North, Longitude 104.1018906° West
NMOCD Reference Nos. 2RP-4510, 2RP-4862

February 2019

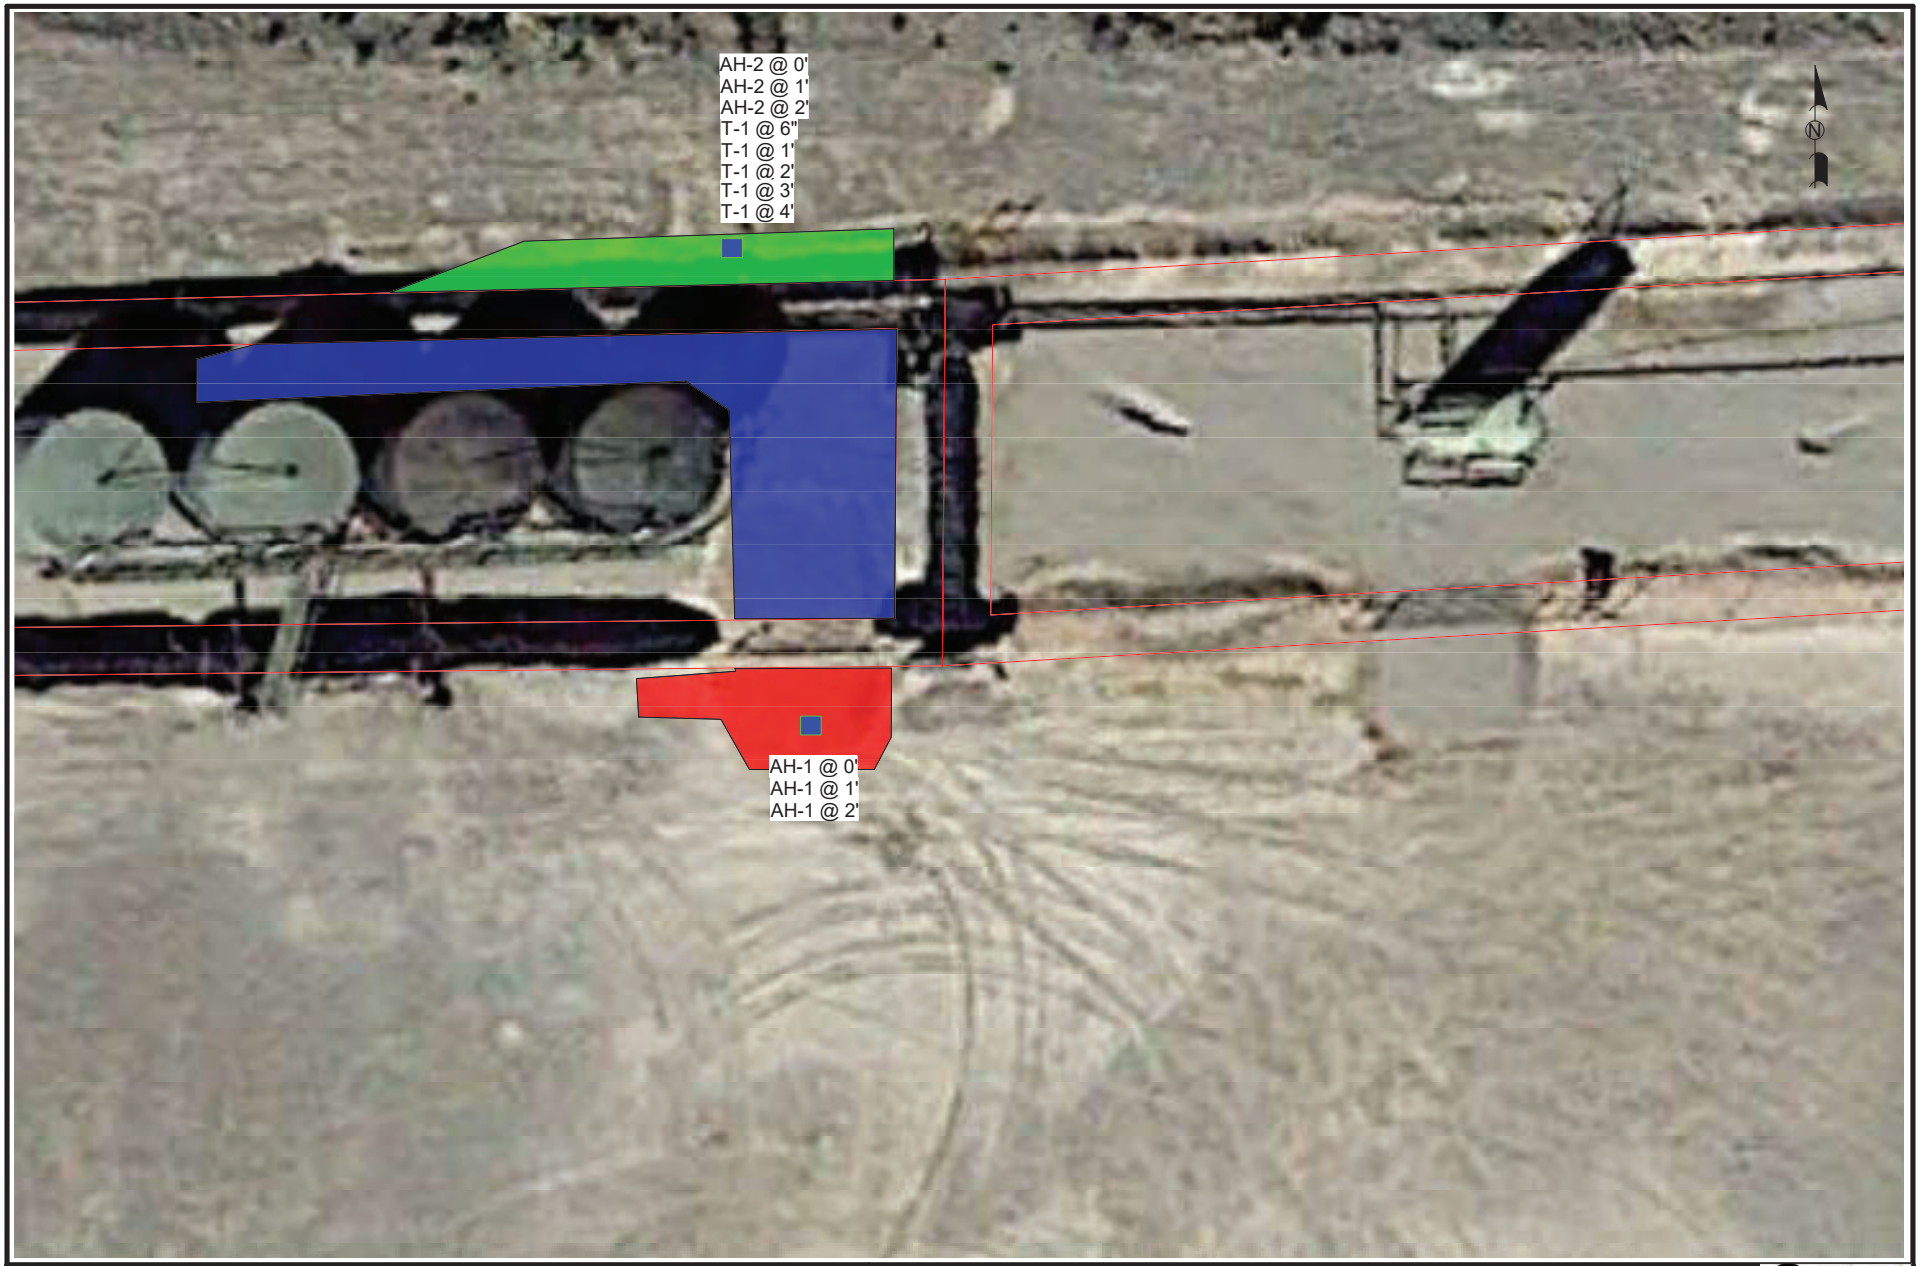
COG, SRO State Com #002H

Leak date: 07/15/2018
Eddy County, NM
API# 30-015-37141
2RP-4862

- Excavate to two feet below ground surface
- Excavate to two and one half feet below ground surface
- Excavate impacted material above the lined surface
- Vertical Soil Sample Location
- Lined Berm

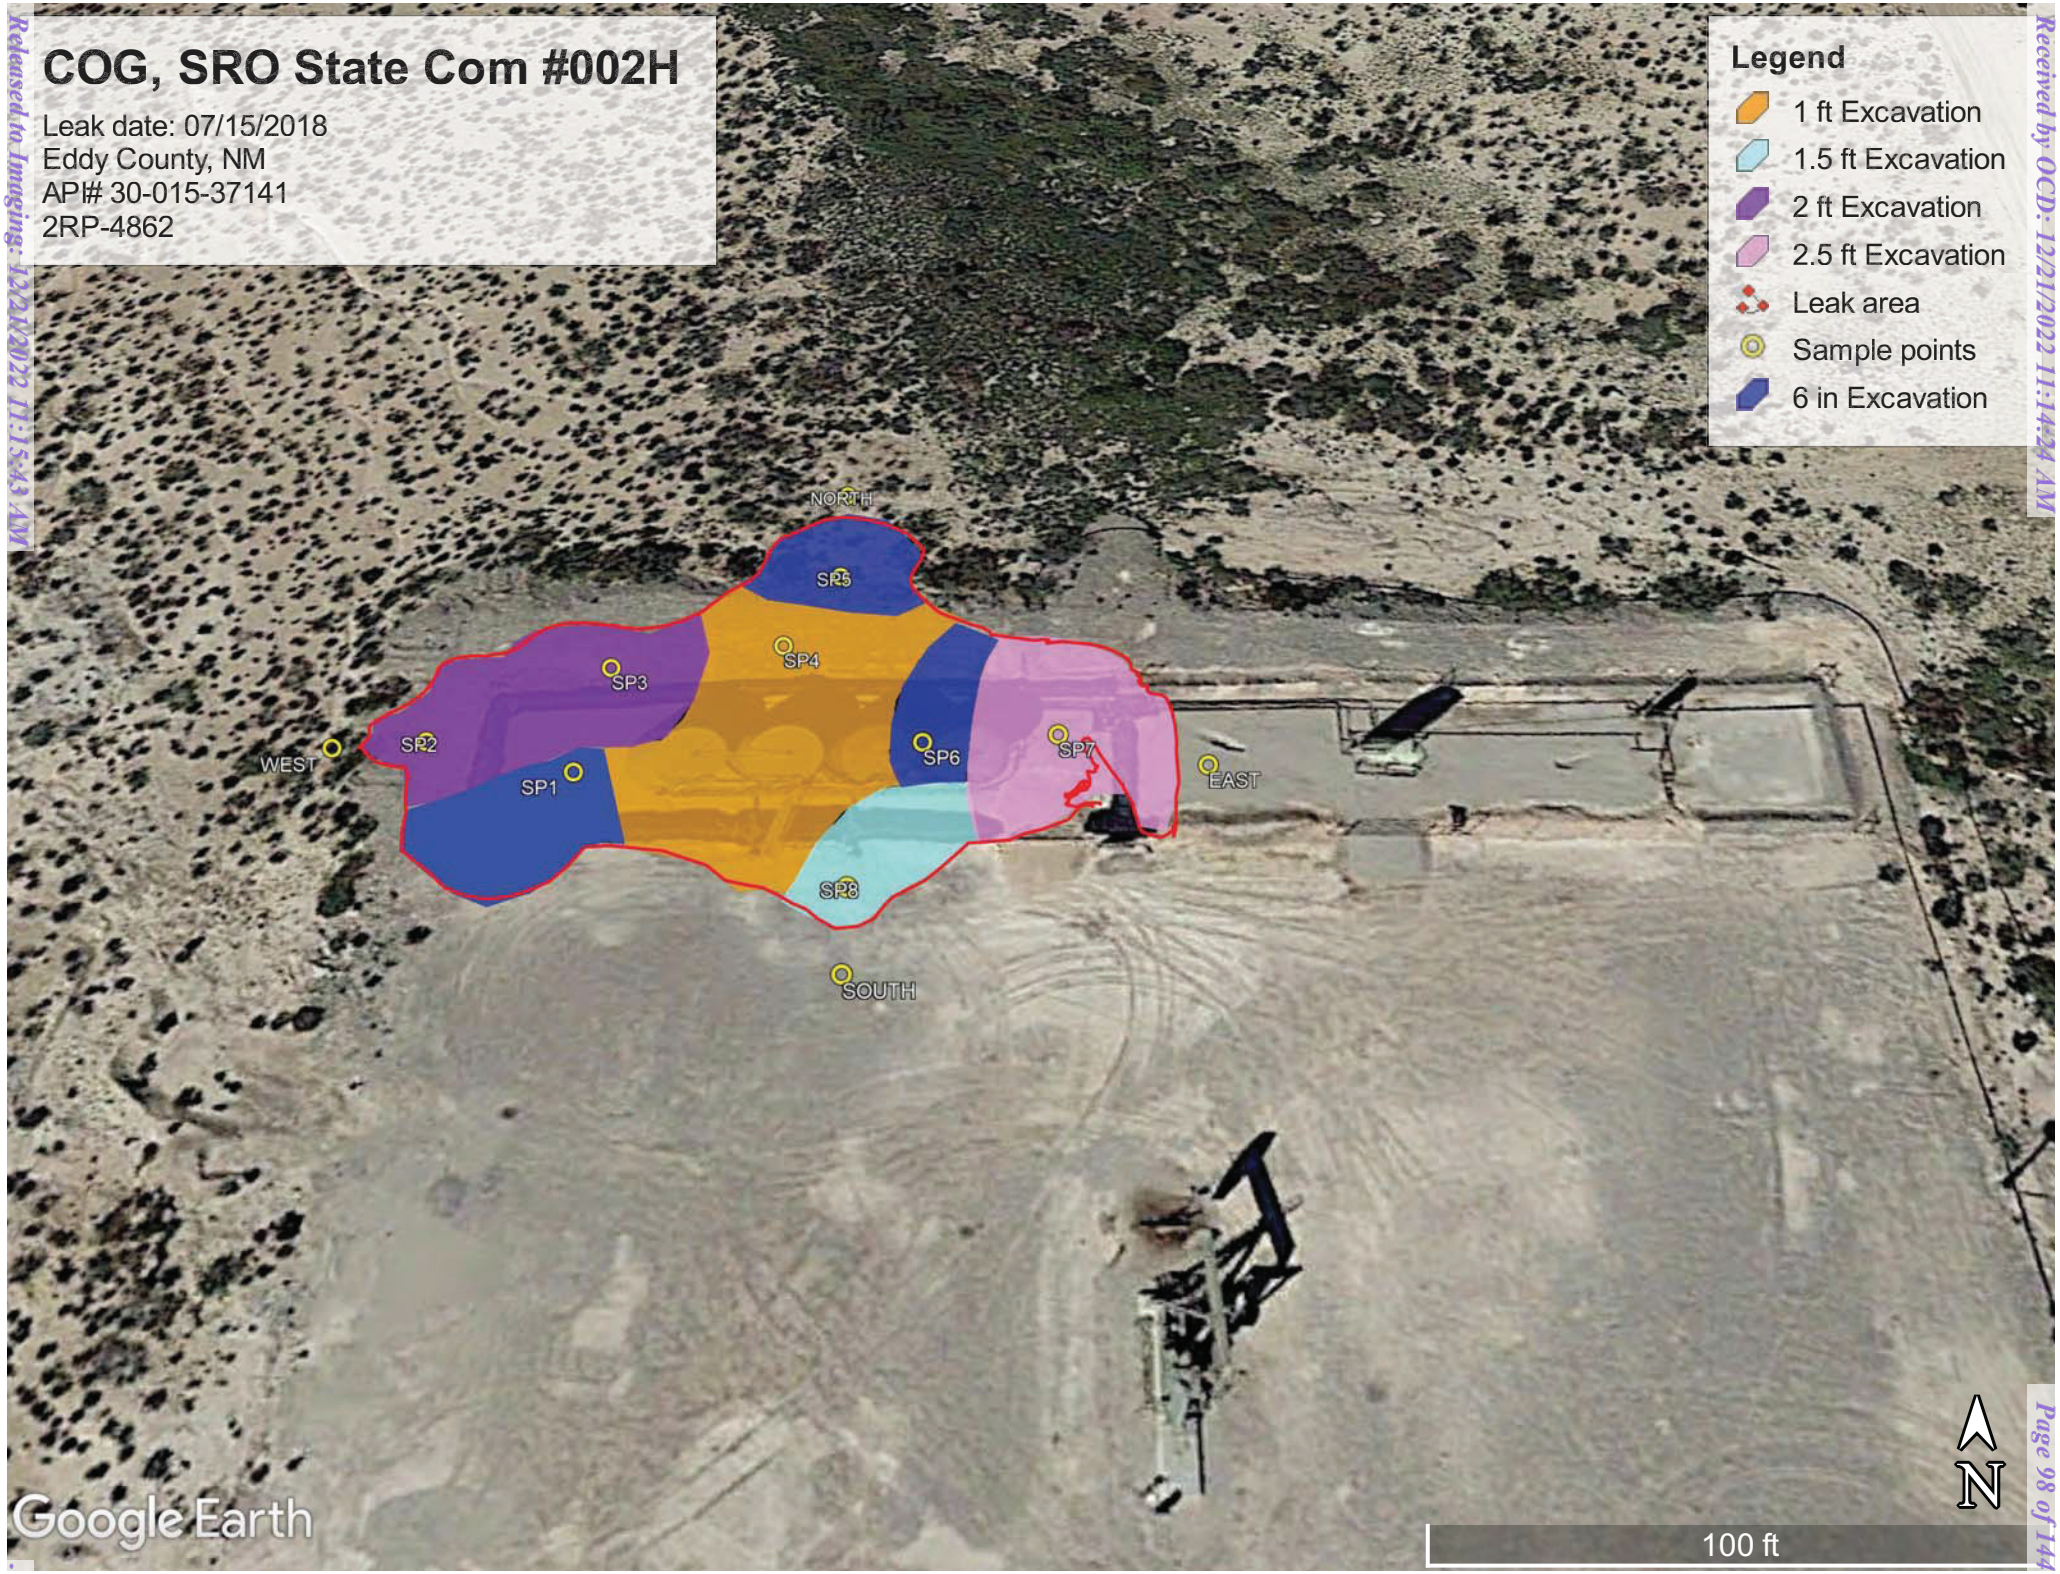
COG, SRO State Com #002H

Leak date: 07/15/2018
Eddy County, NM
API# 30-015-37141
2RP-4862

COG will excavate the spill area as depicted on the following site diagram. The battery was destroyed in the fire and was dismantled so the delineation activities could be conducted. The leak area near SP1, SP5, and SP6 (BLUE shade on diagram) will be excavated to a depth of 6 inches. The leak area near SP2 and SP3 (PURPLE shade on diagram) will be excavated to a depth of 2 feet. The leak area near SP4 (ORANGE shade on diagram) will be excavated to a depth of 1 foot. The leak area near SP7 (PINK shade on diagram) will be excavated to a depth of 2.5 feet.
