Closure Report
Admiral Federal Com 002H (11.07.22)
Incident #: NAPP2231848433
Eddy County, New Mexico
Unit O Sec 28 T25S R29E
32.0941°, -103.9867°

Produced Water Release
Point of Release: Tank overflow
Release Date: 11/07/2022
Volume Released: 9.295 barrels of Produced Water
Volume Recovered: 9 barrels of Produced Water

Re: Closure Report
Admiral Federal Com 002H (11.07.22)
Concho Operating, LLC
Incident ID NAPP2231848433
Site Location: Unit O, S28, T25S, R29E
(Lat 32.0941º, Long -103.9867º)
Eddy County, New Mexico

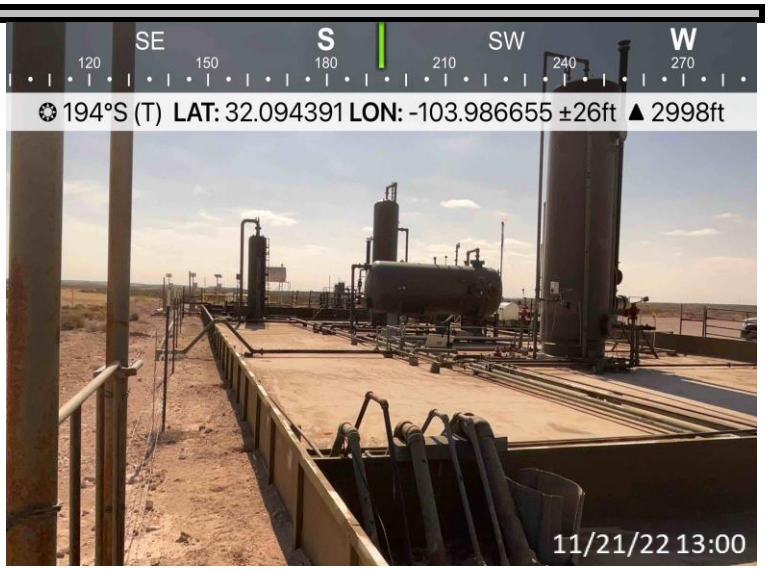
Photograph No. 4

Description:
View South of the lined facility.
