January 26, 2023

Subject: **2022 Fourth Quarter – Solar SVE System Update**
Trunk S
Harvest Four Corners, LLC
Incident Number NCS1931842879
Remediation Permit Number 3RP-1014
Rio Arriba County, New Mexico

Photographic Log
Trunk S Tank Battery
Harvest Four Corners, LLC
Rio Arriba County, New Mexico

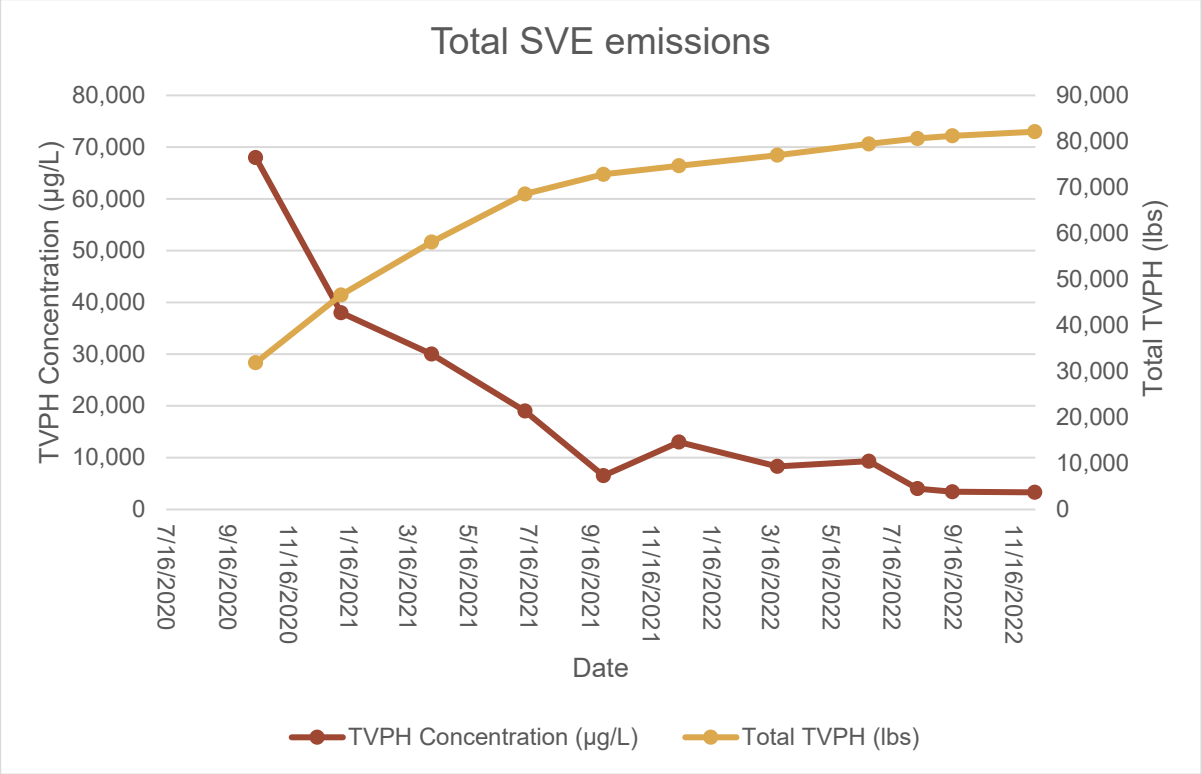
Estimated air emissions were calculated using air sample data collected to-date (Table 2). The impacted mass source removal via the solar SVE system to-date is estimated to be 82,112 pounds (lbs) of TVPH. Since system startup petroleum hydrocarbon emissions have steadily declined as shown in the chart below.

Despite the expected decrease in the mass removal rate over time, the December 2022 TVPH emissions rate remained at approximately 0.88 pounds per hour (lb/hr) or approximately 9.24 pounds per day (lb/day), indicating that the SVE system is still effectively remediating the Site.

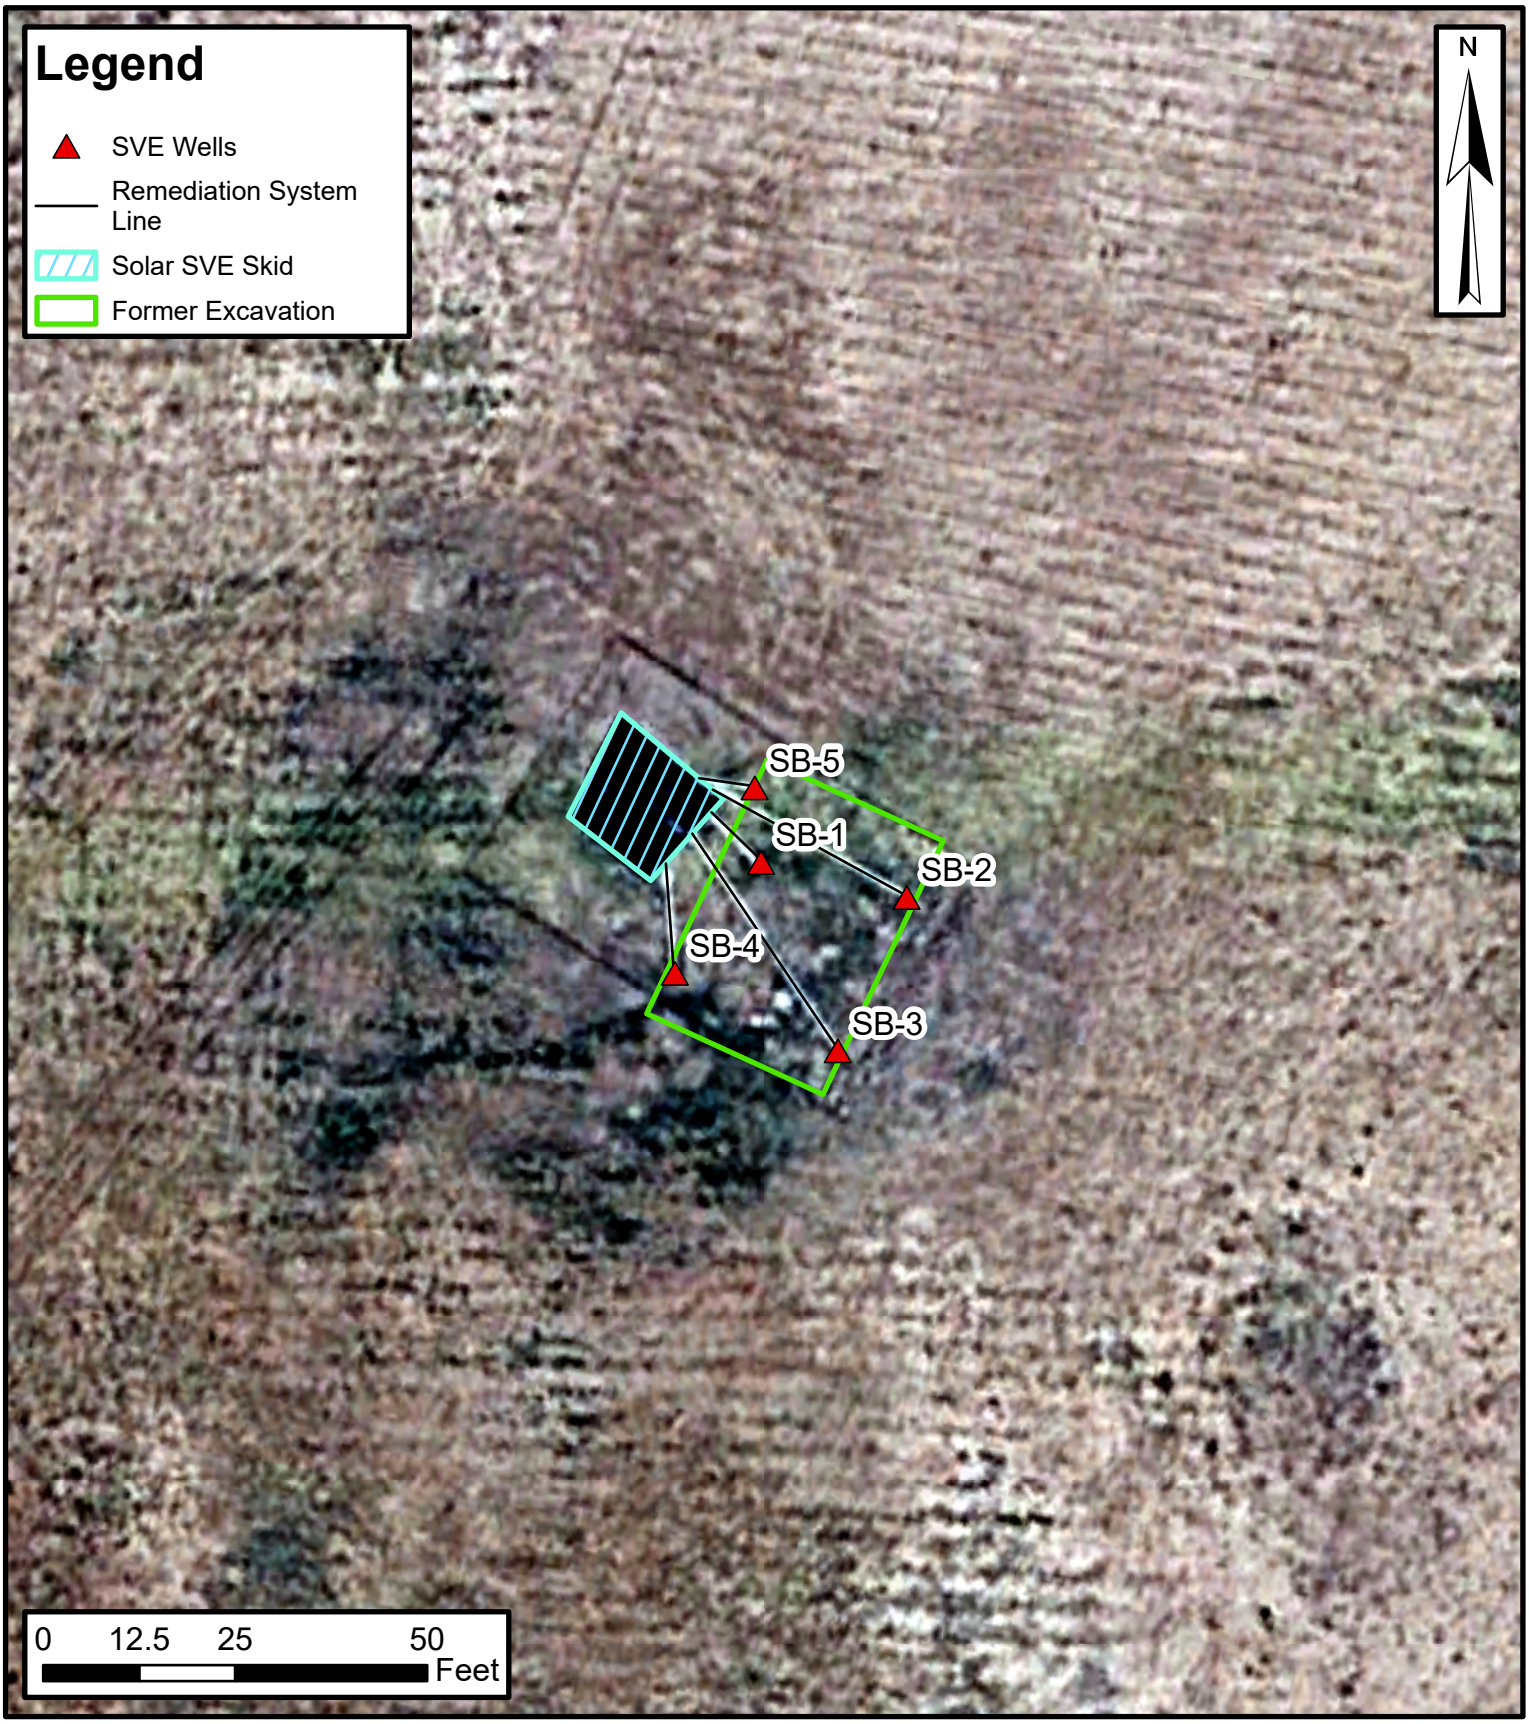
FIGURE
2

SVE System Layout

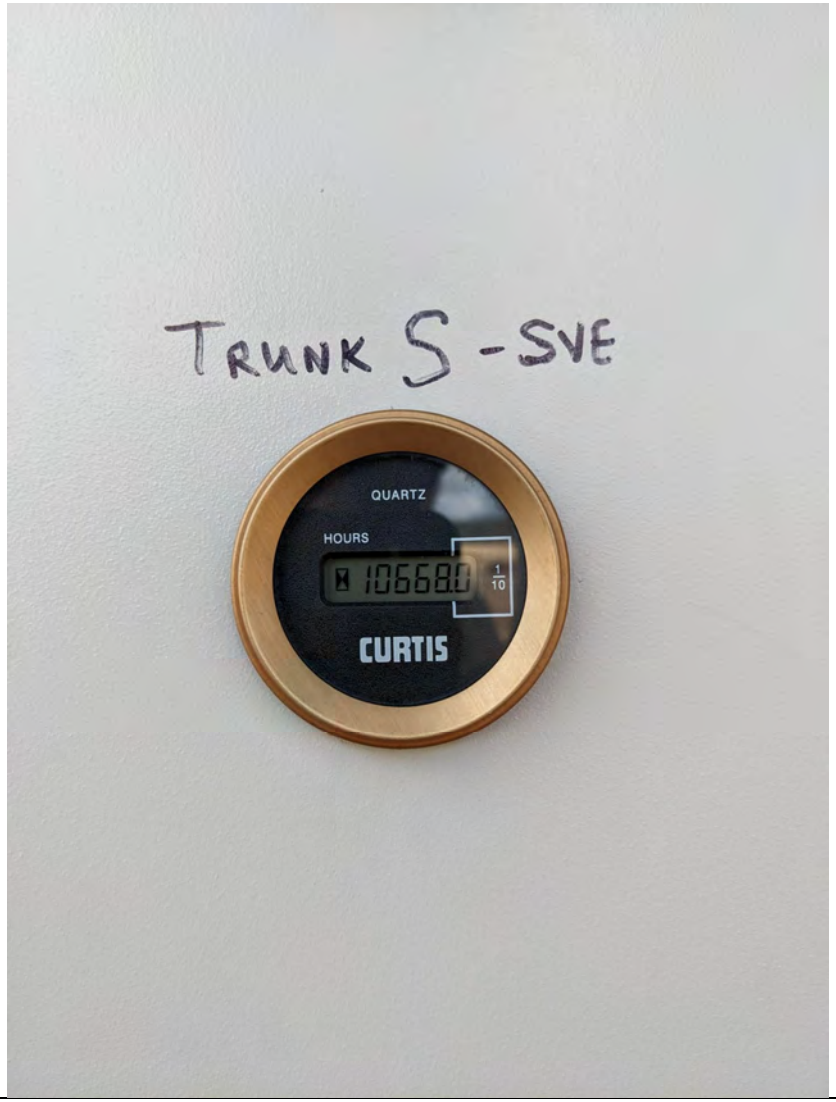
Photo #1
SVE Hours Reading 12-7-2022
