Report Type: Revised Closure Report 1RP-4760

General Site Information:						
Site:	**Battle Federal #4H**					
Company:	**Marathon Oil Company**					
Section, Township and Range	**Unit M**	**Sec. 27**	**T 21S**	**R 33E**		
Lease Number:	**API No. 30-025-42636**					
County:	**Lea County**					
GPS:	**32.4430715º N**			**103.565825º W**		
Surface Owner:	Merchant Livestock					
Mineral Owner:	State					
Directions:	From the major intersection of HWY 8 and HWY 176, go west for 13.4 miles, turn left onto lease road. In 1.5 miles, turn right onto lease roa. In 3 miles, turn right. Travel for 3 miles and destination will be on your left.

Re: Revised Closure Report for the Marathon Oil, Battle Federal #4H, Unit M, Section 27, Township 21 South, Range 33 East, Lea County, New Mexico. 1RP-4760.

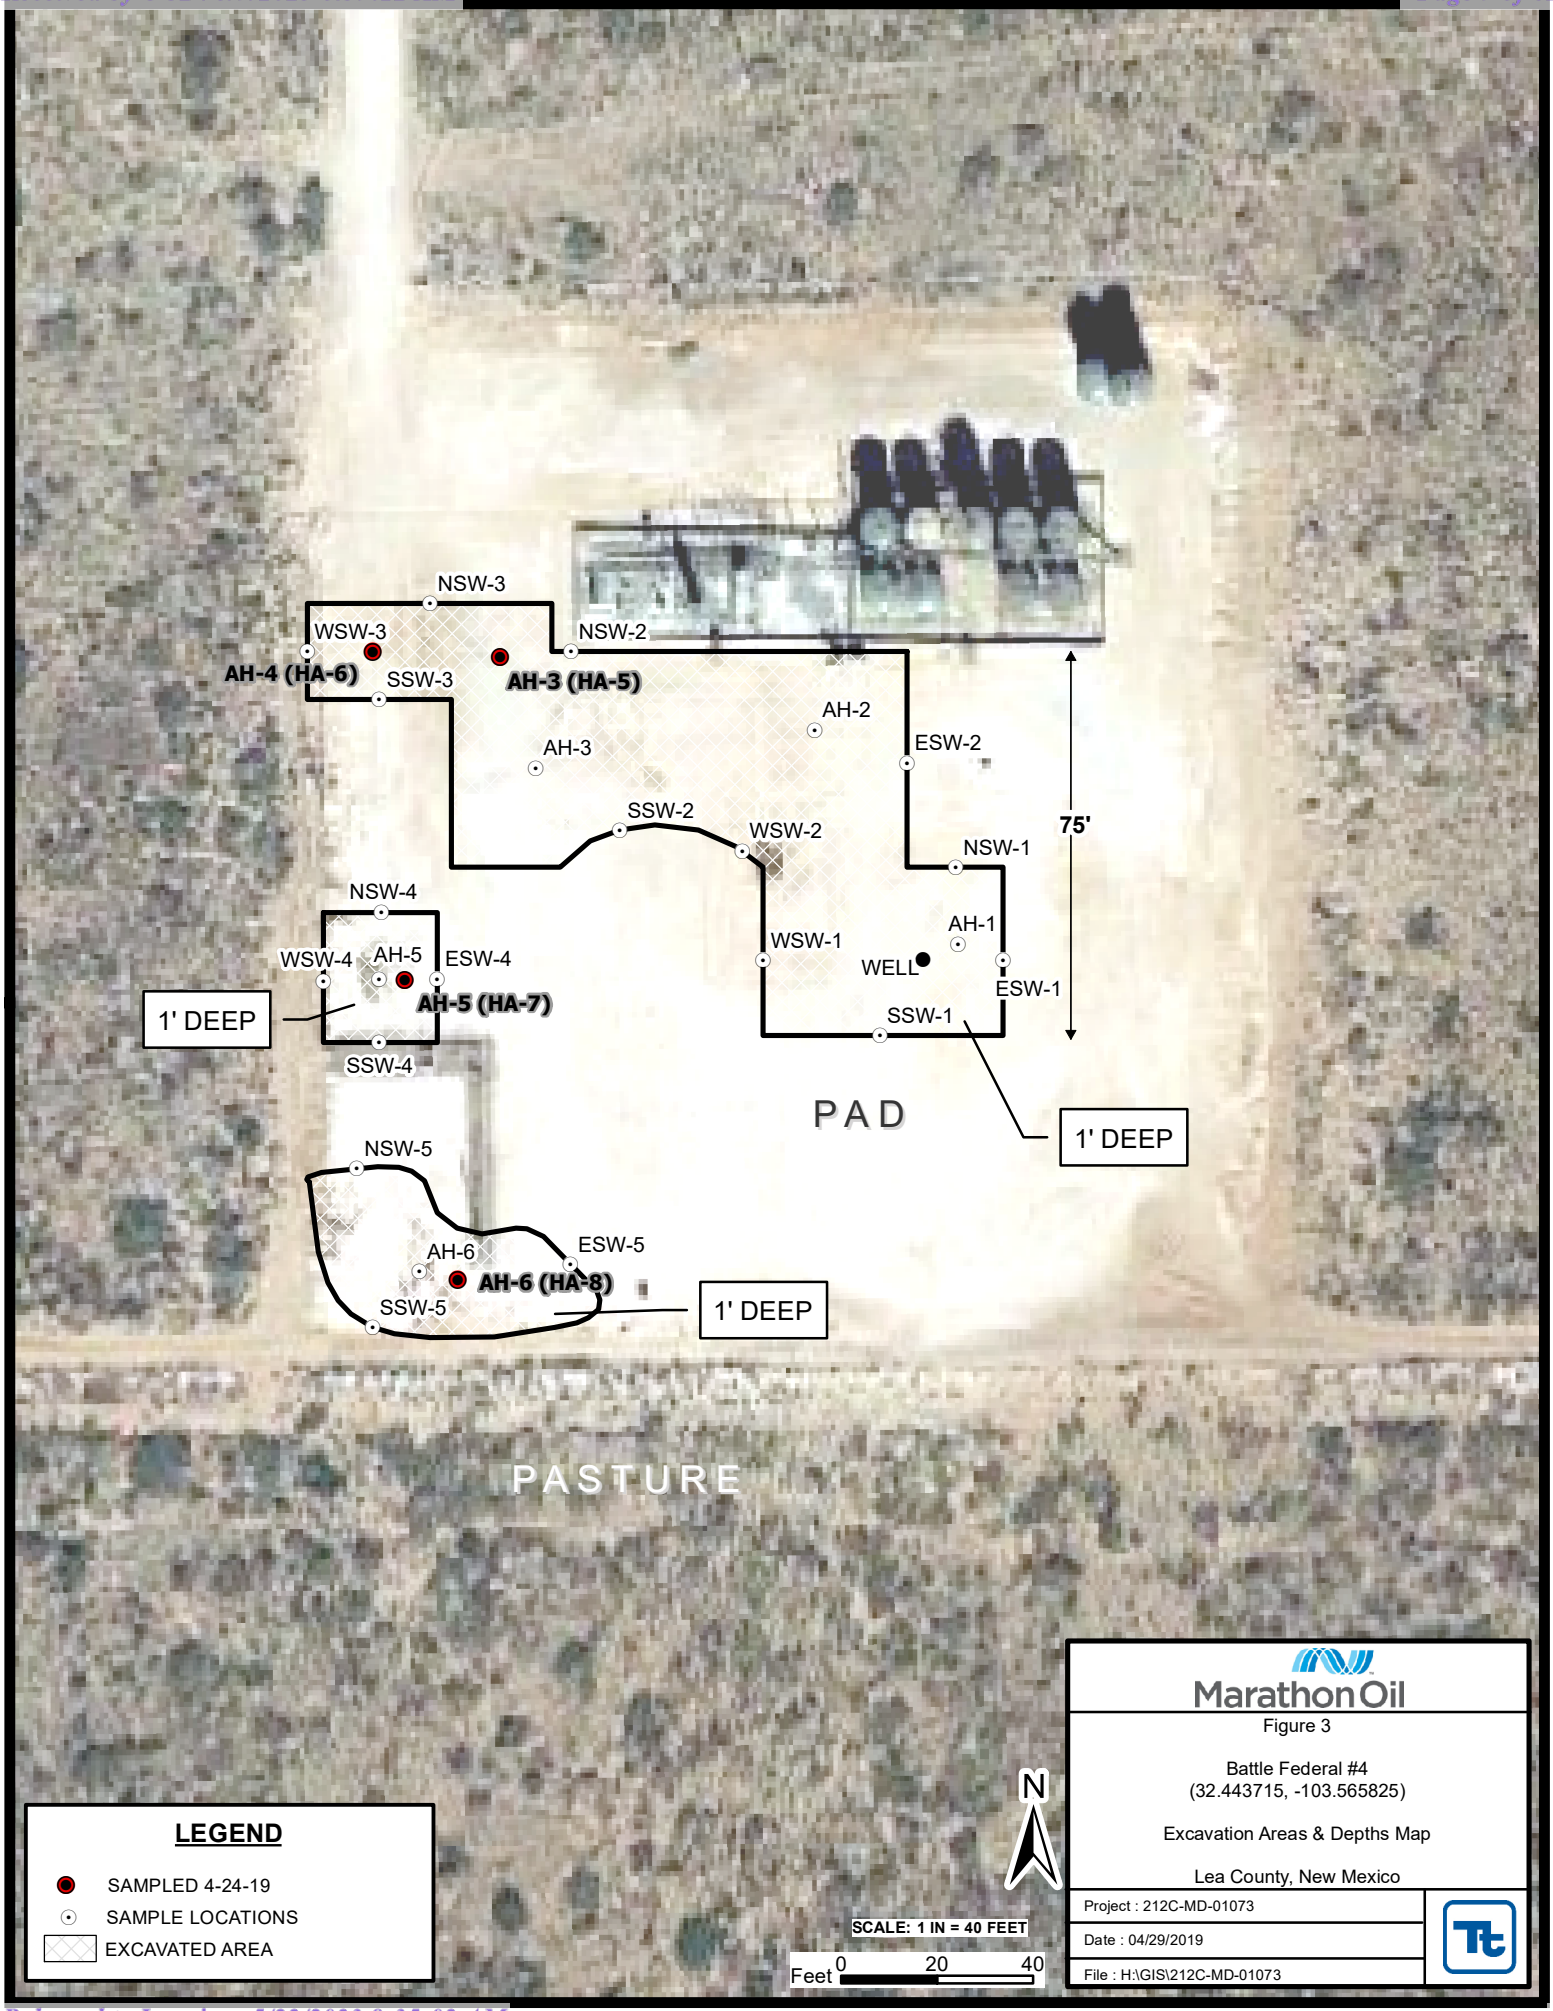
Tetra Tech was contacted to review the submitted work plan and implement the plan. On January 10-11, 2018, Tetra Tech personnel were onsite to supervise the excavation of the impacted areas. All of the areas were excavated to a total depth of 1.0' below surface. All of the excavated material was hauled for proper disposal. The excavation areas and depths are shown on Figure 3.

In order to ensure all of the impacted material was properly removed, bottom hole samples (AH-1, AH-2, AH-3, AH-4, AH-5, and AH-6) were collected as well as appropriate sidewall samples in each area. The samples were analyzed for chloride by EPA method 300.0. Copies of laboratory analysis and chain-of-custody documentation are included in Appendix C. The sampling results are summarized in Table 1. The sampling locations are shown on Figure 3.

Referring to Table 1, all of the bottom hole and sidewall samples showed chloride concentrations below the 600 mg/kg threshold, with the exception of sidewall samples (NSW-2 and SSW-2). Due to safety concerns, any additional excavation in these areas were not performed due to the proximity of an active gas meter and underground electrical line in the area. The impacted soils were excavated to the maximum extent practicable. In addition, sidewall samples (NSW-5 and ESW-5) reported chloride concentrations above the 600 mg/kg limit. As a result, excavation was extended 1.0' to remove the soil above 600 mg/kg. Once the excavation was completed, the areas were backfilled with clean material to surface grade.

As requested by the NMOCD, Tetra Tech returned to the location on April 24, 2019, to collect samples below the excavation depth in the areas of HA-5 (AH-3), HA-6 (AH-4), HA-7 (AH-5), and HA-8 (AH-8). The samples were collected at 12”-16” below surface and were submitted to the laboratory for chloride analysis. The sample locations are shown on Figure 4 and summarized on Table 1.

Based on the soil assessment and remediation work performed at the site, Marathon requests acknowledgment of the overall remediation and the deferral of sample locations SSW-2 and NSW-2. The updated C-141 is enclosed in Appendix A. If you have any questions or comments concerning the assessment or the remediation activities for this site, please call me at (432) 682-4559.
