Raybaw Operating, LLC.
2626 Cole Ave., Suite 300
Dallas, TX 75204
214-800-2301

July 12, 2023

RE: Site Assessment, Remediation, and Variance Request
Chimayo 16 State #003
API No. 30-015-38105
GPS: Latitude 32.1329002 Longitude -103.9933624
UL "F", Section 16, Township 25S, Range 29E,
Eddy County, NM
NMOCD Reference No. NAB1728637411

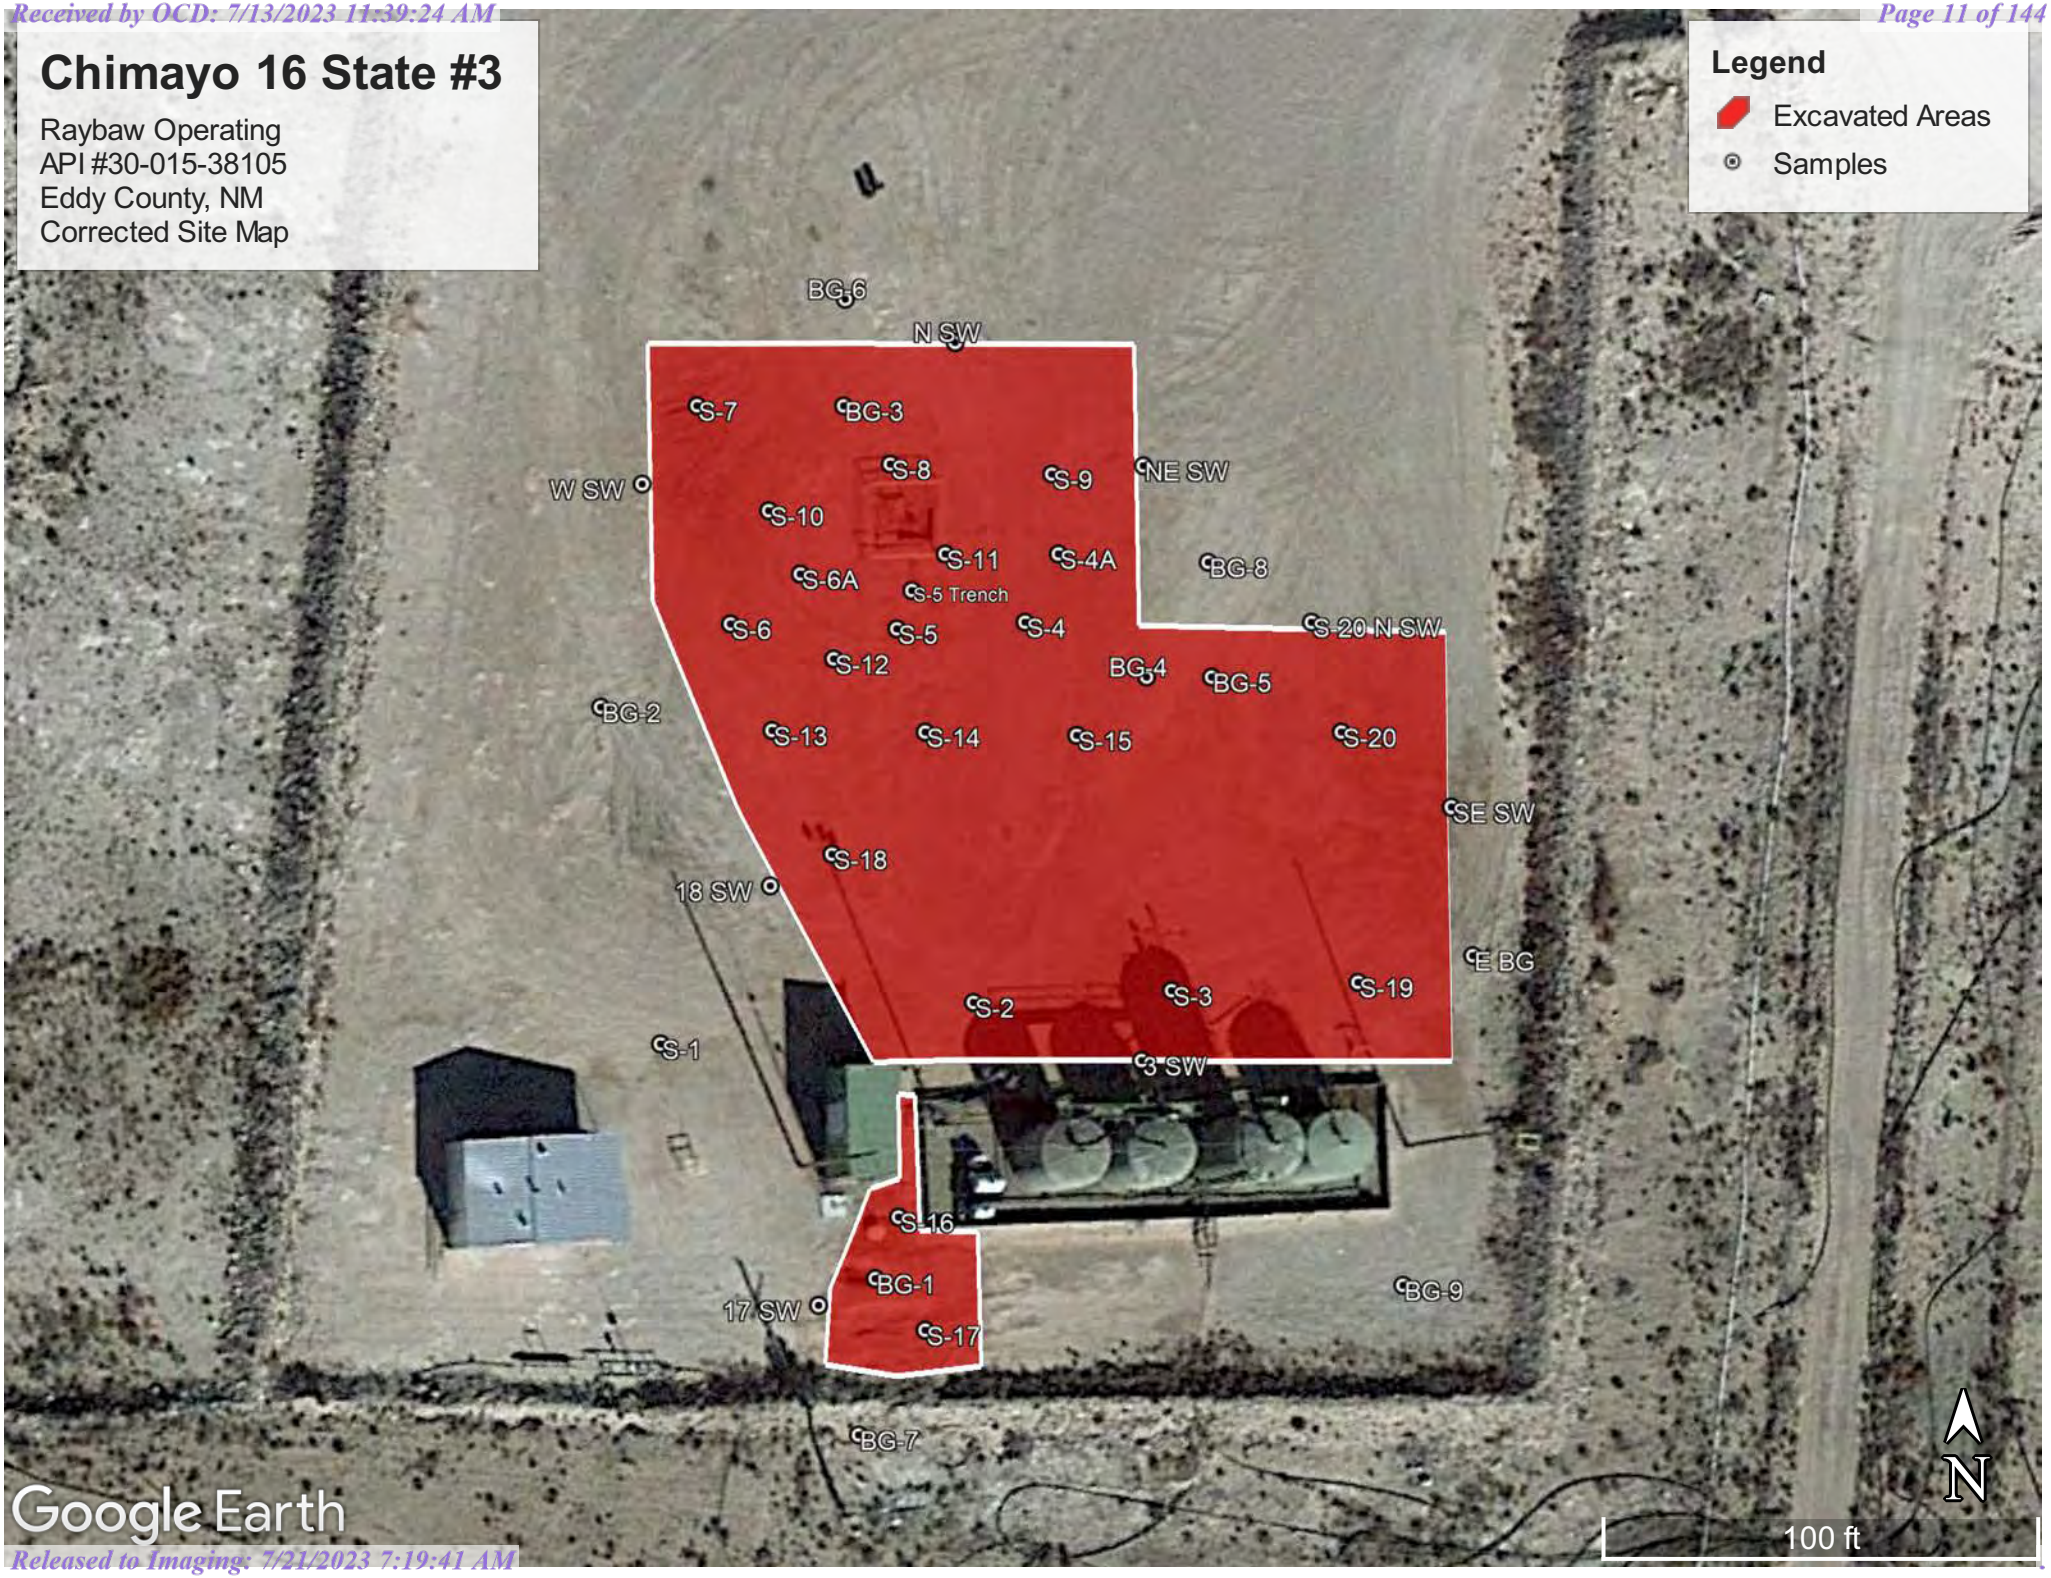
Raybaw Operating
API #30-015-38105
Eddy County, NM
Corrected Site Map

On July 23, 2020, Talon/LPE mobilized personnel to perform a site assessment and collect soil samples. Grab soil samples were collected within and around the impacted area utilizing a hand auger. Further sampling took place in September in conjunction with remediation, utilizing first a backhoe and then an excavator due to the hard rock refusal experienced at approximately 2' BGS. Sampling continued into October both to guide further excavation and to delineate the site. The laboratory results from these sampling events can be found in the data tables on pages 4 - 6 of this report. A Corrected Site Map can be found in Figure 4.

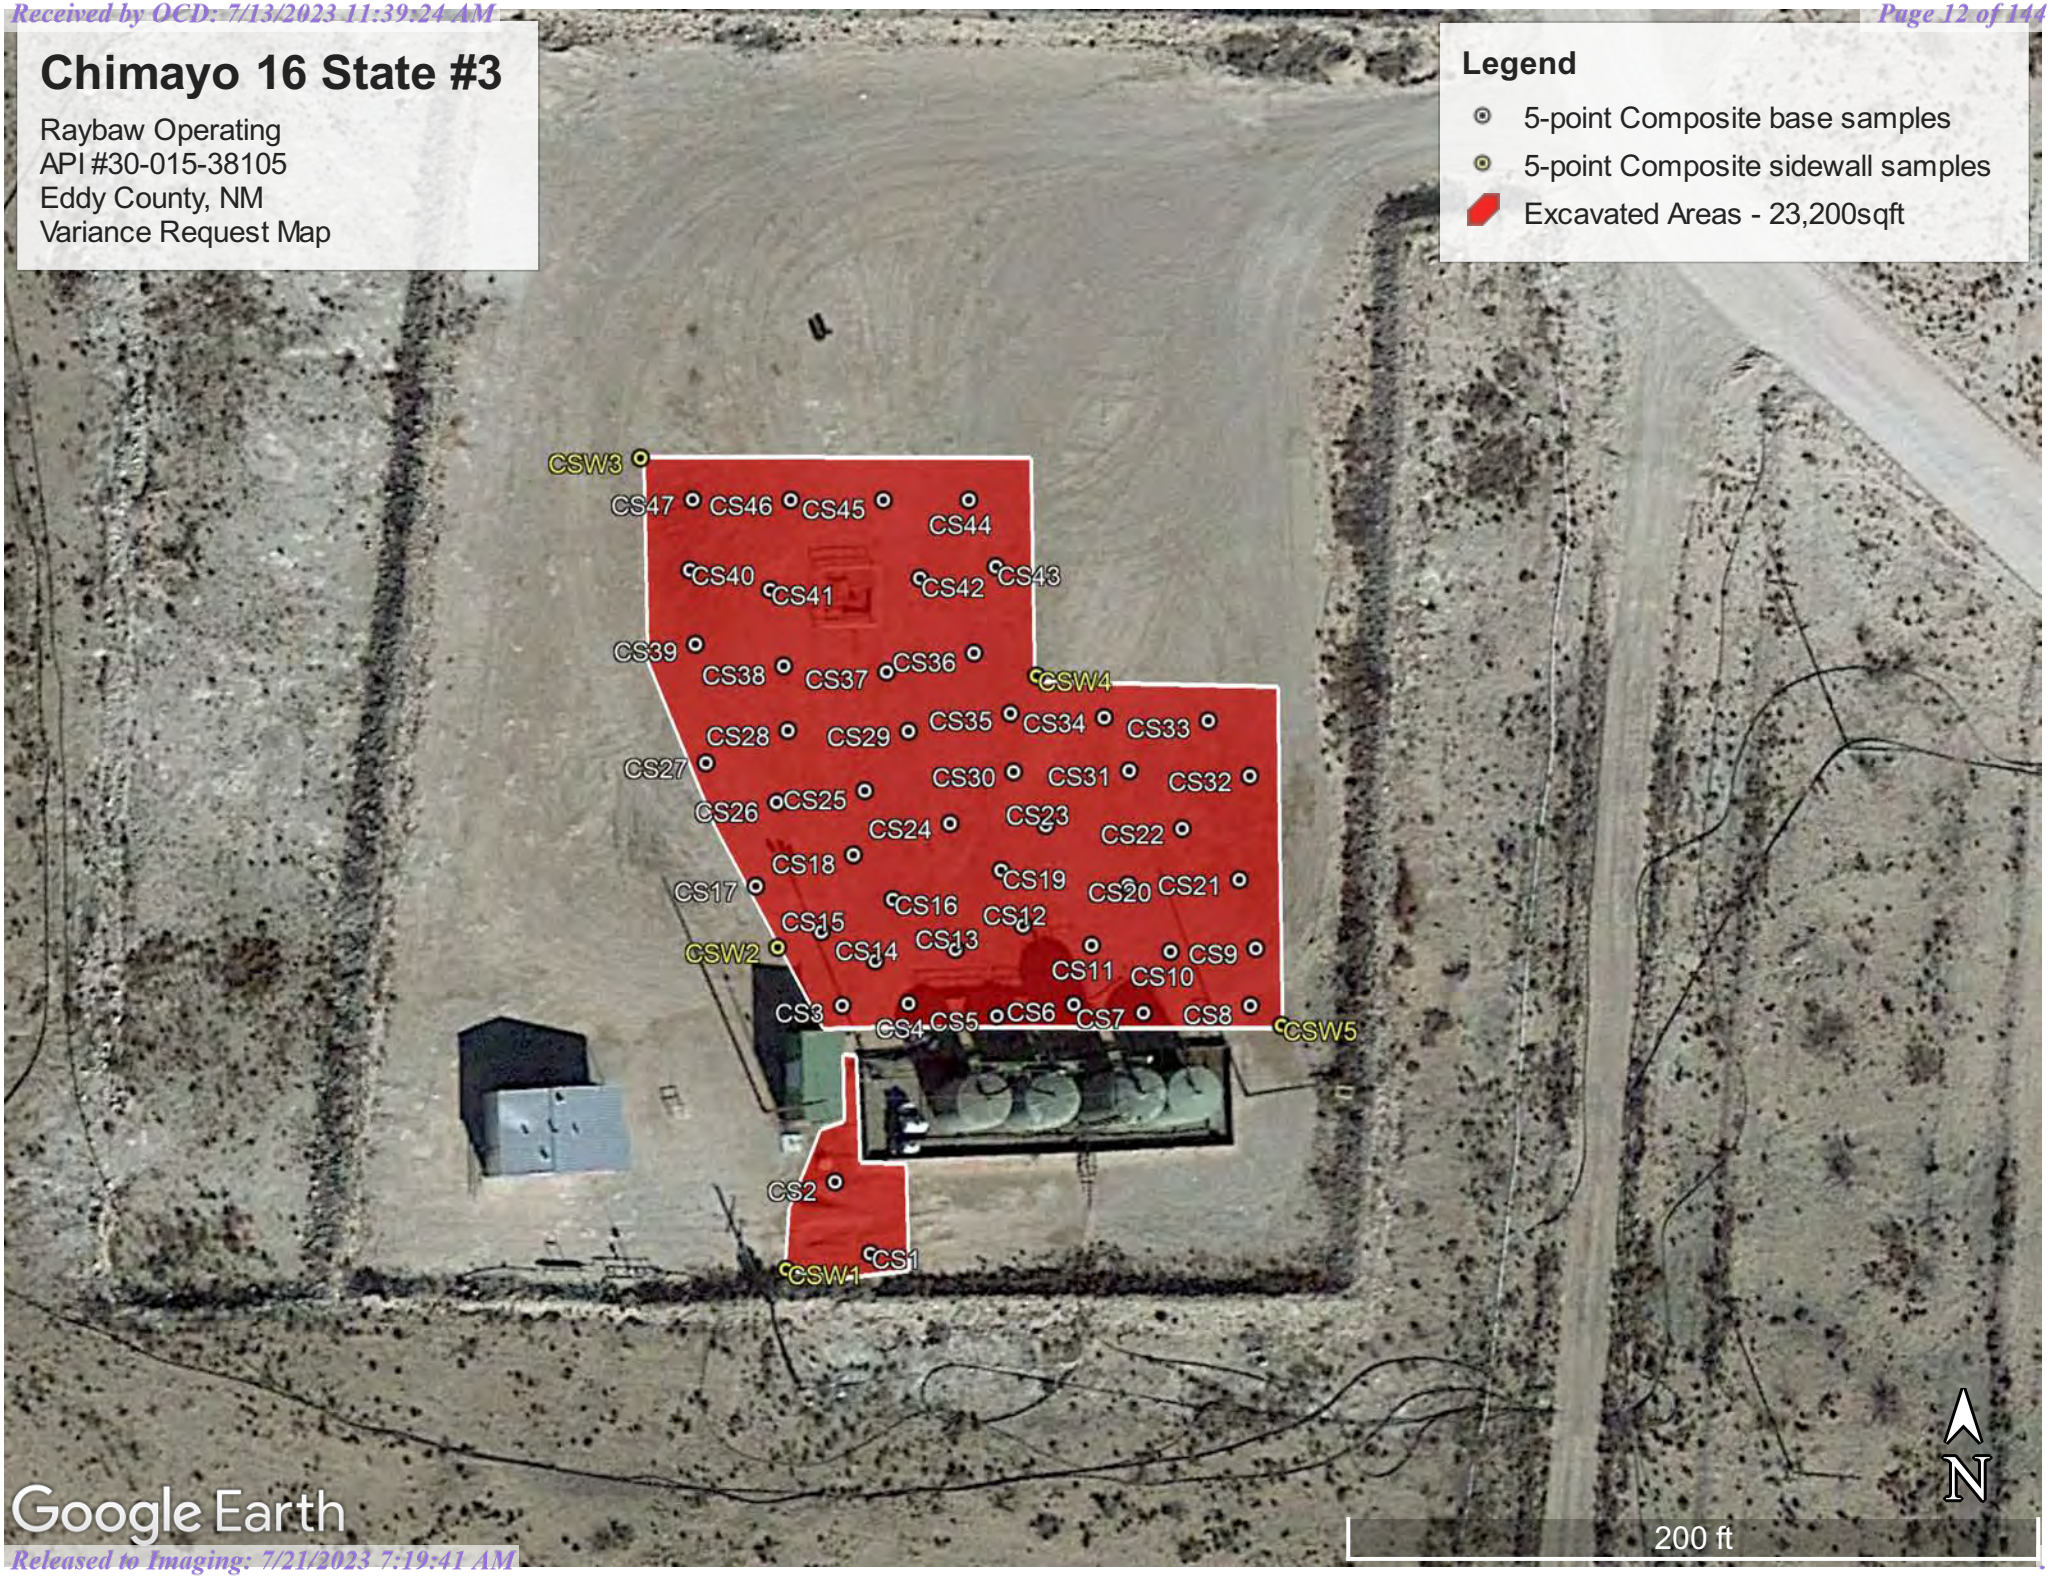
Raybaw Operating
API #30-015-38105
Eddy County, NM
Variance Request Map

Based on the large area associated with the Chimayo releases, nAB1532742191 & nAB1728637411, Raybaw would like to request a variance regarding the number of 5-point composite confirmation samples required for closure. The current release area is approximately 23,200 feet squared, requiring 116 confirmation base samples and 9 confirmation sidewall samples, following the 200 square foot rule. We believe we can obtain an accurate representation of the remediated area by collecting 5-point composite confirmation samples every 500 square feet. If further contamination is encountered, the number of required samples will be adjusted to maintain representation of every 500 square feet. Maps and data will be adjusted to accurately reflect the field information. A Variance Request Map is included as Figure 6. A Written Demonstration of Equal Protection can be found in Figure 7.

1. Begin excavating the top 2' of soil from the previously backfilled spill area.
2. Pima personnel will field screen for contaminants as the soil is excavated. If any contaminated soil is encountered, it will be loaded up and transported to an NMOCD-approved, lined disposal facility.

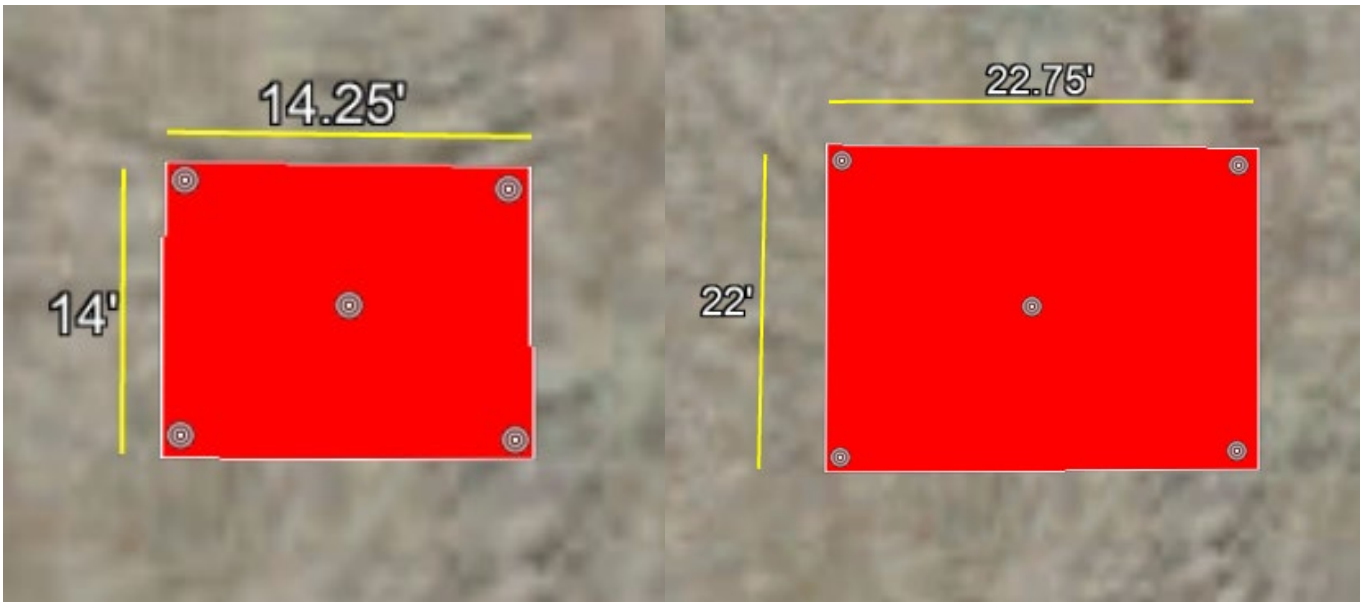
200 Square Foot **500 Square Foot**

8. The impacted difference in collecting 5-point composite samples from every 500 square feet versus every 200 square feet can be seen in the following illustrations.

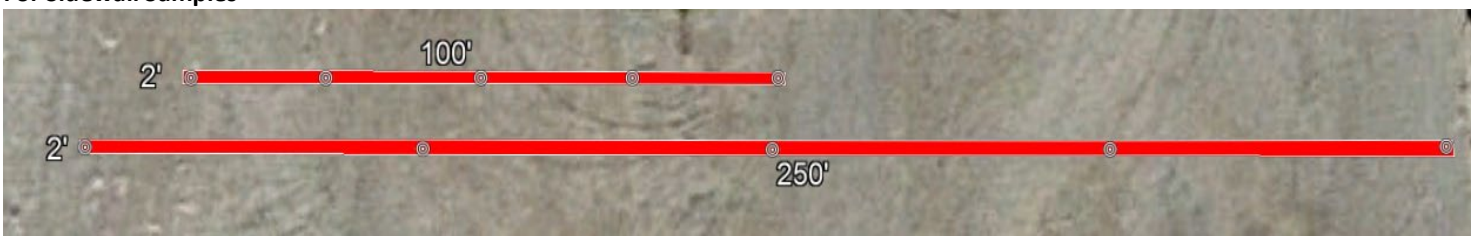
Top Line = 200 Square Foot **Bottom Line = 500 Square Foot**

For Sidewall Samples

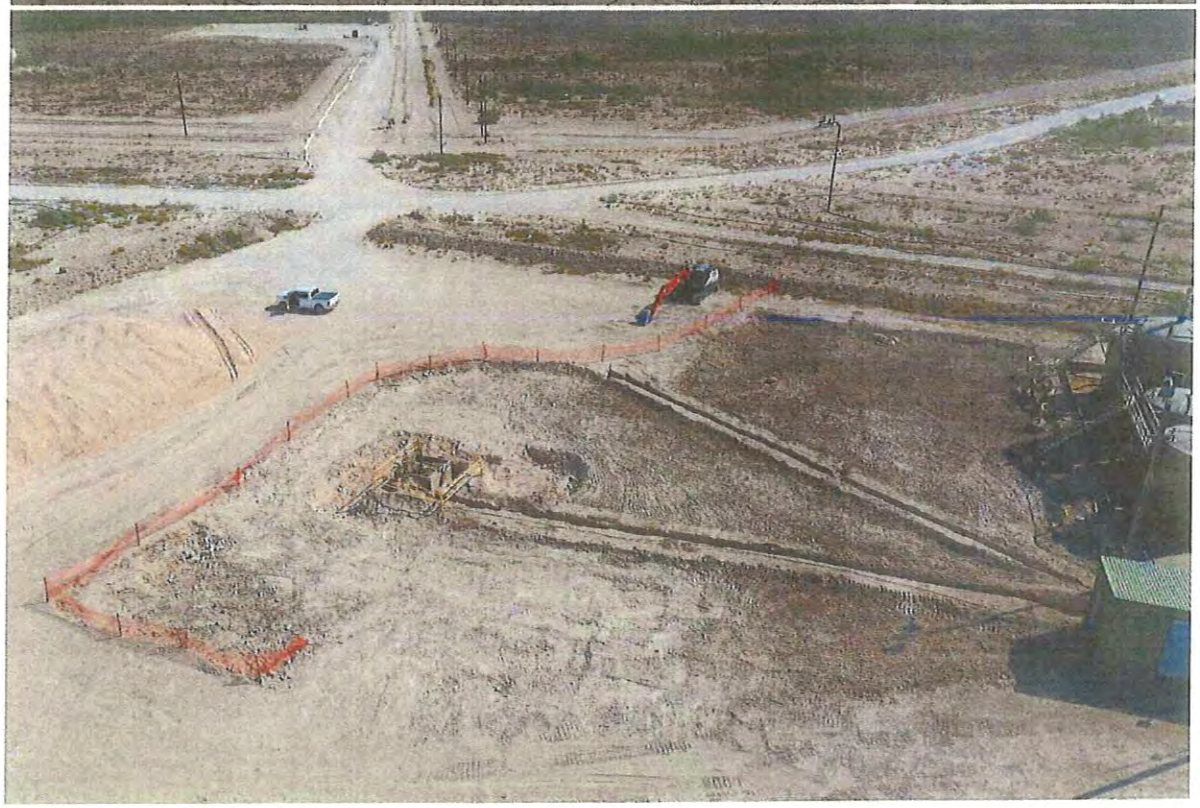
Chimayo 16 State #003 Excavation

In November of 2020, Talon/LPE mobilized personnel and equipment to begin remediation activities. The impacted areas in the vicinity of sample locations S-8 and S-11 were excavated to a depth of 4-feet BGS where hard rock refusal was encountered. After the borehole was installed, and the absence of ground water was verified, the remaining impacted areas on the well pad were excavated to a depth of 2-feet BGS. Confirmation samples were obtained from the sidewalls and bottoms of the excavated areas to verify that all contaminants above closure criteria had been removed. All the excavated material was hauled to Lea Land, LLC., an NMOCD-approved solid waste disposal facility. The excavated area was backfilled with new caliche, machine compacted and contoured to match the surrounding location. Photographic Documentation can be found in Appendix D.
