Re: Second Quarter 2023 – SVE System Update
Lambe 2C
San Juan County, New Mexico
Hilcorp Energy Company
NMOCD Incident Number: NVF1836050592
Ensolum Project No. 07A1988008

Ensolum, LLC (Ensolum), on behalf of Hilcorp Energy Company (Hilcorp), presents this *Second Quarter 2023 – SVE System Update* report summarizing the soil vapor extraction (SVE) system performance at the Lambe 2C natural gas production well (Site), located in Unit H, Section 20, Township 31 North, and Range 10 West in San Juan County (Figure 1). Specifically, this report summarizes Site activities performed in April, May, and June of 2023 to the New Mexico Oil Conservation Division (NMOCD).

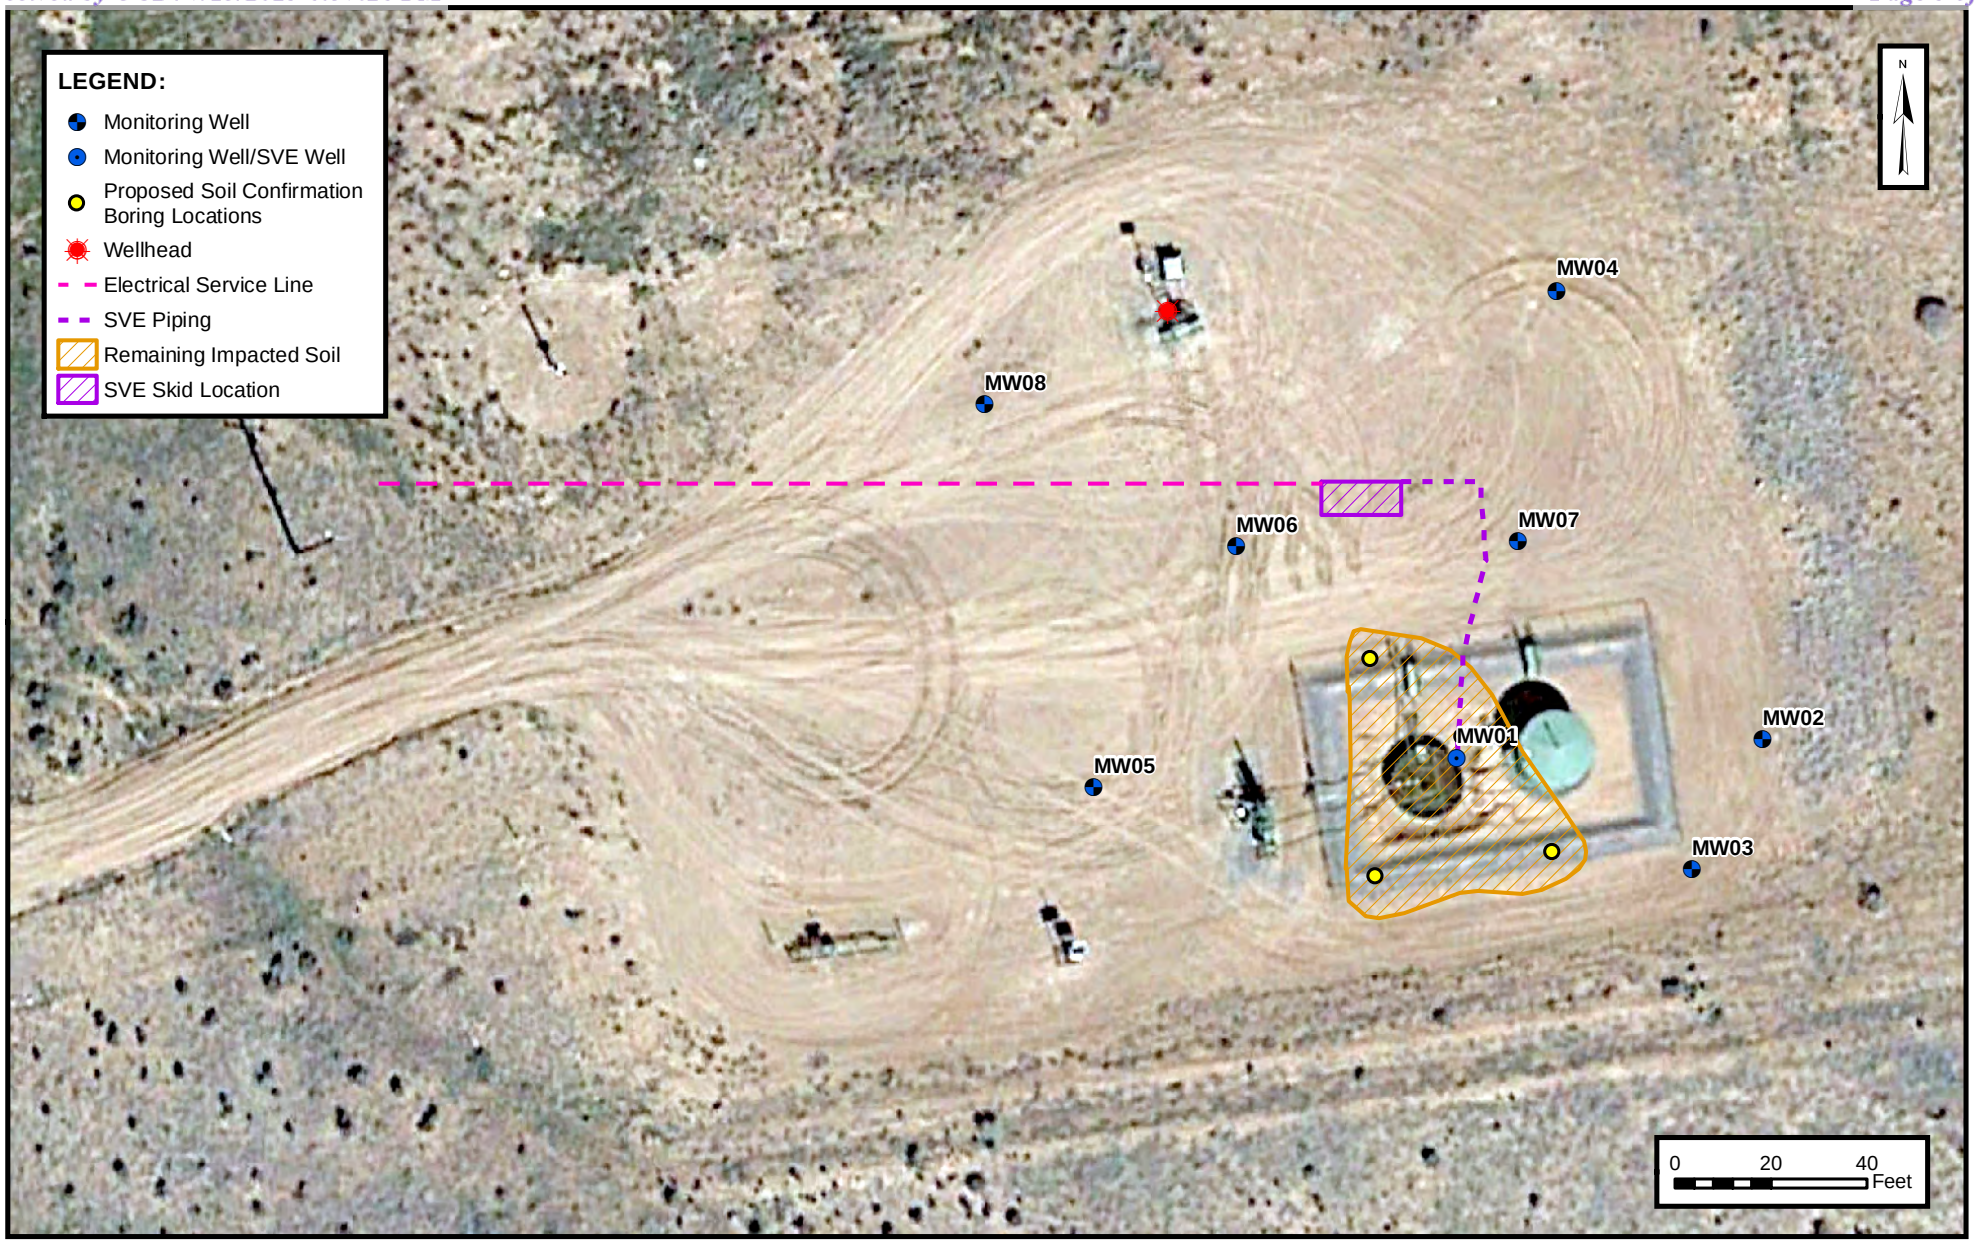
FIGURE

The current SVE system was installed at the Site in September 2021, with operation beginning on September 24, 2021. The SVE system is configured so vacuum is being applied to well MW01 (shown on Figure 2). SVE well MW01 is screened across the impacted soil interval from approximately 20 feet to 35 feet below ground surface (bgs). The SVE system consists of a 1 horsepower Atlantic Blower model AB-202/1 regenerative blower capable of producing 50 standard cubic feet per minute (scfm) flow and 30 inches of water column (IWC) vacuum. The layout of the SVE system and piping is shown on Figure 2.
