Pima Environmental Services
5614 N. Lovington Highway
Hobbs, NM 88240
575-964-7740

October 24, 2023

Re: Site Assessment and Closure Report
Galapagos 14 CTB 2
API No. N/A
GPS: Latitude 32.308700 Longitude -103.748633
UL -- C, Section 14, T23S, R31
Eddy County, NM
NMOCD Ref. No. nAPP2201435462

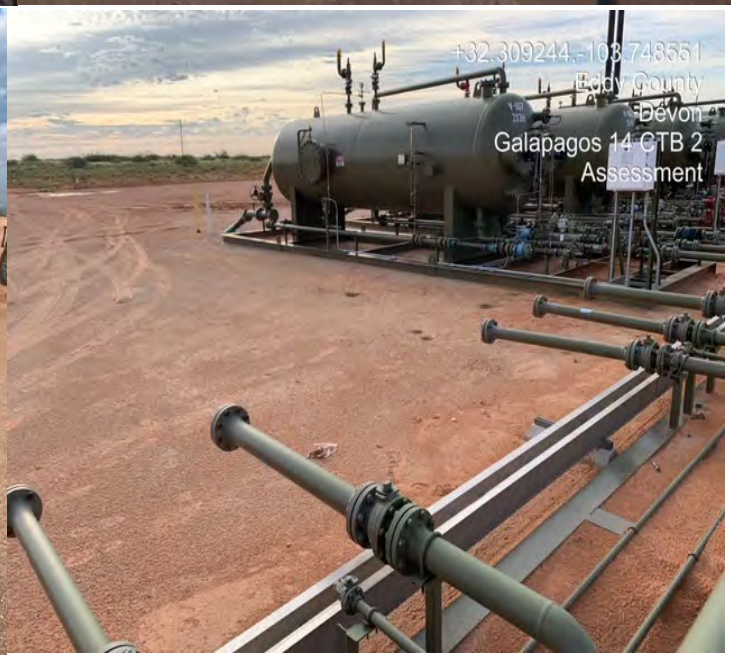
+32.309171,-103.748471
Eddy County
Devon
Galapagos 14 CTB 2
Assessment

LINER INSPECTION
DEVON ENERGY – GALAPOGOS 14 CTB 2

Site Assessment
