March 15, 2023

Re: 2022 Annual Groundwater Monitoring Report
San Juan 29-7 Unit 37
San Juan County, New Mexico
Hilcorp Energy Company
NMOCD Incident Number: NCS1904241144
NMOCD Administrative Order: 3R-425

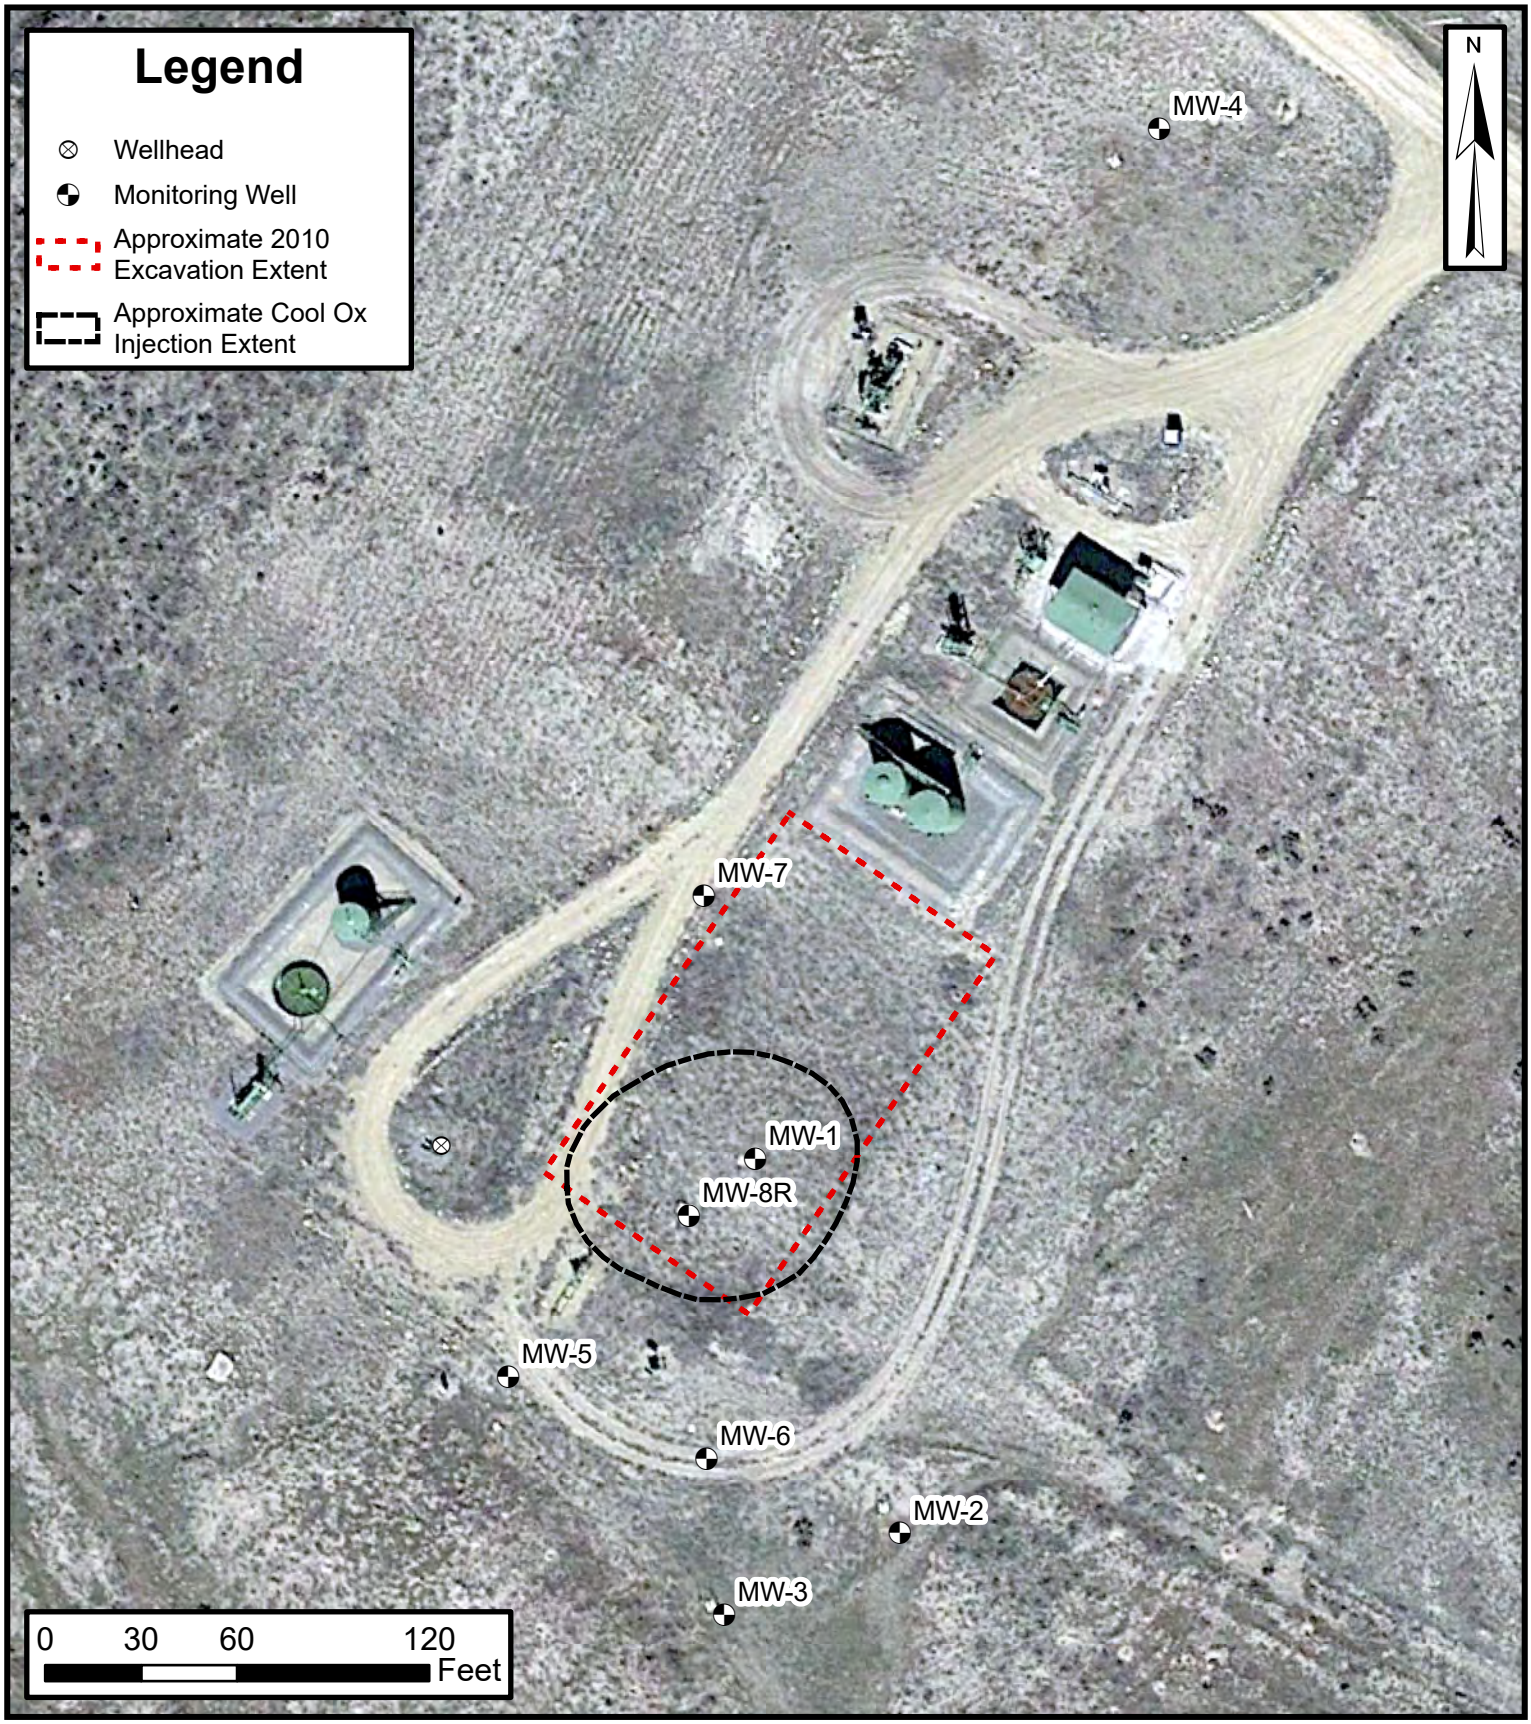
FIGURE
2

Based on historical sampling results and prior agreements with NMOCD, dissolved manganese is considered the only COC for groundwater in wells MW-1, MW-3, and MW-8R at the Site (as presented below). Well locations and Site features are shown on Figure 2.

Site Map

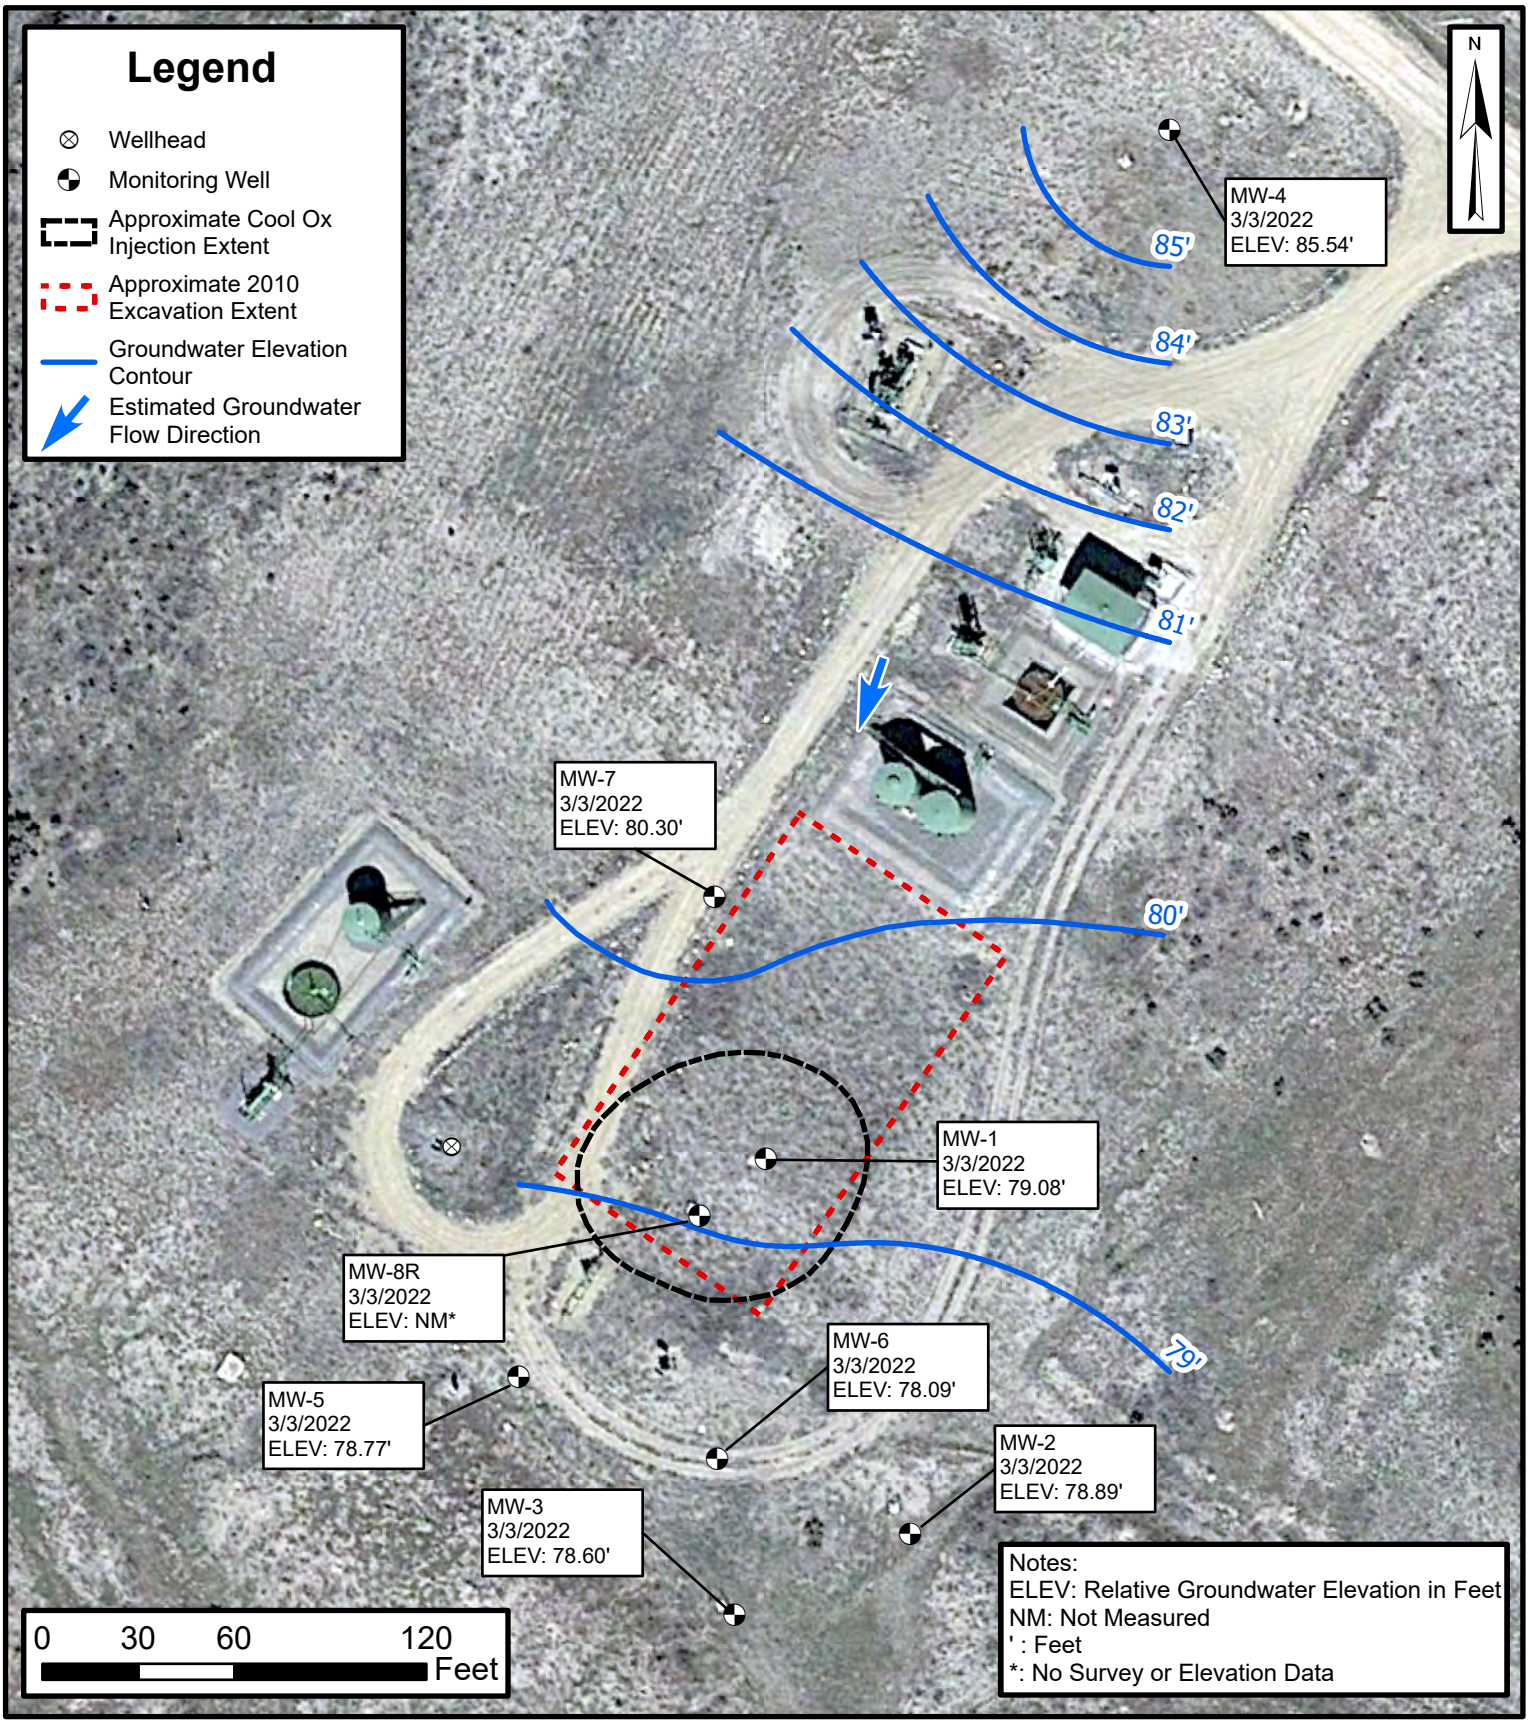
FIGURE
3

Semi-annual groundwater sampling events were conducted at the Site in March and September 2022. Prior to collection of groundwater samples in selected monitoring wells, depth to groundwater was measured using a Keck oil/water interface probe. The interface probe was decontaminated with Alconox™ soap and rinsed with distilled water prior to each measurement to prevent cross-contamination. Groundwater elevations measured in monitoring wells during the 2022 sampling events are presented in Table 1 and were used to develop groundwater potentiometric surface maps (Figures 3 and 4). The inferred groundwater flow direction is to the south.

Q1 Groundwater Elevation Map

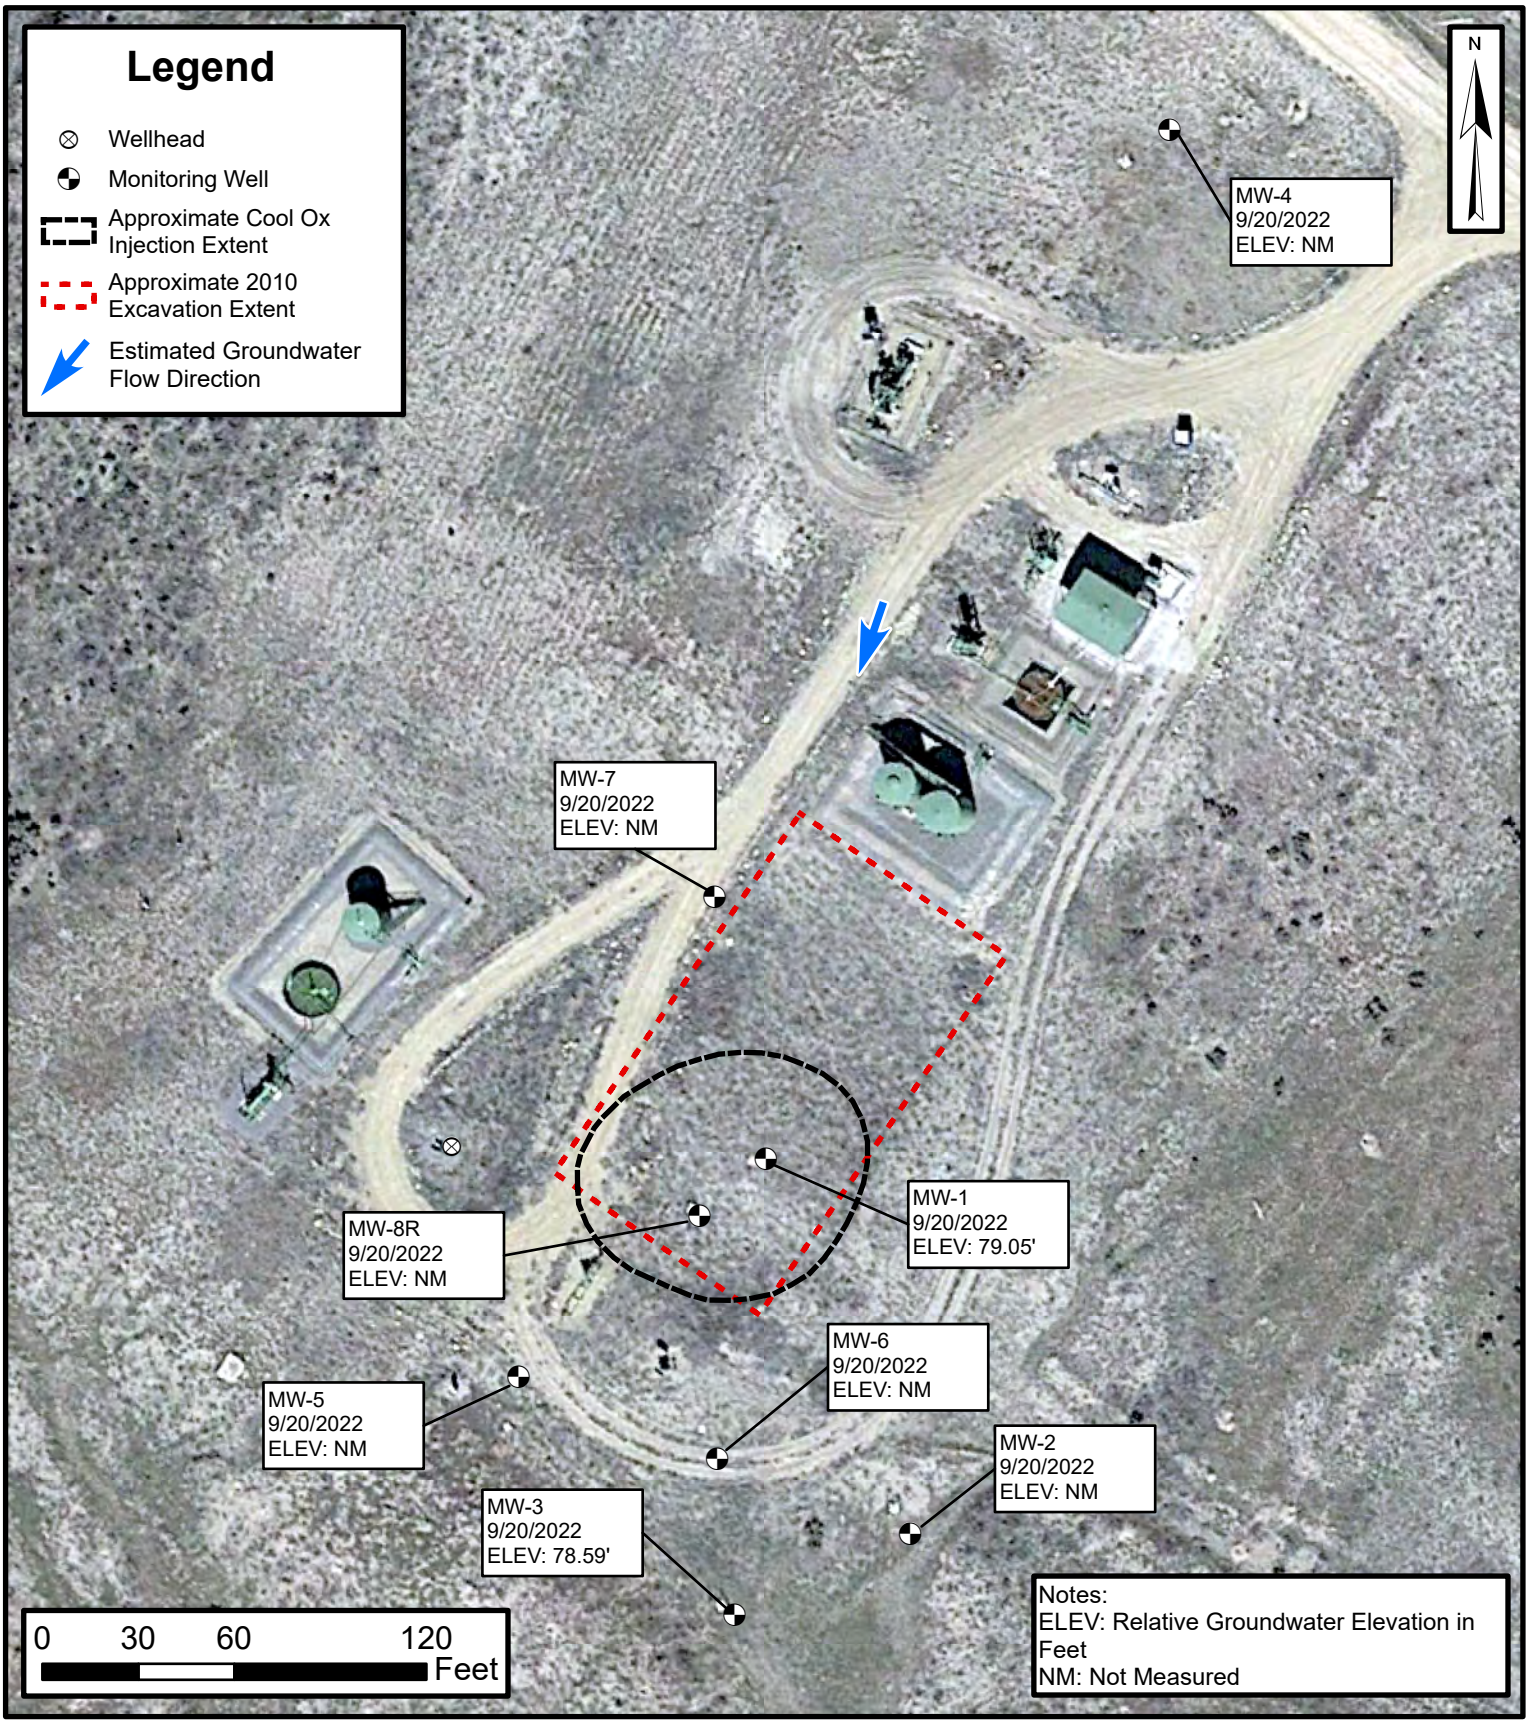
FIGURE
4

Q3 Groundwater Elevation Map

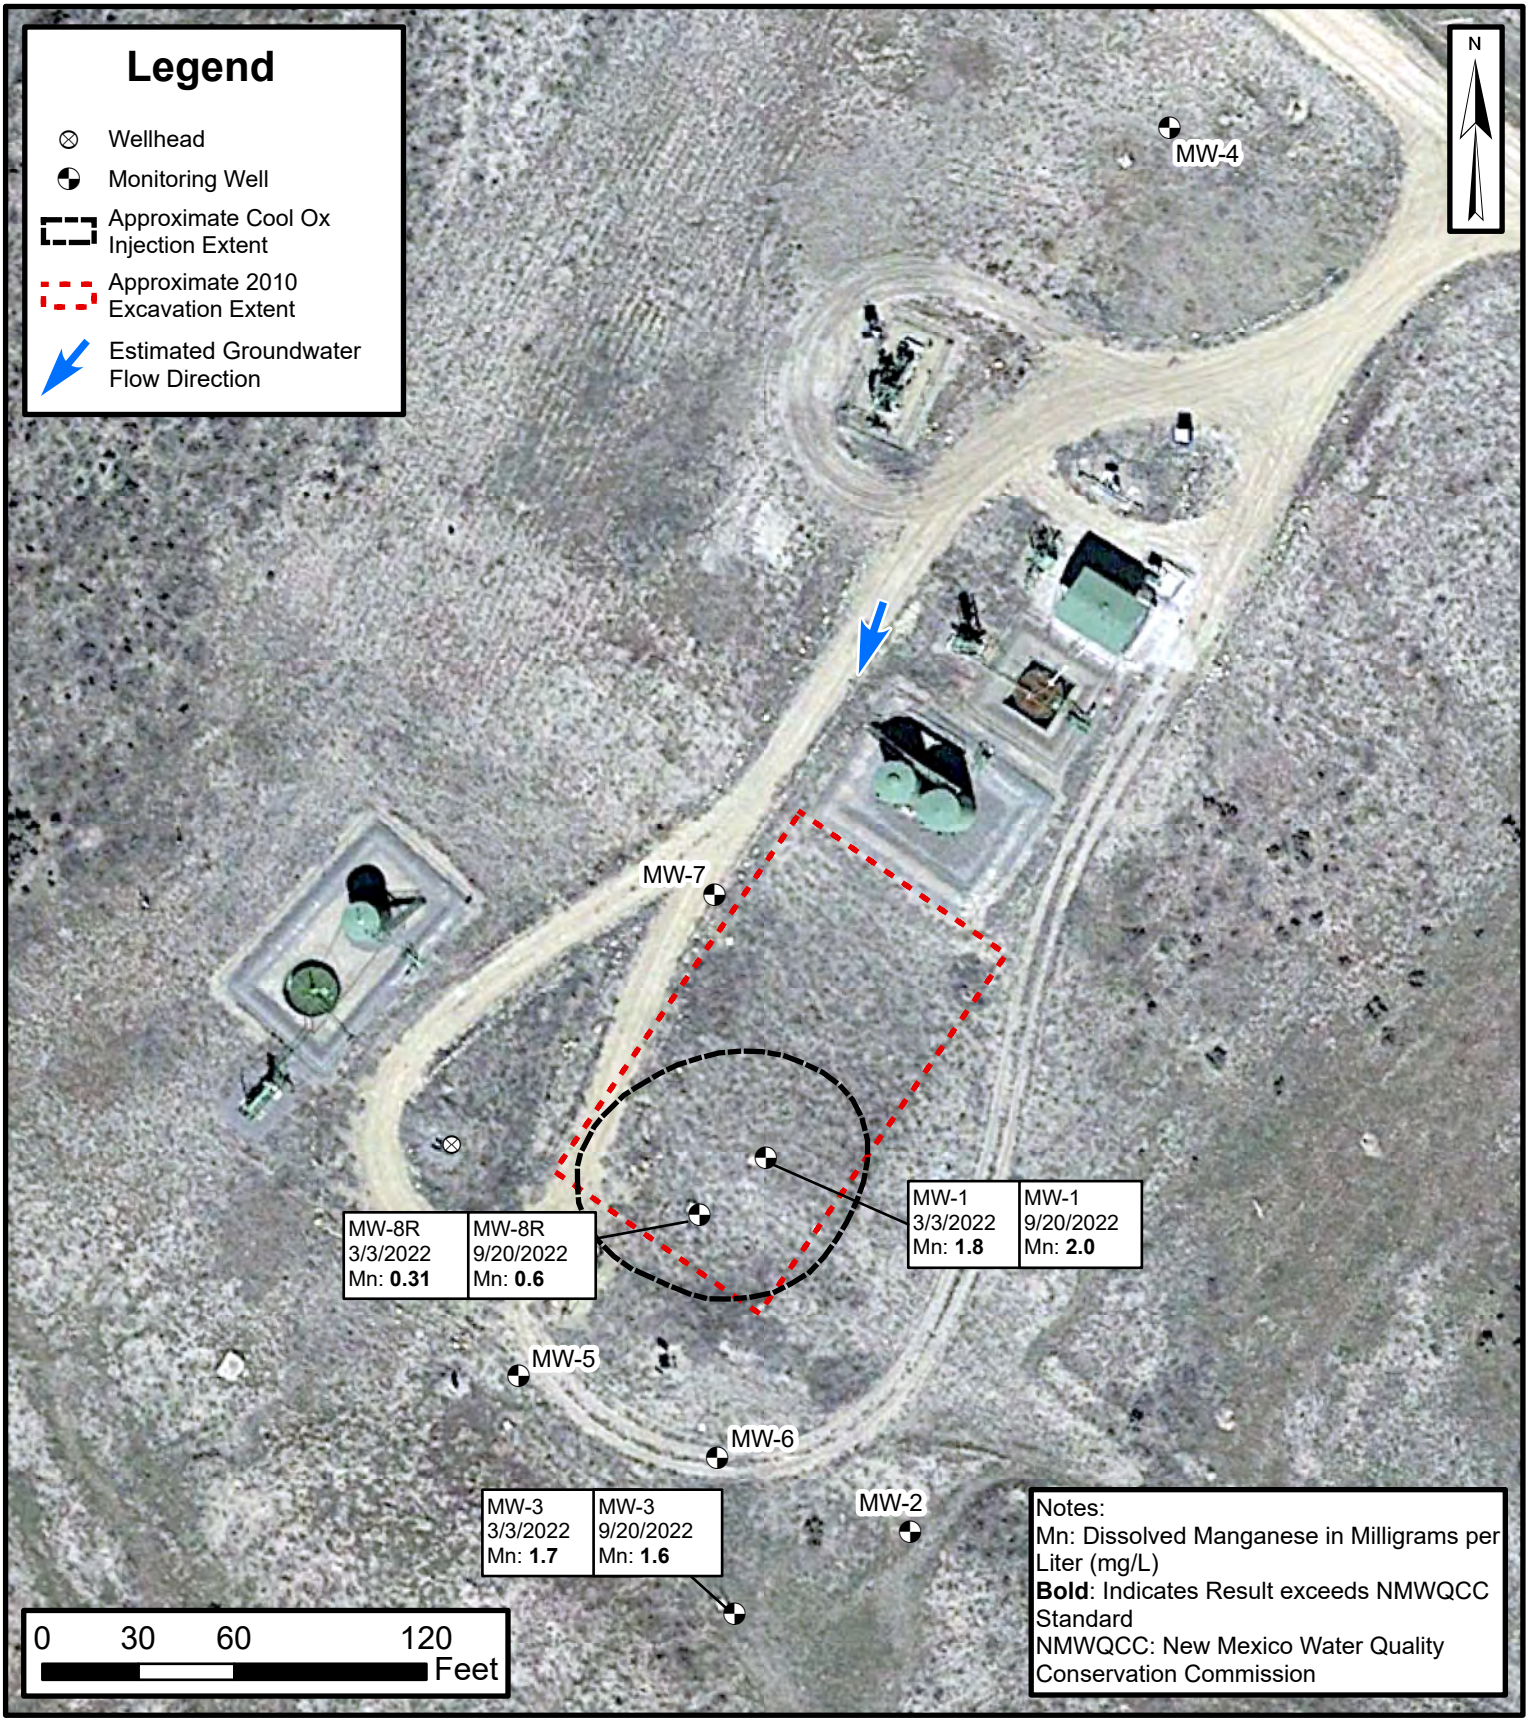
FIGURE
5

During the 2022 groundwater sampling events, dissolved manganese concentrations exceeded the NMWQCC standard during all sampling events collected from wells MW-1, MW-3 and MW-8R. Dissolved manganese concentrations ranged from 0.60 mg/L in well MW-8R to 2.0 mg/L in well MW-1. A summary of analytical results is presented in Table 3 and depicted on Figure 5, with complete laboratory reports attached as Appendix A.

Groundwater samples collected from wells MW-1, MW-3, MW-8R continue to contain dissolved manganese concentrations exceeding the NMWQCC groundwater quality standard. Elevated dissolved manganese concentrations appear to be a result of low-oxygen and reducing groundwater conditions in these wells. Average oxygen concentrations in wells MW-1, MW-3, and MW-8R (from data collected between 2015 and 2021) range from 1.68 mg/L to 2.02 mg/L, whereas average oxygen concentrations in all other on-Site wells range from 2.97 mg/L to 6.06 mg/L. Additionally, the oxidation-reduction potential (ORP) in wells MW-1, MW-3, and MW-8R range from -17.3 millivolts (mV) to -84.3 mV, suggesting continued reducing groundwater conditions in these wells leading to the dissolution of manganese and increased dissolved manganese concentrations. Conversely, the remaining wells at the Site have ORP values ranging from 18.0 mV to 35.8 mV, suggesting oxidizing conditions conducive to the precipitation of manganese, resulting in lower dissolved manganese concentrations.

2022 Groundwater Analytical Results

As groundwater conditions at the Site continue to equilibrate and dissolved oxygen increases, groundwater conditions will become increasingly aerobic. As this happens, dissolved manganese has the ability to precipitate out of solution leading to decreased concentrations in groundwater. This trend has already been documented in wells MW-2, MW-4, MW-5, MW-6, and MW-7. Because there are no potential receptors downgradient of the Site (closest water well SJ-03390, is located 1,900 feet southeast and cross gradient from the Site and is screened in a hydrogeologically separate water-bearing zone), Ensolum and Hilcorp recommend conducting annual sampling of wells MW-1, MW-3, MW-8R until dissolved manganese concentrations achieve the NMWQCC standard. At that time, Hilcorp will begin quarterly sampling until eight consecutive quarters indicate that manganese concentrations are below NMWQCC standards.
