SEVENTH ANNUAL GROUNDWATER MONITORING REPORT
CHESAPEAKE ENERGY CORPORATION
STATE M LEASE (AP-72)
LEA COUNTY, NEW MEXICO

May 26, 2021

SEVENTH ANNUAL GROUNDWATER MONITORING REPORT
CHESAPEAKE ENERGY CORPORATION
STATE M LEASE (AP-72)
LEA COUNTY, NEW MEXICO
MAY 26, 2021

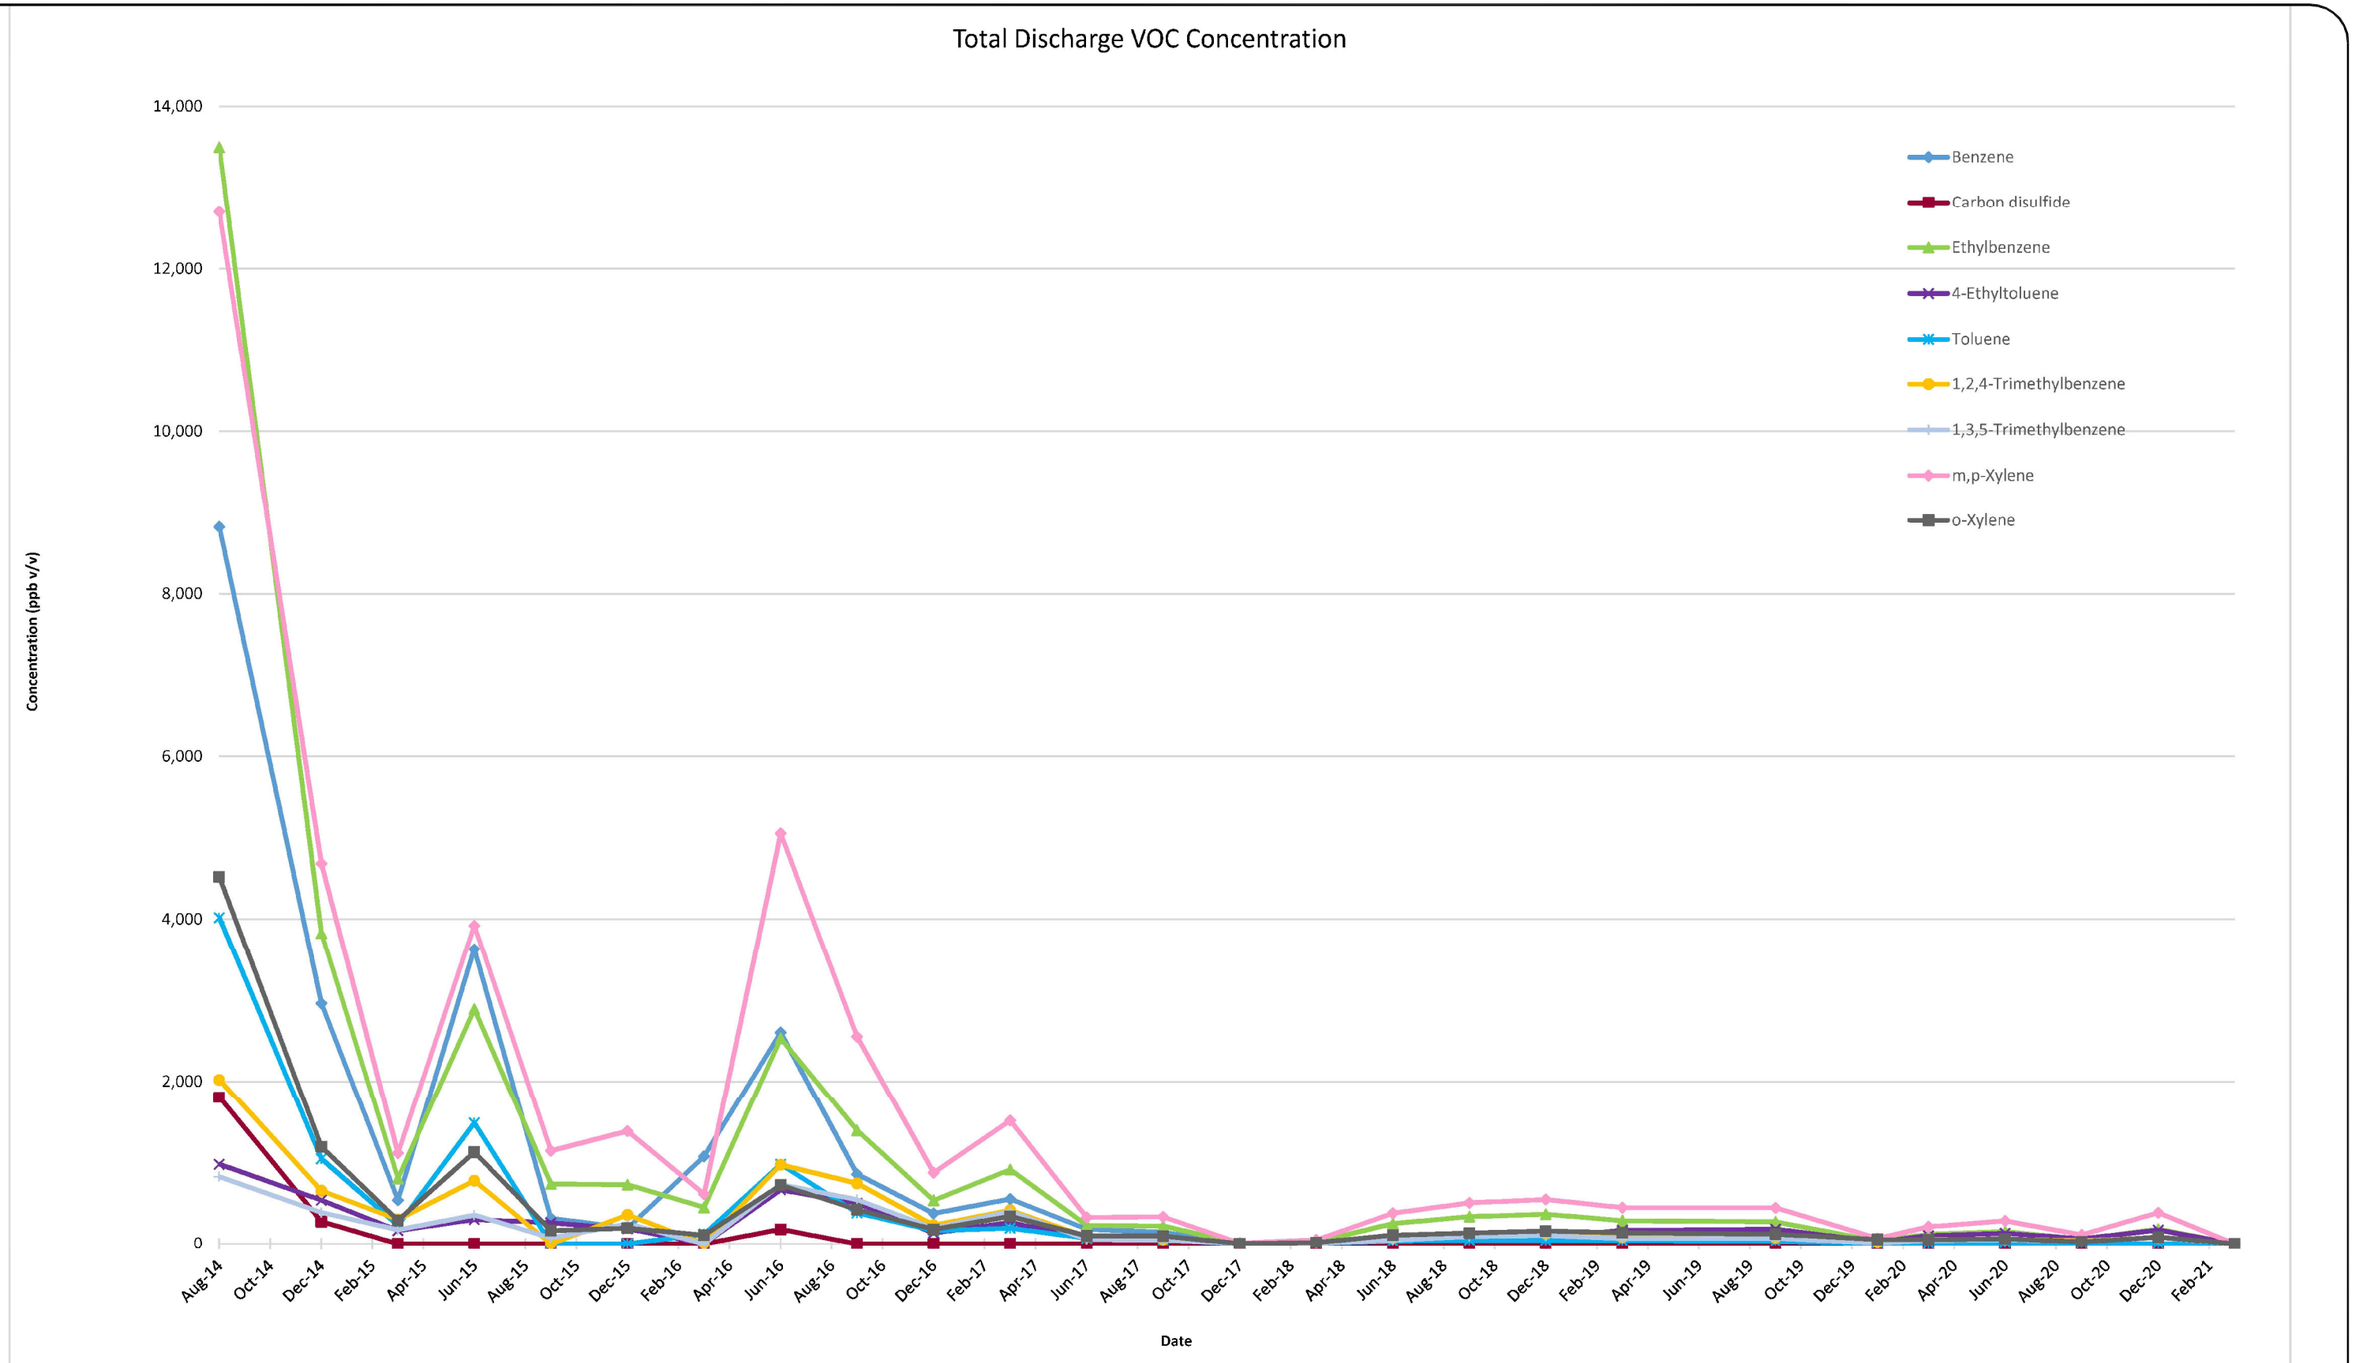
PROJECT NUMBER	FIGURE NUMBER
CHKSTATM:H20001	3

Figure 3 presents a graph of the VOC concentrations observed in the discharge air stream versus time. As can be seen on this figure, the levels of VOC observed in the air discharge stream have decreased dramatically since startup. These data indicate that the System is effective at removing the hydrocarbon vapors from the subsurface. Removal of hydrocarbon vapors coupled with the influx of oxygen drawn into the impacted area by the System enhances biodegradation of the hydrocarbon impacts observed in this area.

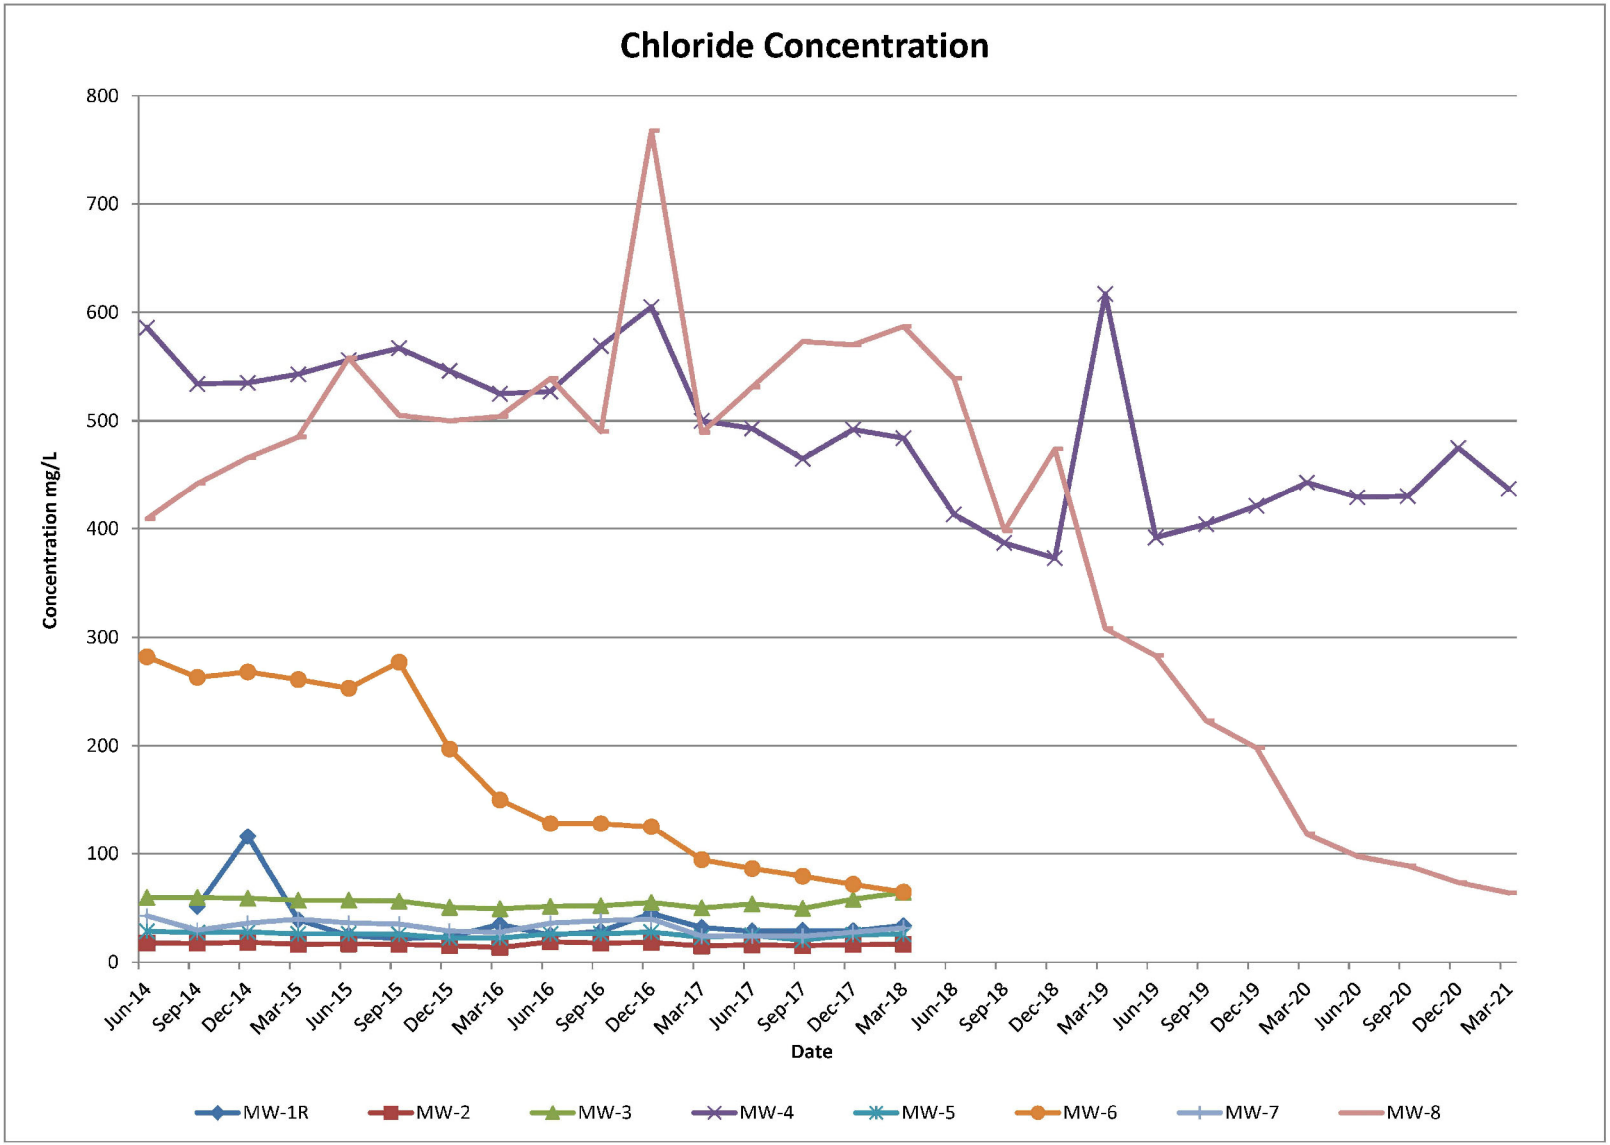
DOCUMENT TITLE: SEVENTH ANNUAL GROUNDWATER MONITORING REPORT	FIGURE TITLE: *CHLORIDE CONCENTRATION TREND GRAPHS*
CLIENT: CHESAPEAKE ENERGY CORPORATION OKLAHOMA CITY, OKLAHOMA	PROJECT NUMBER: CHKSTATM:H20001
LOCATION: STATE M LEASE (AP-72) SEC. 18, T17S, R36E, LEA COUNTY, NEW MEXICO	FIGURE NUMBER: 9

Figure 9 presents chloride concentration trend graphs for each of the monitoring wells sampled at the Site. A review of this figure indicates that the chloride concentration trends observed in the groundwater samples are, in general, decreasing in monitoring wells MW-4 and MW-8. The soil remediation activities conducted in the first quarter of 2014 have removed the continuing source of chloride impacts to the groundwater at the Site. Source removal has facilitated the

physical natural attenuation mechanisms of dispersion and dilution on remnant chloride concentrations present in Site groundwater.

- The groundwater within monitoring wells MW-4 and MW-8 should continue to be monitored on a quarterly basis for chloride until eight consecutive quarterly sampling events result in chloride levels less than the New Mexico Water Quality Control Commission standards. The next groundwater monitoring event at the Site is scheduled to be conducted in June 2021.
