Location of spill: VACUUM GLORIETTA WEST UNIT #27 (32.8052254, -103.5228958) **Date of Spill:** 7/29/2020

Incident ID	NRM2023058280
District RP	
Facility ID	
Application ID

On 8/17/2020, Chevron reported a release at the Vacuum Glorietta West Unit #27. The release was caused by external corrosion of a 2" buried steel injection line. Approximately 16,744 sqft. of the Pad was found to be damp upon initial inspection.

NRM2023058280 | VACUUM GLORIETTA WEST UNIT #27

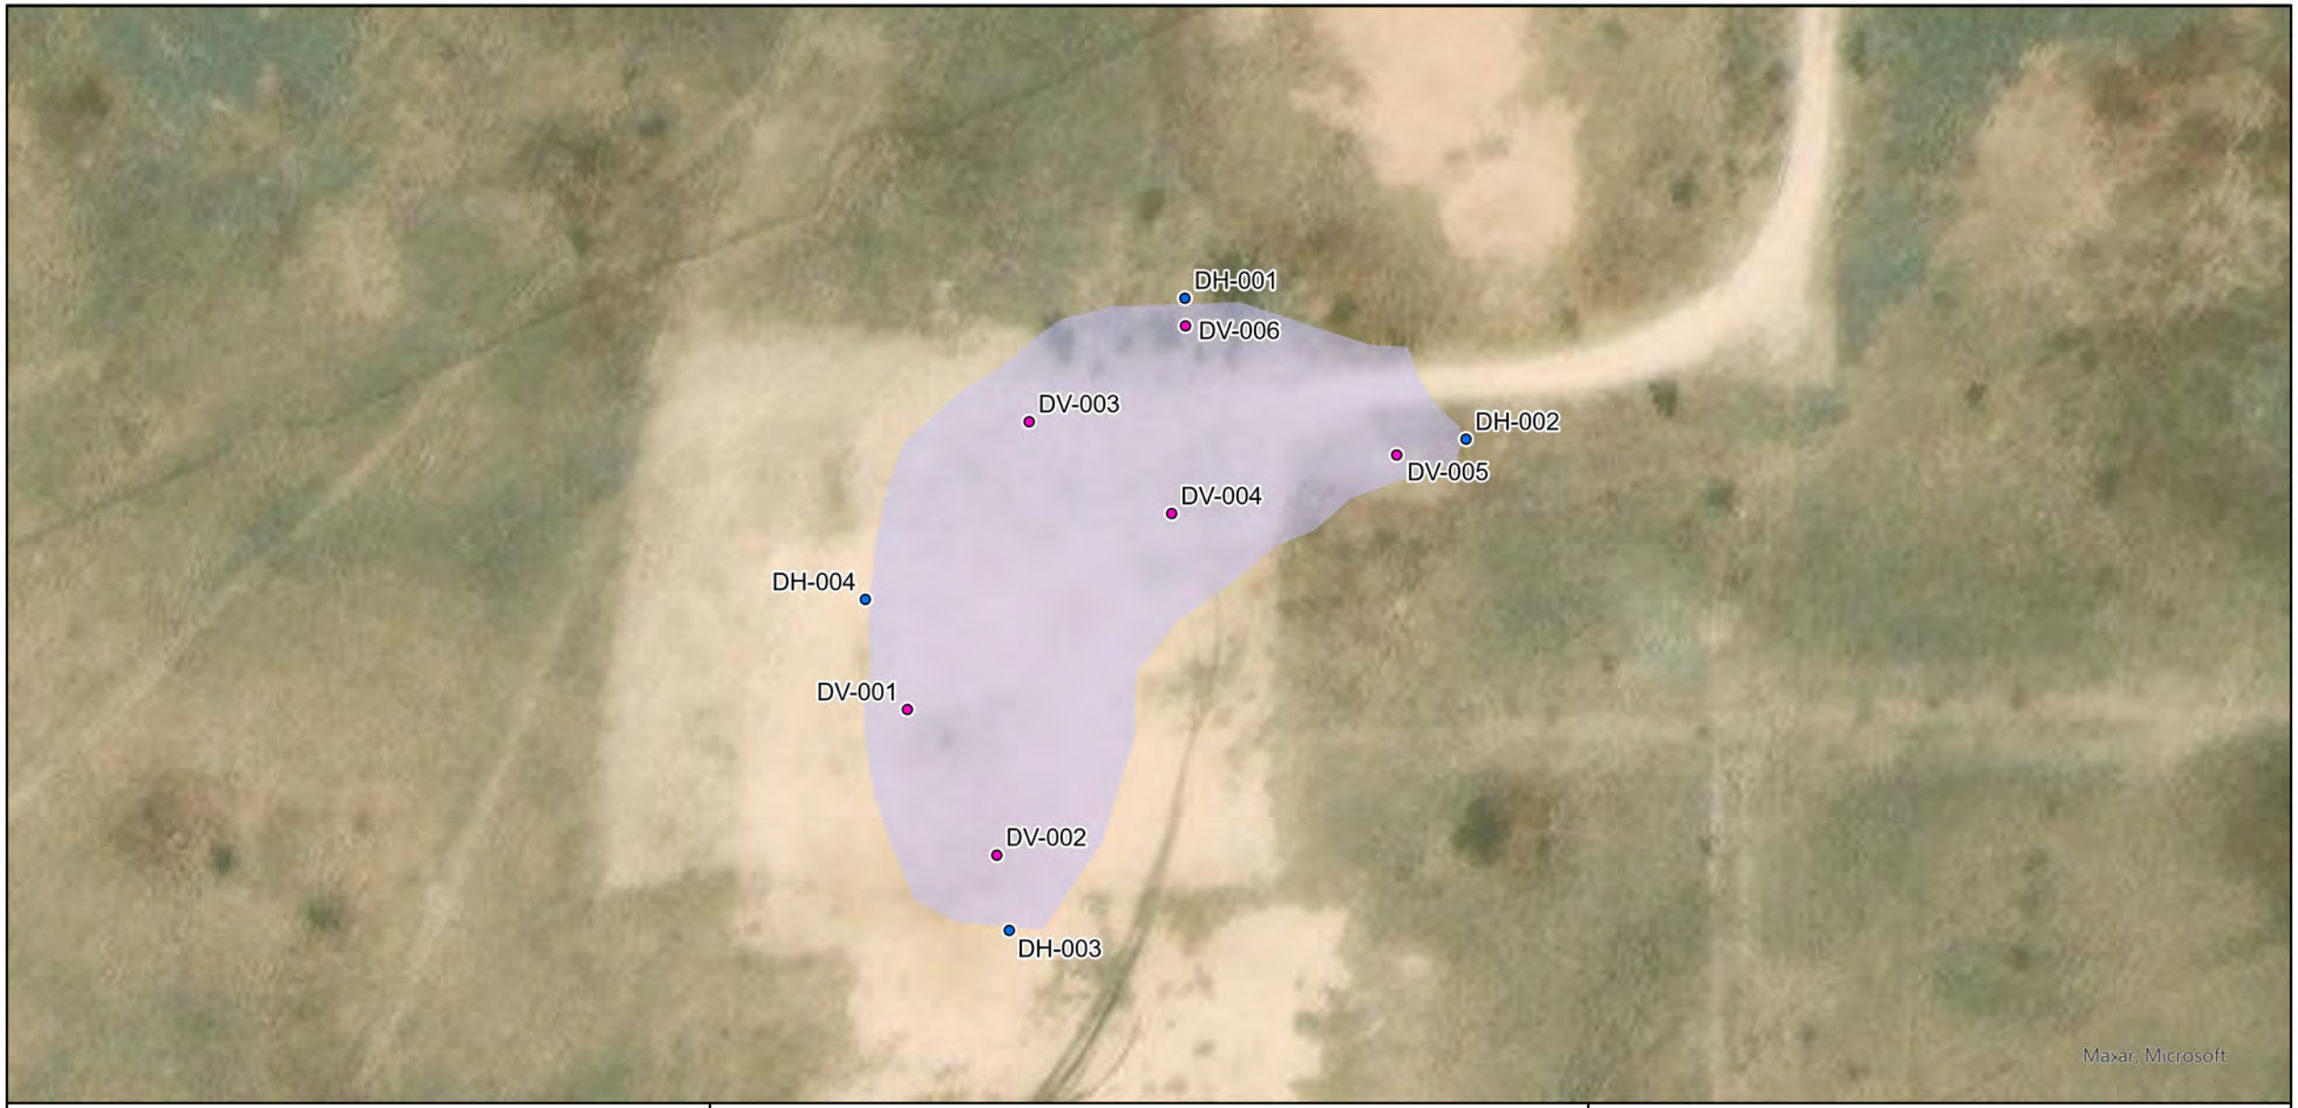
- Vertical Delineation
- Horizontal Delineation
- Release Area

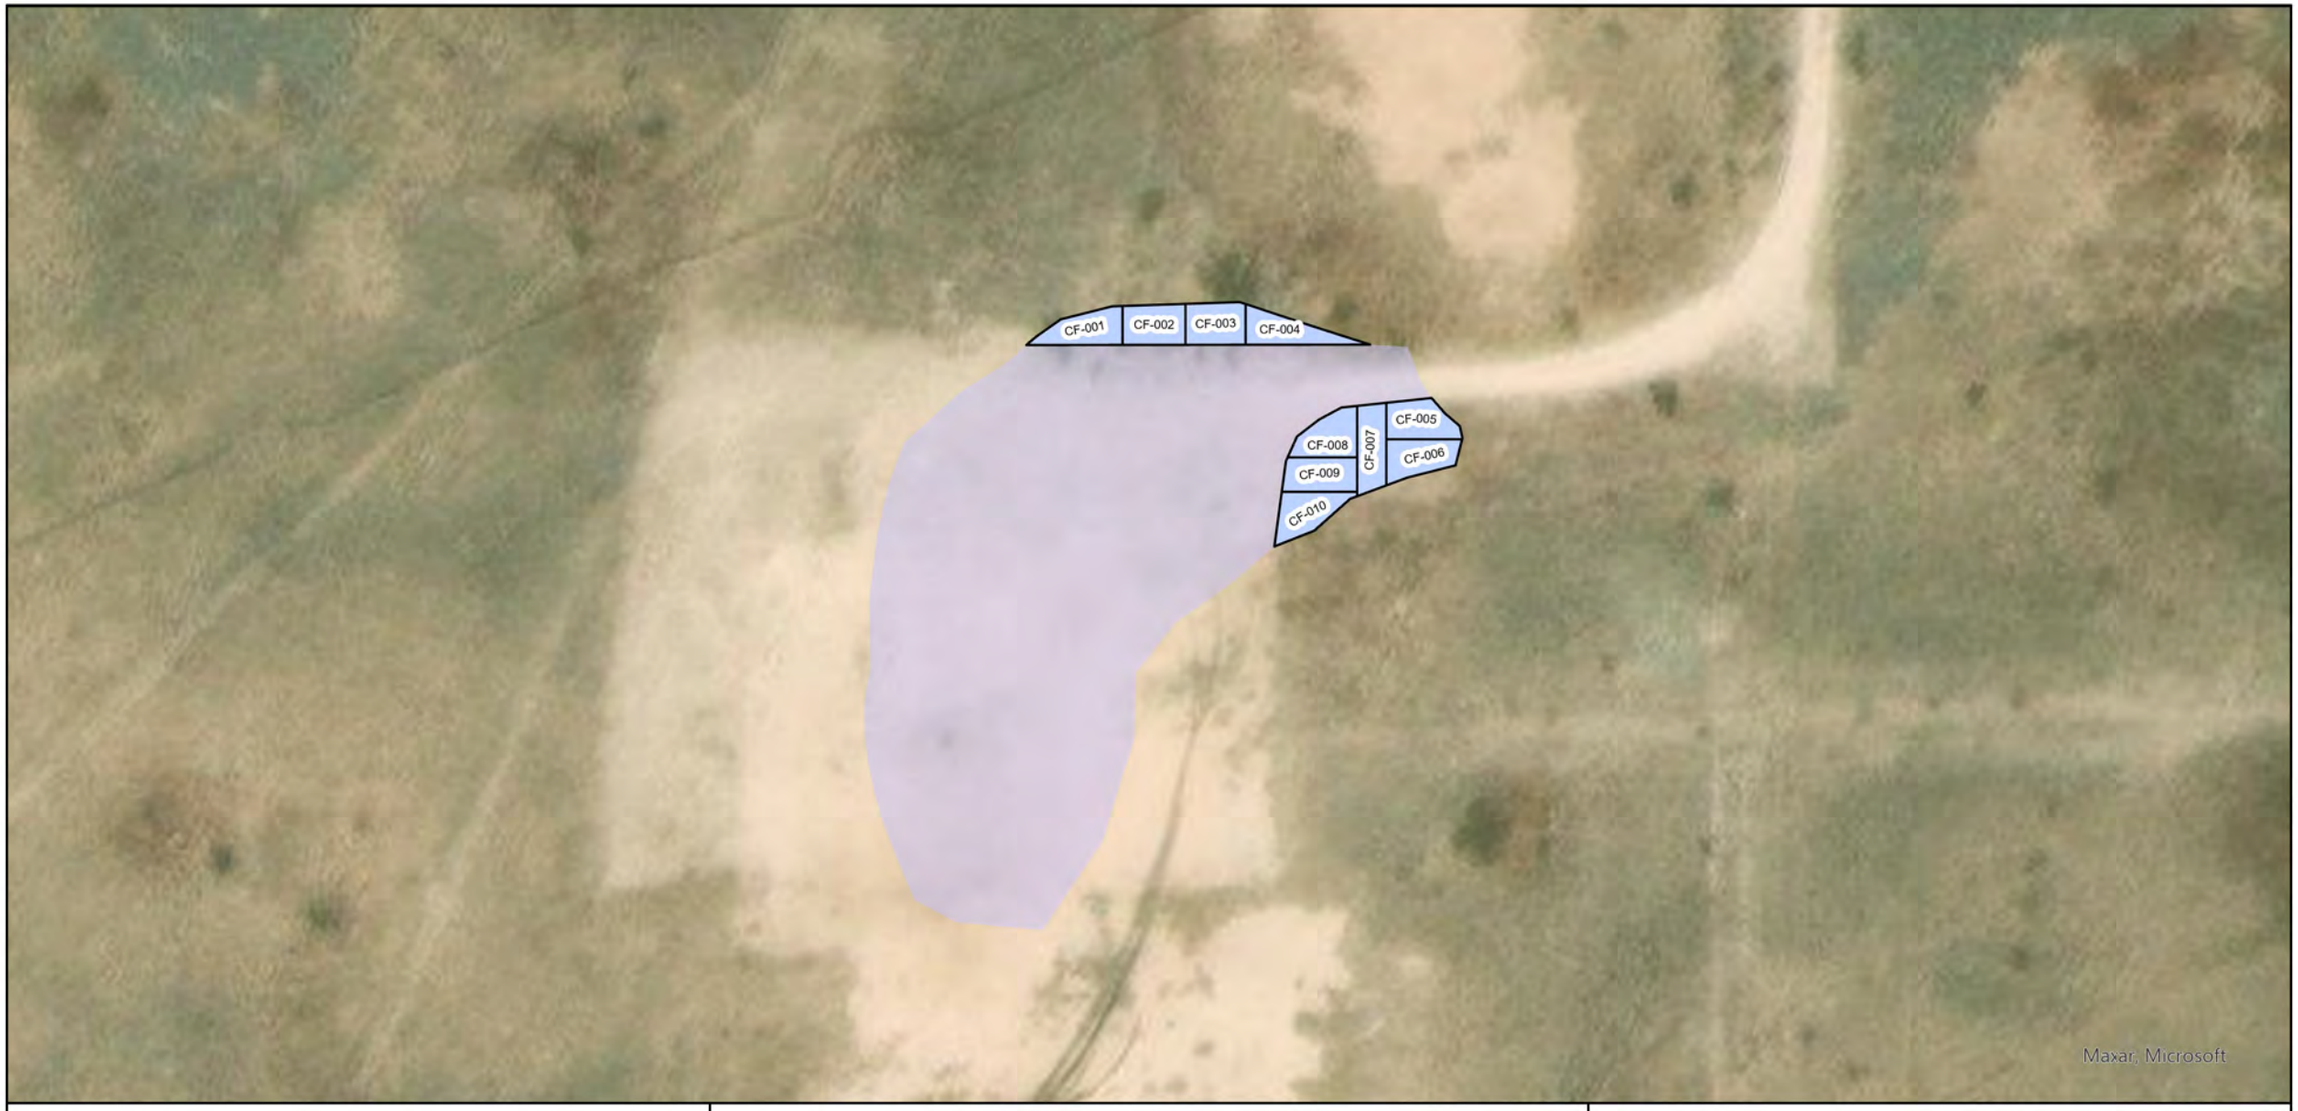
- Remediation Floor
- Release Area
