CLOSURE REPORT

Bisti 10A (07/17/24)
Unit Letter K, S16 T25N R11W
San Juan County, New Mexico

New Mexico EMNRD OCD Incident ID No. NAPP2419947182

October 10, 2024

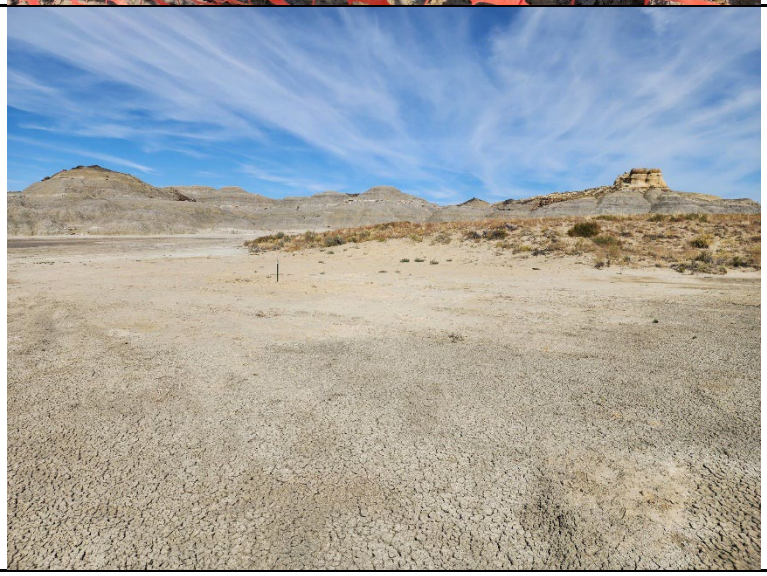
Photograph 4 Photograph Description: View of final excavation.	
Photograph 4 Photograph Description: View of the site after initial restoration.
