CLOSURE REPORT

Huerfano #188 (05/18/24)
Unit Letter D, S7 T25N R9W
San Juan County, New Mexico

New Mexico EMNRD OCD Incident ID No. NAPP2413950856

August 19, 2024

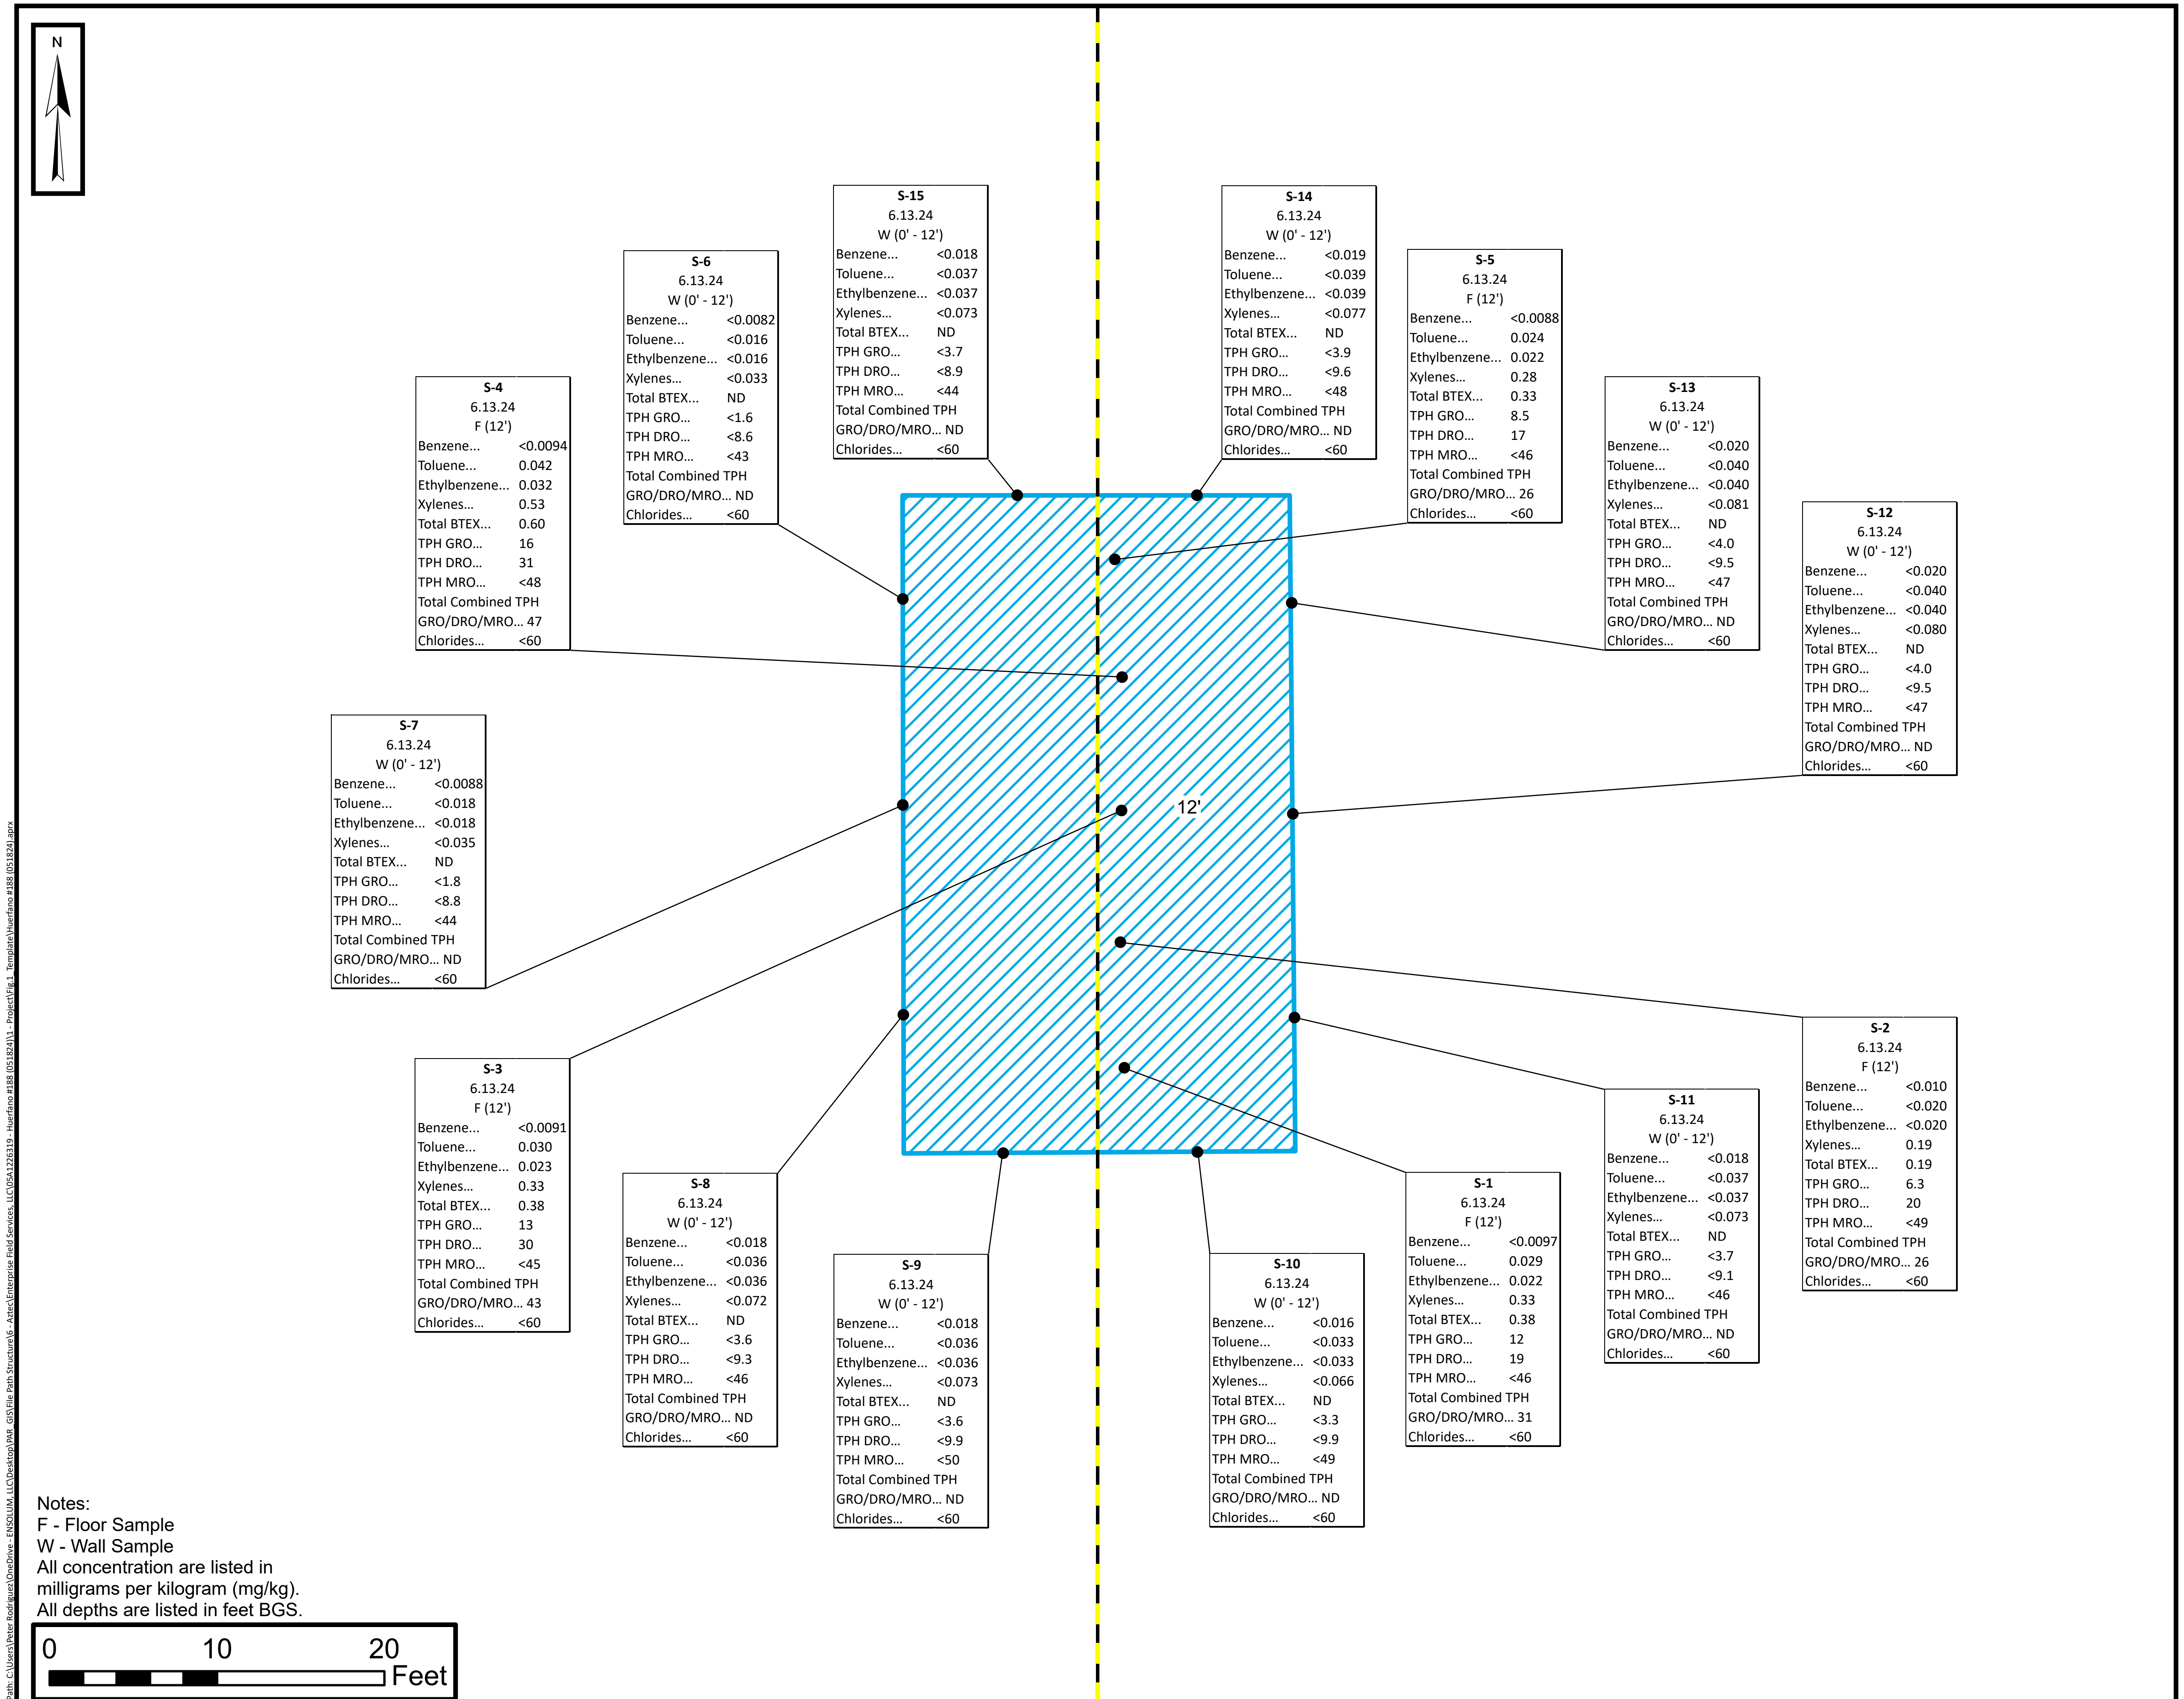
The excavation measured approximately 40 feet long and 23 feet wide at the maximum extents. The maximum depth of the excavation measured approximately 12 feet bgs. The lithology encountered during the completion of remediation activities consisted primarily of Sand underlain by sandstone.

Figure 3 is a map that identifies approximate soil sample locations and depicts the approximate dimensions of the excavation with respect to the pipeline (**Appendix A**). Photographic documentation of the field activities is included in **Appendix D**.

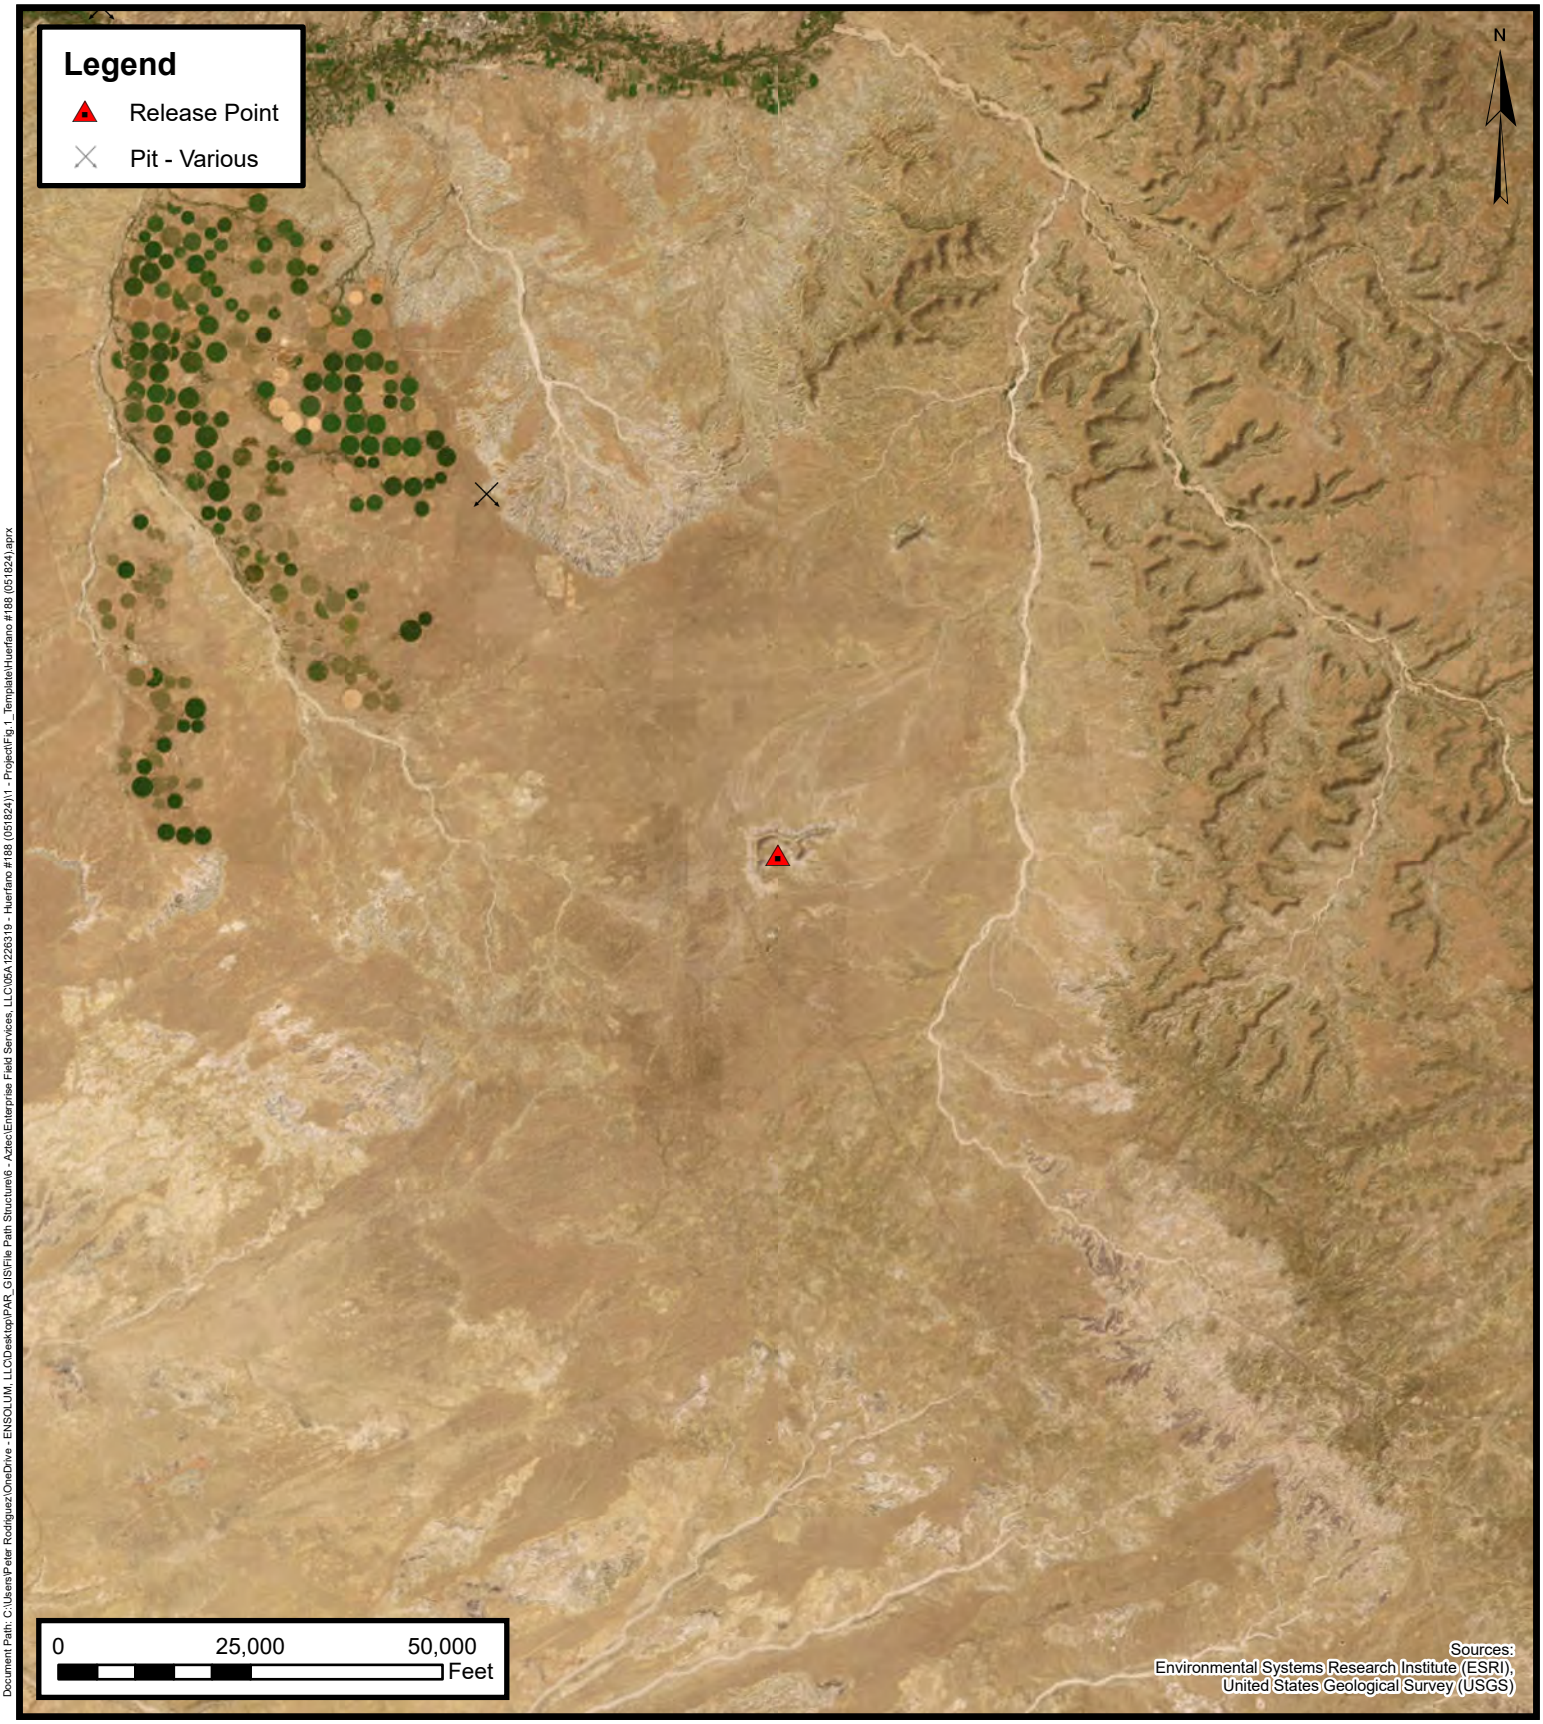
FIGURE
G

- Based on information provided by the Federal Emergency Management Agency (FEMA) National Flood Hazard Layer (NFHL) geospatial database, the Site is not within a 100-year floodplain (**Figure H**, **Appendix B**).
