Tracking Number: nRM2031146817
2024 Second Quarter Groundwater Monitoring Report
Northeast Drinkard Unit #829, #830, #922, #928, and #929
Lea County, New Mexico

Larson & Associates, Inc.
Environmental Consultants

LAI Project No: 19-0112-22

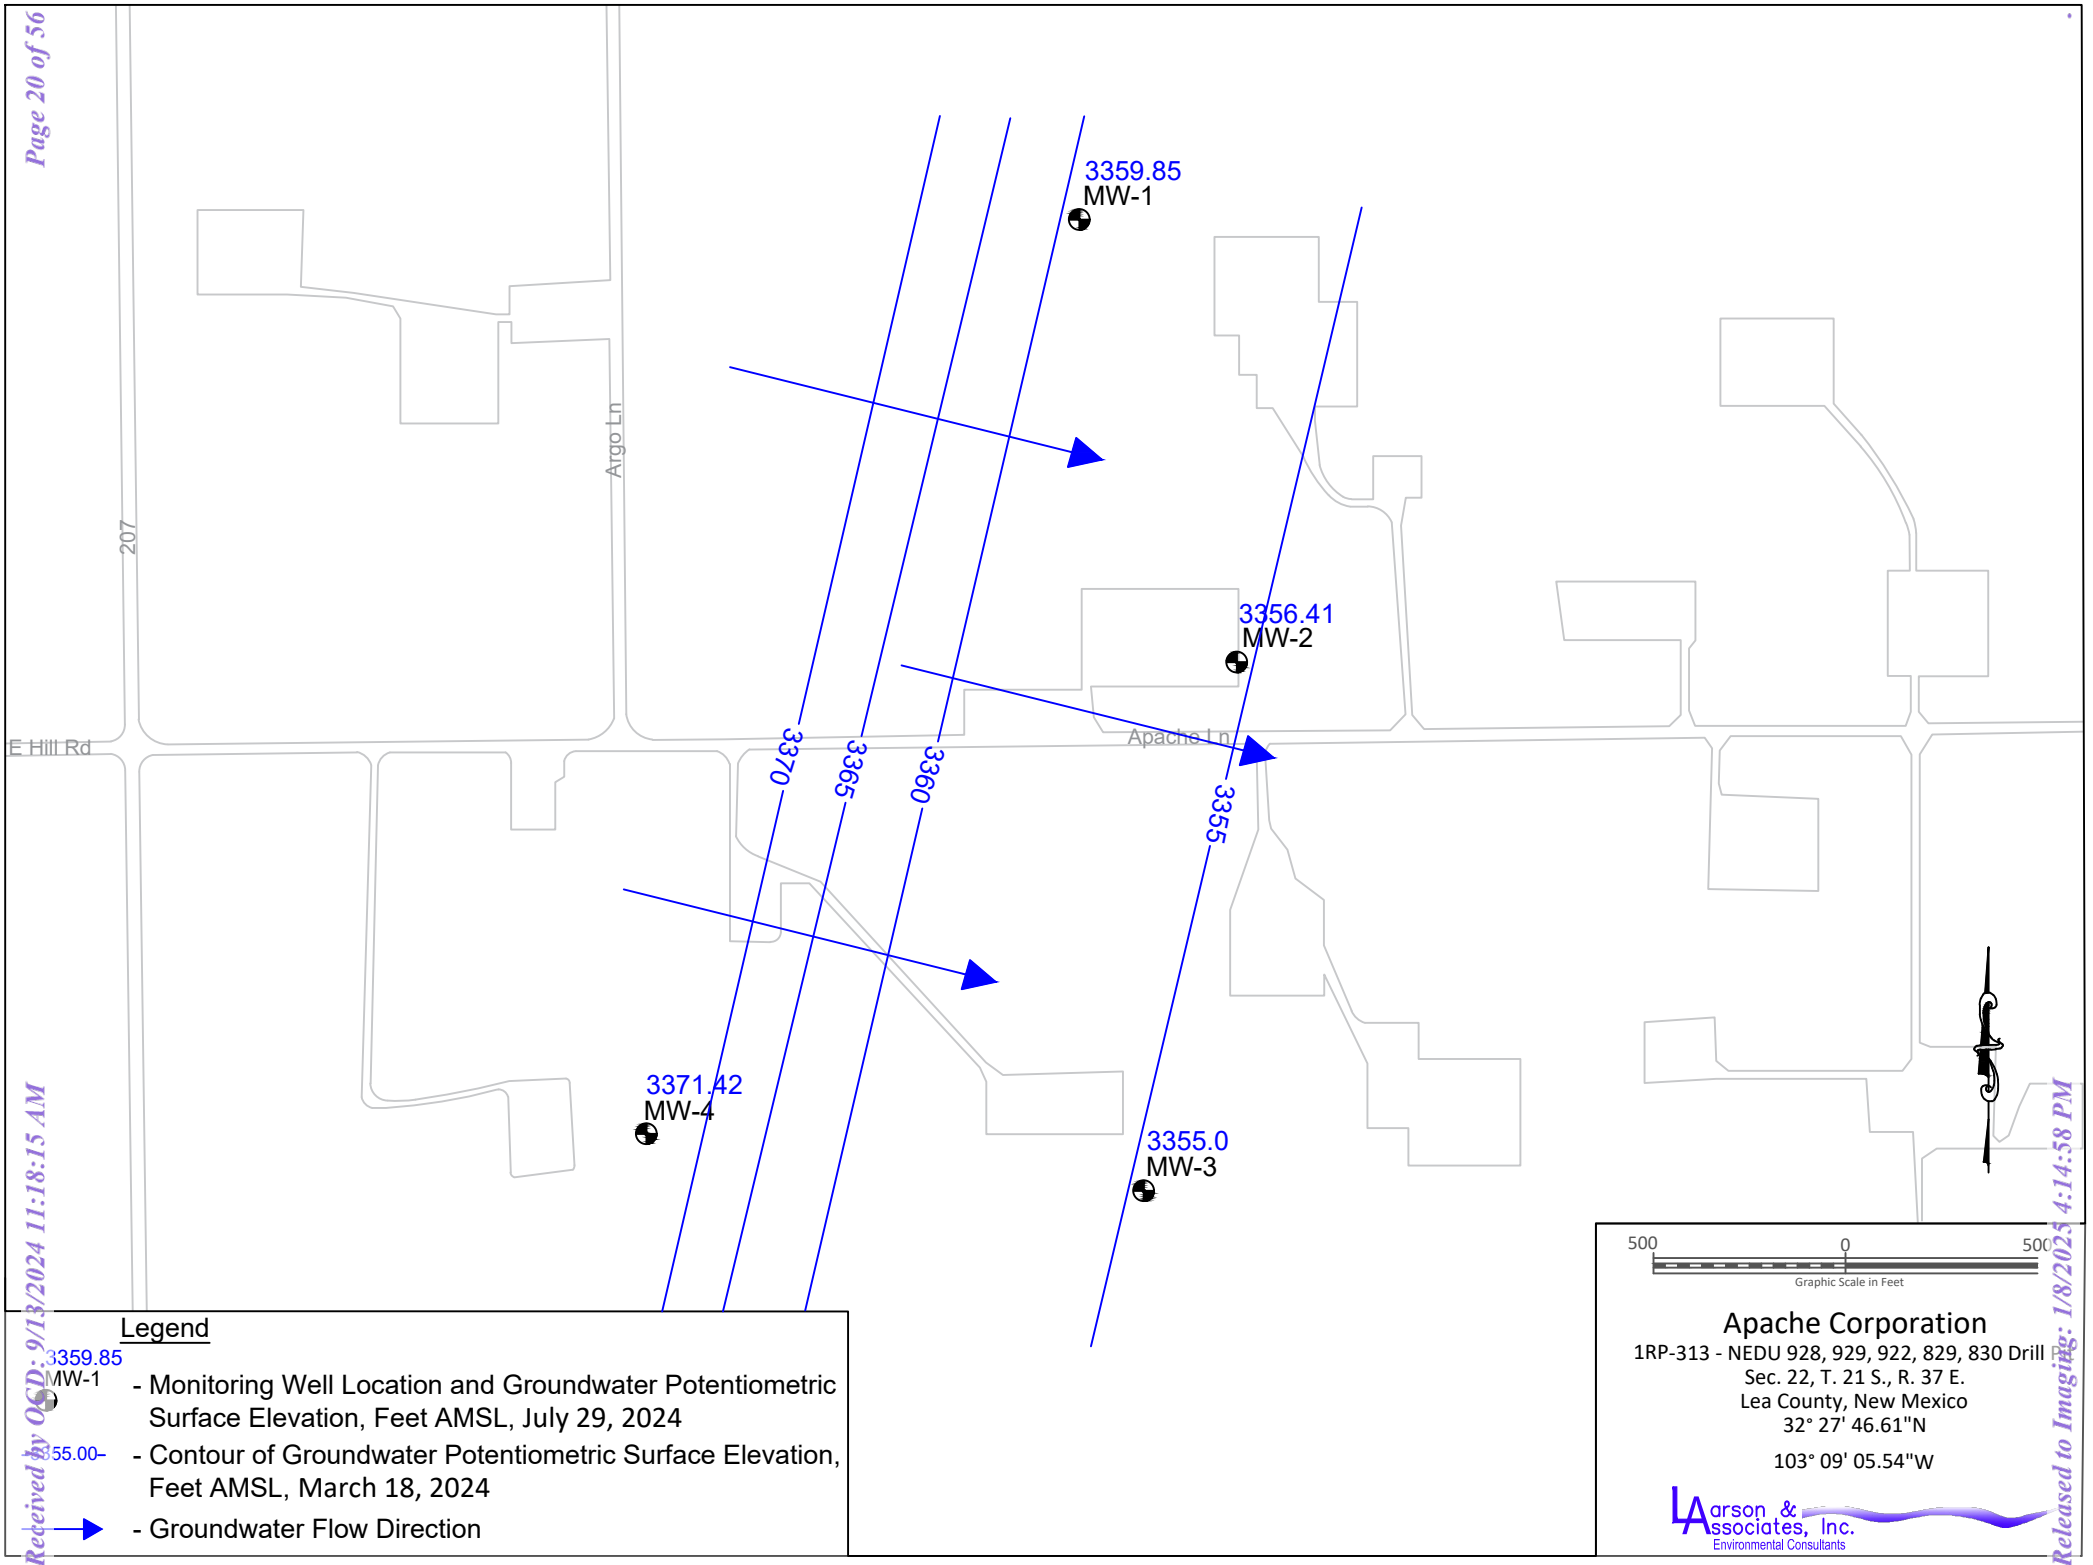
Figure 4 - Groundwater Potentiometric Map, July 29, 2024

On July 29, 2024, LAI personnel gauged monitoring wells MW-1 through MW-4 for depth to groundwater. Groundwater was gauged in monitoring well MW-1 (54.49 feet bgs), MW-2 (55.25 feet bgs), MW-3 (51.22 feet bgs), and MW-4 (40.52 feet bgs). The groundwater potentiometric surface elevation was recorded 3,371.42 feet above MSL in well MW-4 (upgradient) and at 3,555 feet above MSL at well MW-3 (downgradient). The groundwater flow direction was from northwest to southeast at a gradient of about 0.013 ft/ft. Figure 4 presents the groundwater potentiometric surface map for July 29, 2024.

- Groundwater elevation ranged between 3,371.42 feet above MSL at well MW-4 (upgradient) and 3,355 (MSL) at well MW-3 (downgradient).
- The groundwater flow direction was from northwest to southeast at a gradient of about 0.013 feet per foot (ft/ft).
- BTEX concentrations were below the analytical method RL and NMWQCC human health standards in all groundwater samples collected from monitoring wells MW-1 through MW-4.

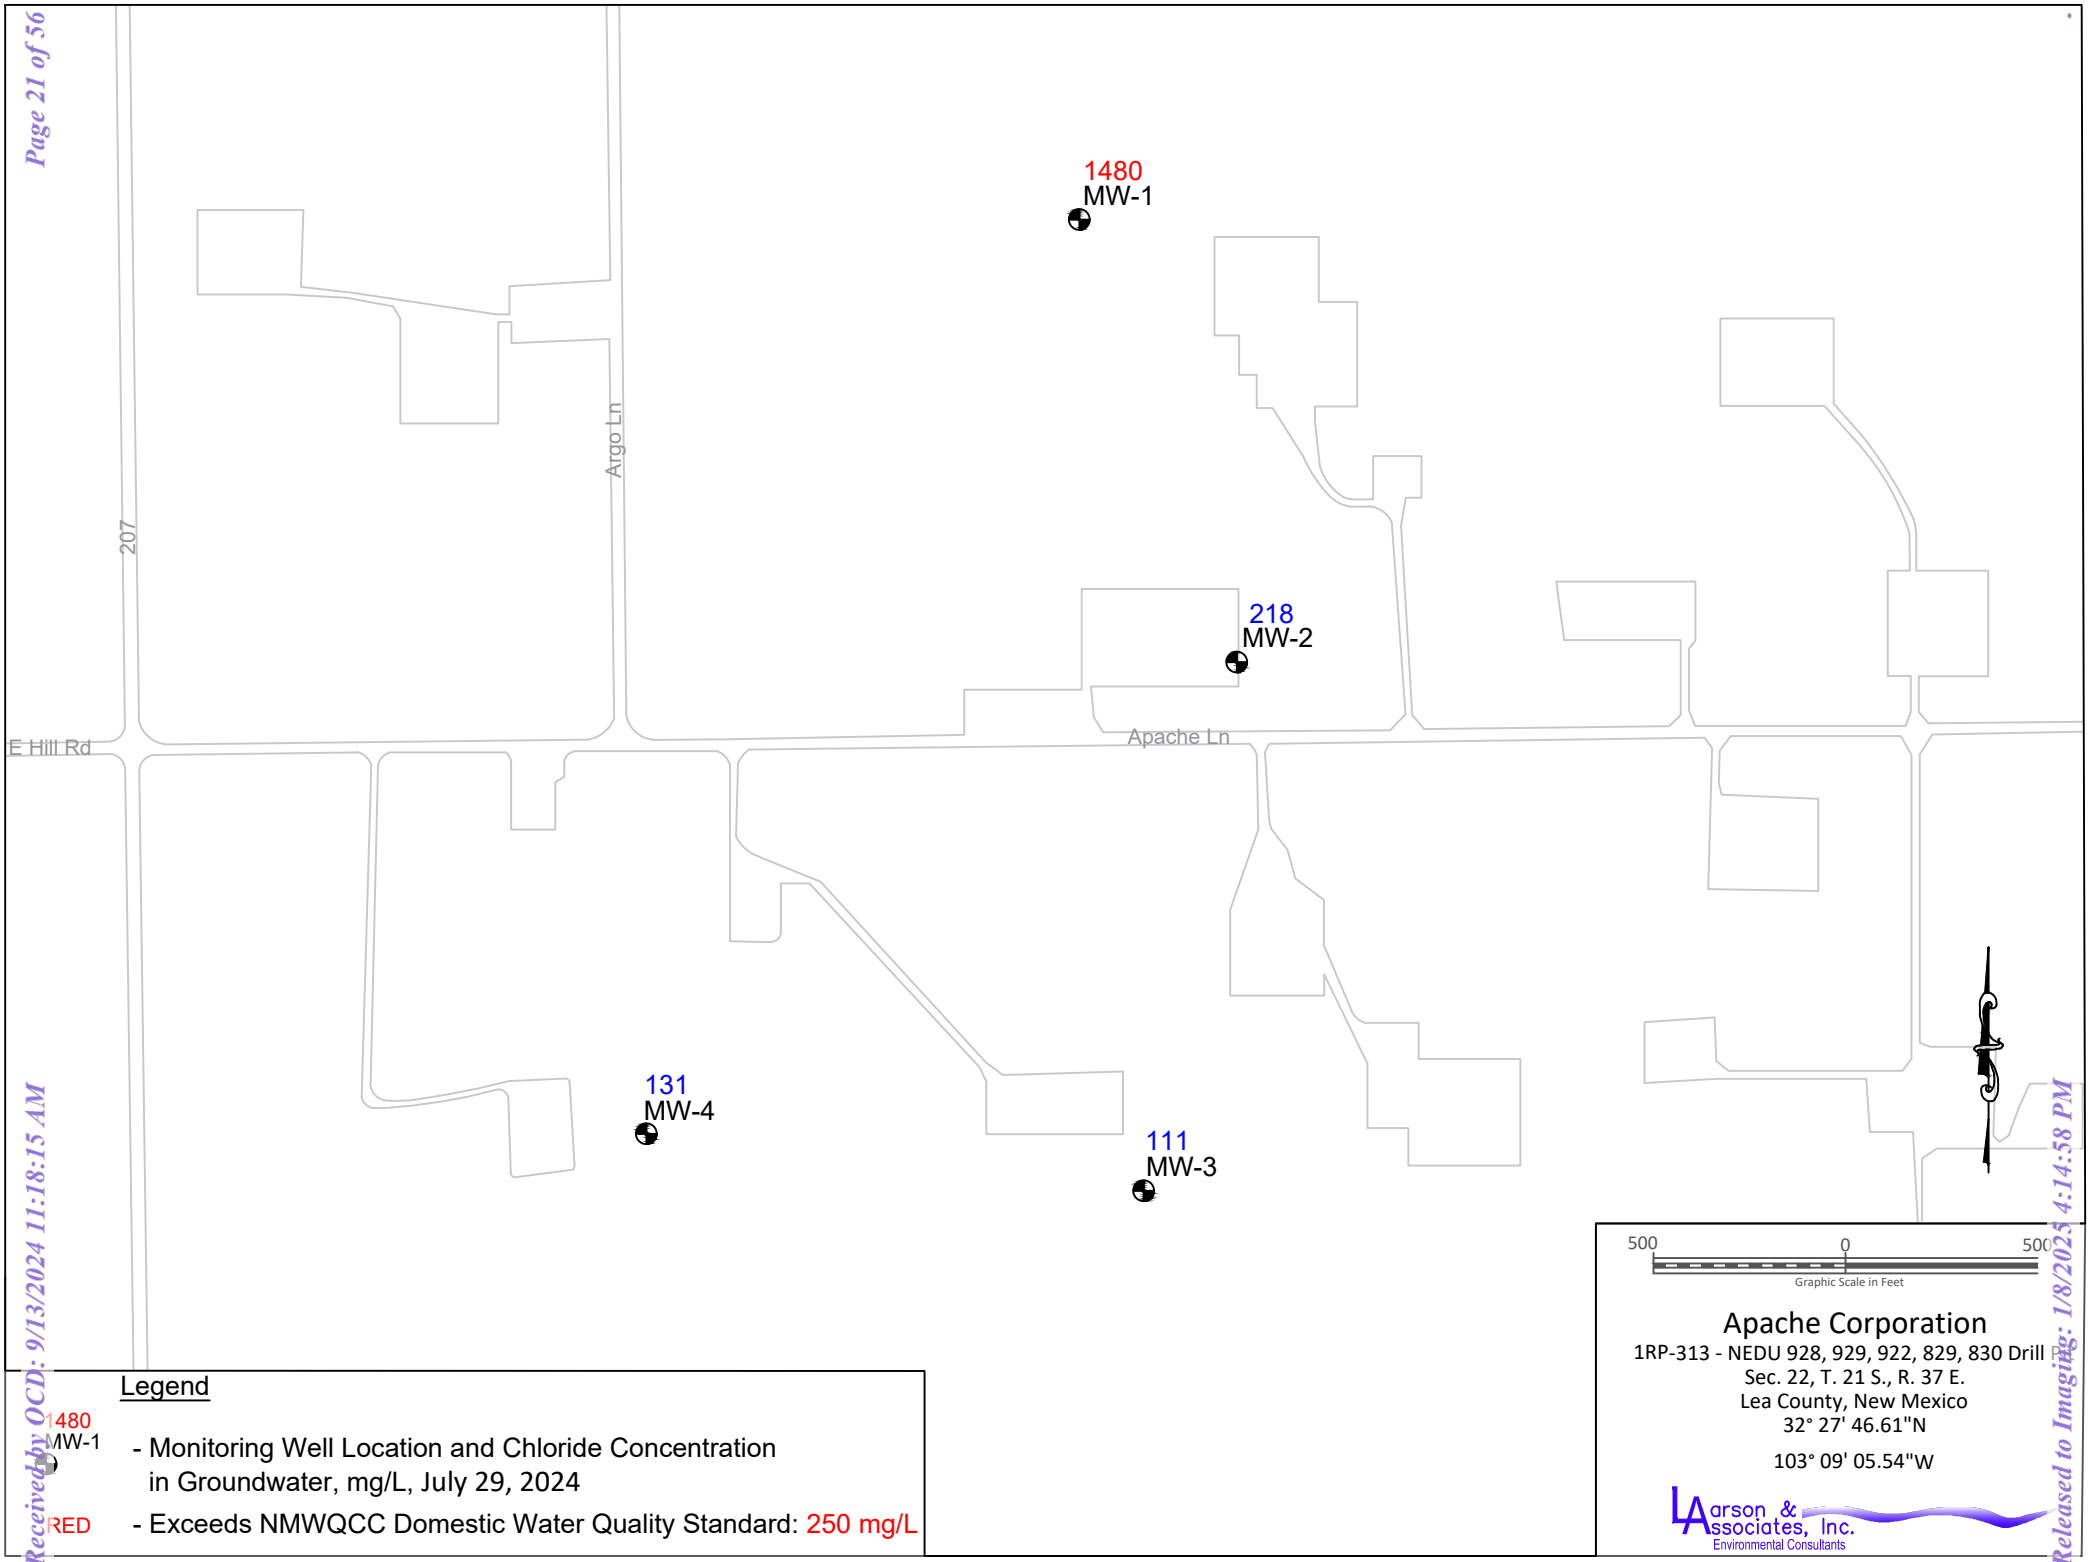
Figure 5 - Chloride Concentration in Groundwater, July 29, 2024

The chloride concentration was above NMWQCC domestic water quality standard in the sample from well MW-1 (1,480 mg/L). Chloride concentrations were below NMWQCC domestic water quality standard of 250 mg/L in monitoring wells MW-2 (218 mg/L), MW-3 (111 mg/L), and MW-4 (131 mg/L). Chloride was reported at 218 mg/L in the QA/QC sample, DUP-1, and was a 4.1 percent change from the original chloride value of 209 mg/L reported for MW-2. No data exceptions were noted in the laboratory report case narratives. The chloride concentrations are consistent with previous groundwater monitoring events. Figure 5 presents the chloride concentration map for July 29, 2024. Appendix D presents the chloride control chart.

- Chloride concentrations were above the NMWQCC domestic water quality standard of 250 mg/L in the sample from MW-1 (1,480 mg/L), and below the standard in samples from MW-2 (218 mg/L), MW-3 (111 mg/L), and MW-4 (131 mg/L).
- TDS concentrations were above the NMWQCC domestic water quality standard (1,000 mg/L) in the groundwater samples MW-1 (2,670 mg/L) and MW-2 (1,020 mg/L), and below the standard in samples from MW-3 (631 mg/L) and MW-4 (755 mg/L).

- Continue groundwater monitoring on a quarterly (4 times per year).
- Gauge each well (MW-1 through MW-4) for depth to groundwater and collect groundwater samples from monitoring wells with sufficient groundwater during each quarterly event.
- Apache will provide notice to the NMOCD in Hobbs and Santa Fe, New Mexico at least 48 hours prior to each monitoring event via the NMOCD web portal.

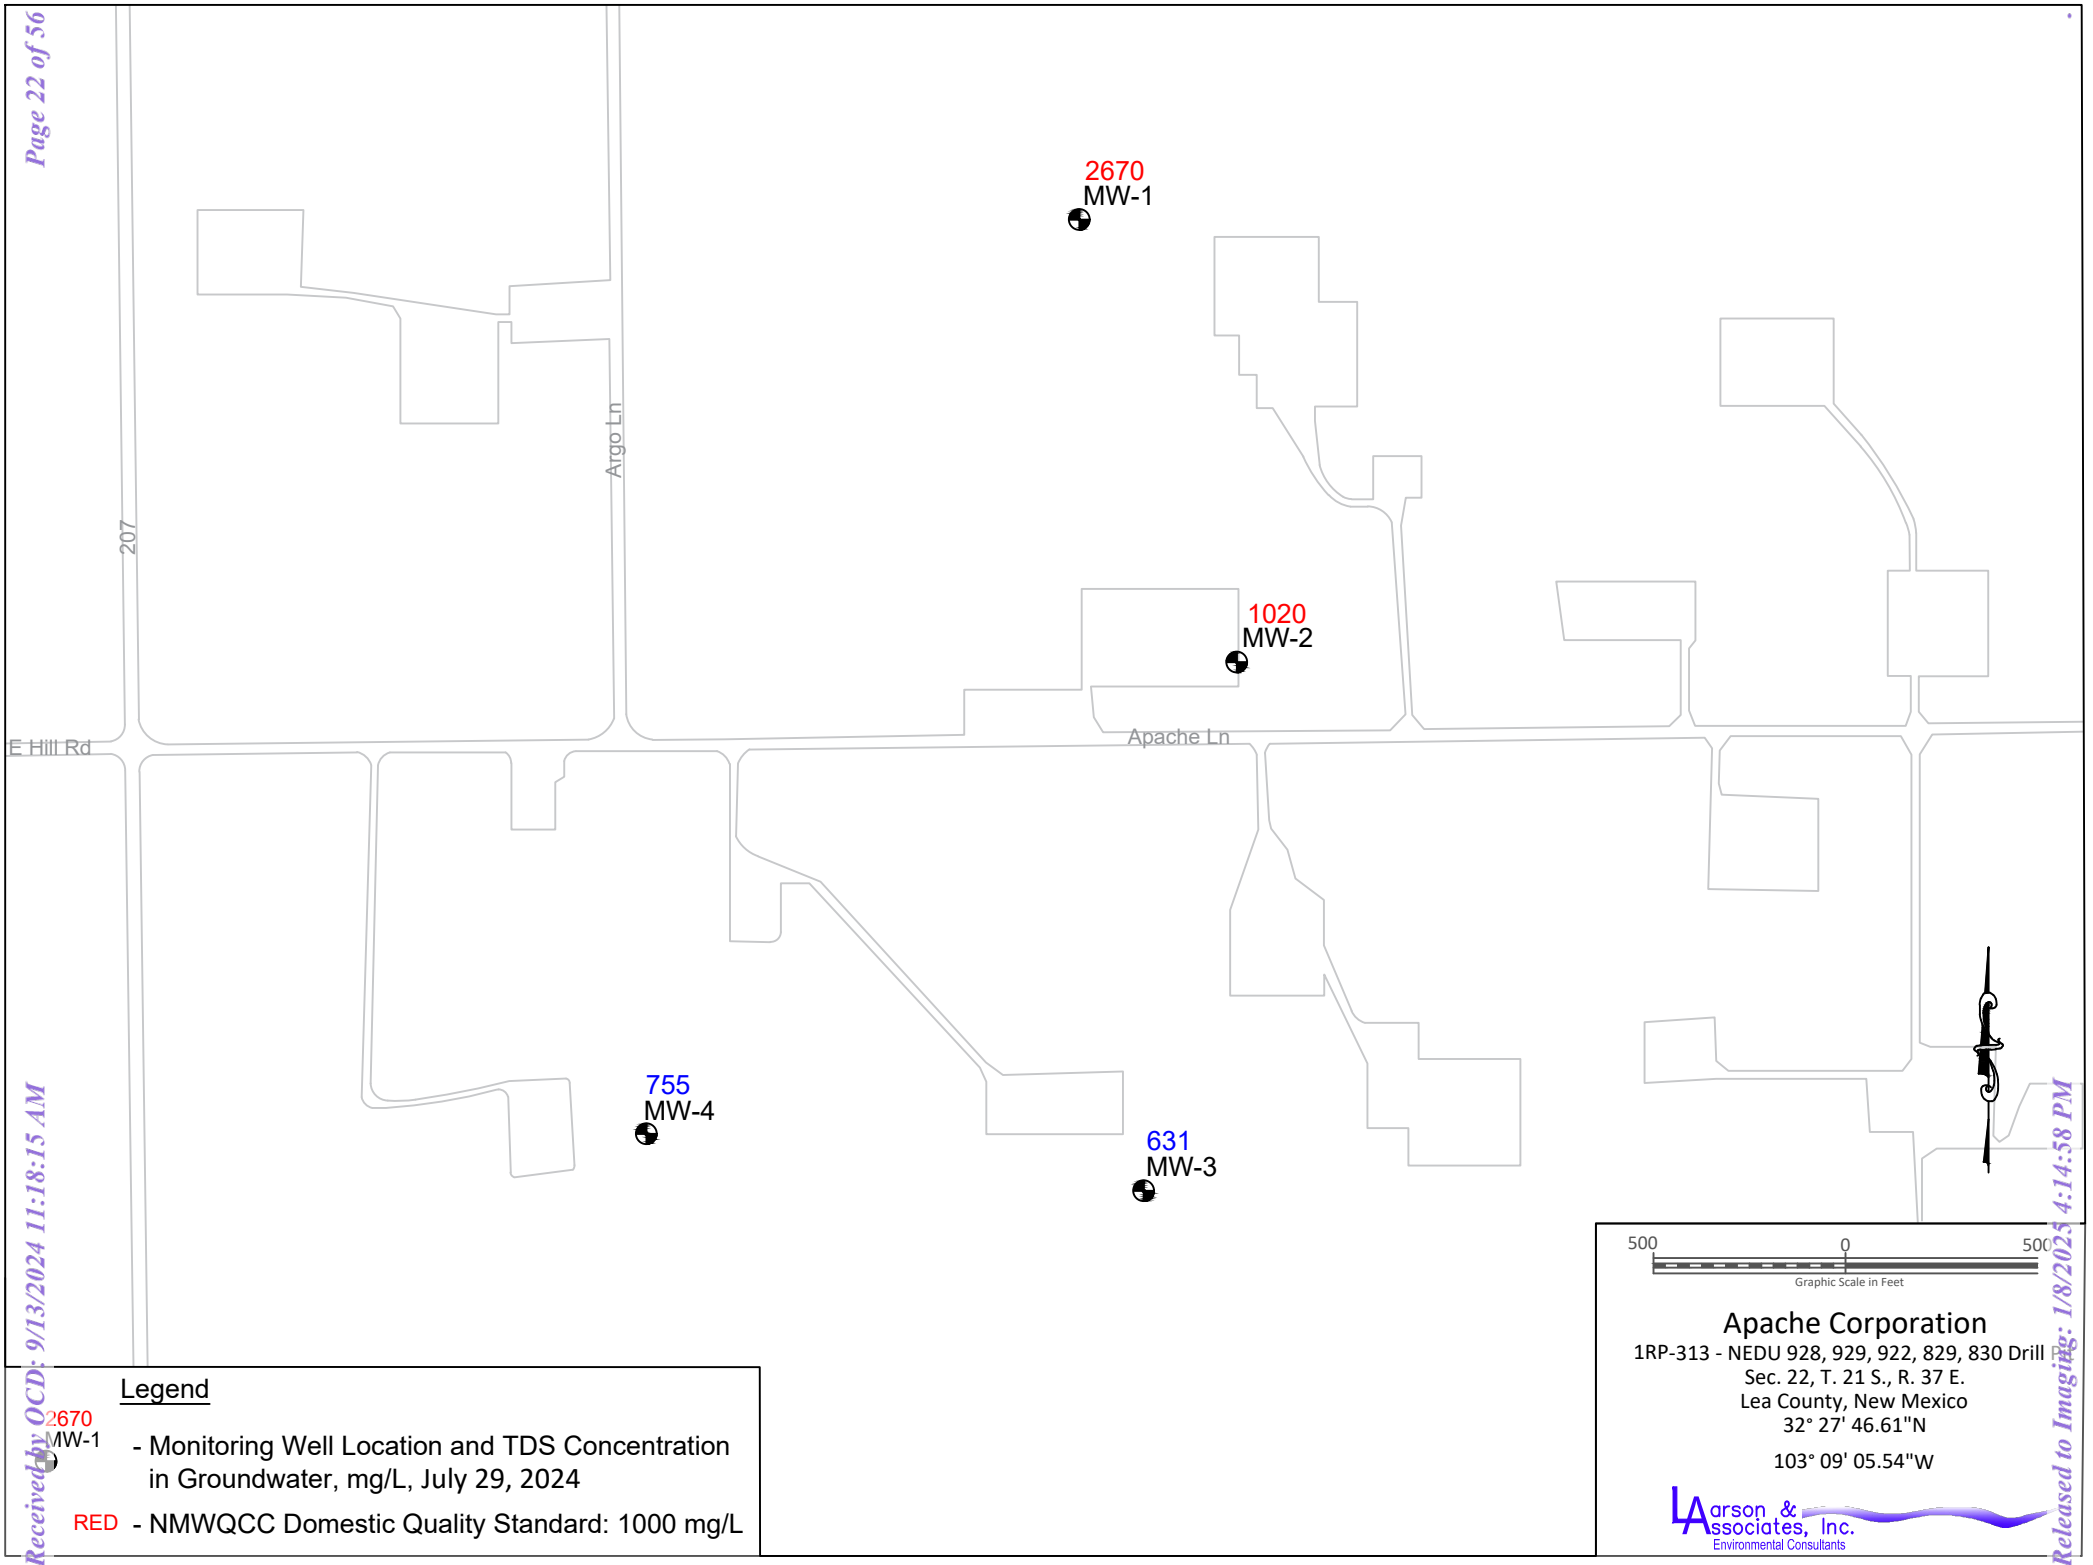
Figure 6 - TDS Concentration in Groundwater, July 29, 2024

TDS concentrations were reported above the NMWQCC domestic water quality standard of 1,000 mg/L in groundwater samples collected from wells MW-1 (2,670 mg/L) and MW-2 (1,020 mg/L). TDS concentrations were below the NMWQCC domestic water quality standard in groundwater samples from wells MW-3 (631 mg/L) and MW-4 (755 mg/L). TDS was reported at 1,030 mg/L in the QA/QC sample, DUP-1, and was a 1 percent change from the original chloride value of 1,020 mg/L reported for MW-2. No data exceptions were noted in the laboratory case narratives. The TDS concentrations are consistent with previous groundwater monitoring events. Figure 6 presents the TDS concentration map for July 29, 2024. Appendix E presents the TDS control chart.
