RICE Operating Company
112 West Taylor • Hobbs, New Mexico 88240
Phone: (575) 393-9174 • Fax: (575) 397-1471

April 1, 2025

RE: **2024 Annual Groundwater Report**
Rice Operating Company – BD SWD System
BD F-29 (1R426-16) and F-29-1 (1R426-15): UL/F, Sec. 29, T21S, R37E
NMOCD Incident ID: nAPP2109649080, nAPP2109650082

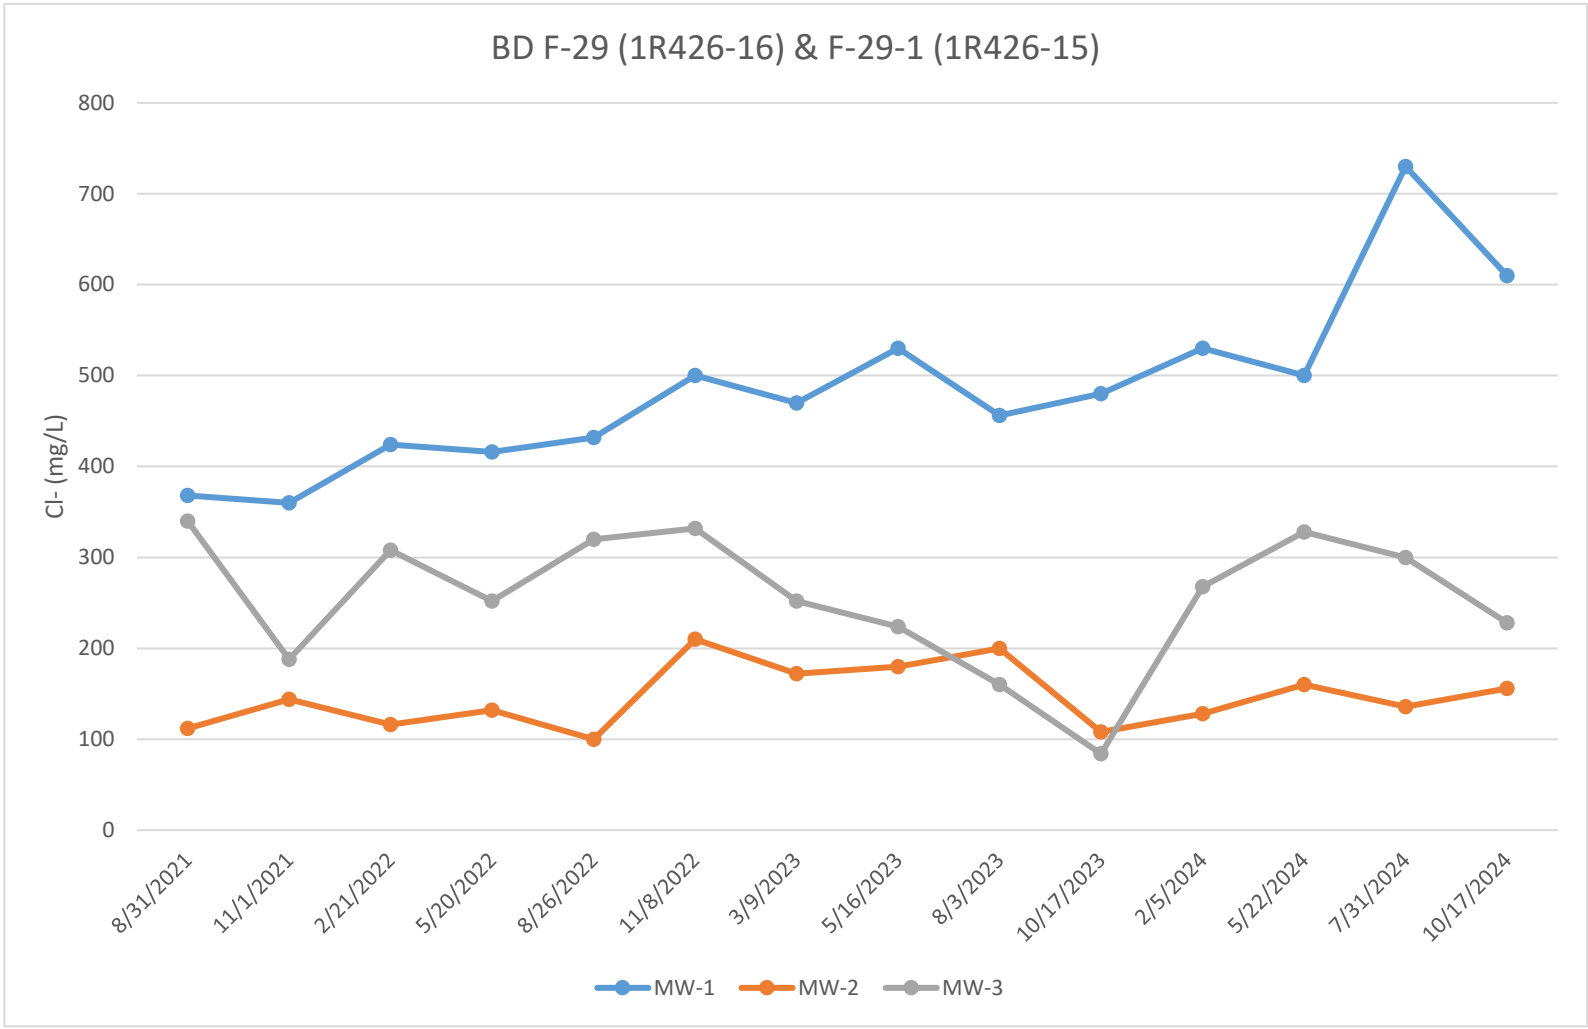
On November 13th, 2018, a near-source monitor well (MW-1) was installed approximately 70 ft southeast of the former junction boxes. On December 10th, 2018, an up-gradient well (MW-2) was installed approximately 133 ft northwest and a down-gradient well (MW-3) was installed approximately 170 ft southeast of the former junction boxes. These wells were developed and have been sampled regularly. The most recent sampling event resulted in a chloride concentration of 610 mg/L in MW-1, 156 mg/L in MW-2, and 228 mg/L in MW-3. BTEX concentrations remained below detectable limits since the wells were installed. In 2020, ROC received NMOCD approval to cease BTEX sampling. On February 4th, 2022, and again on December 13th, 2022, NMOCD granted approval to cease sampling in the up-gradient well, MW-2. NMOCD also granted approval to cease sulfate analysis in MW-1, MW-2, and MW-3. ROC will continue to grab samples from MW-2, as needed, to ensure there are no non-ROC, up-gradient sources contributing to the degradation of groundwater quality. ROC will continue quarterly sampling in 2025.

BD F-29 (1R426-16) & F-29-1 (1R426-15)
Cl- (mg/L)
800
700
600
500
400
300
200
100
0
8/31/2021
11/1/2021
2/21/2022
5/20/2022
8/26/2022
11/8/2022
3/9/2023
5/16/2023
8/3/2023
10/17/2023
2/5/2024
5/22/2024
7/31/2024
10/17/2024
MW-1
MW-2
MW-3
