Sherman 4 Fee 6H TB

Incident ID nAPP2527529167

Liner Inspection and Closure Report

March 10, 2026

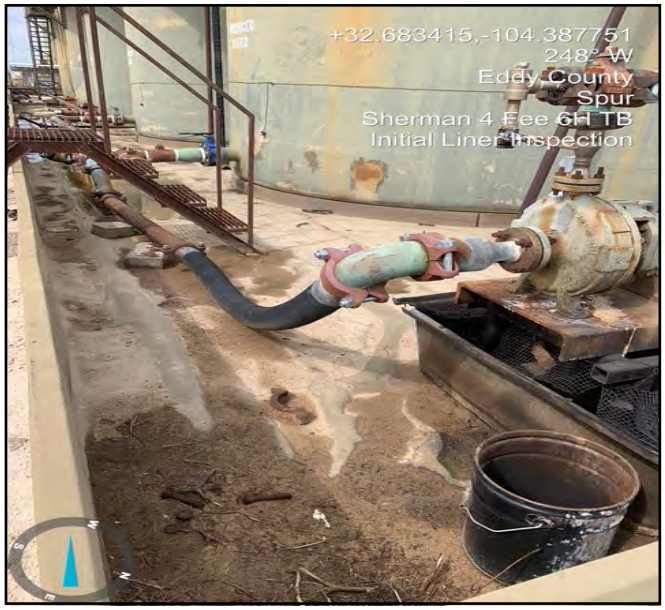
Photo of liner taken during initial liner inspection facing northwest.

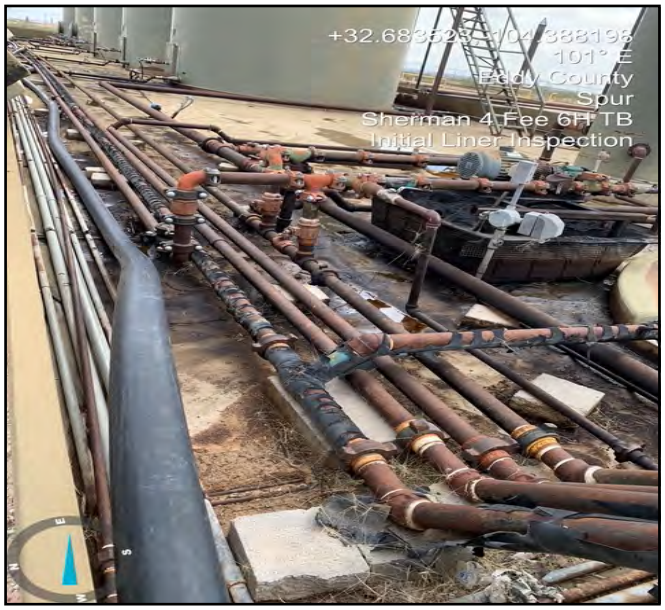
Photo of liner taken during initial liner inspection facing west.

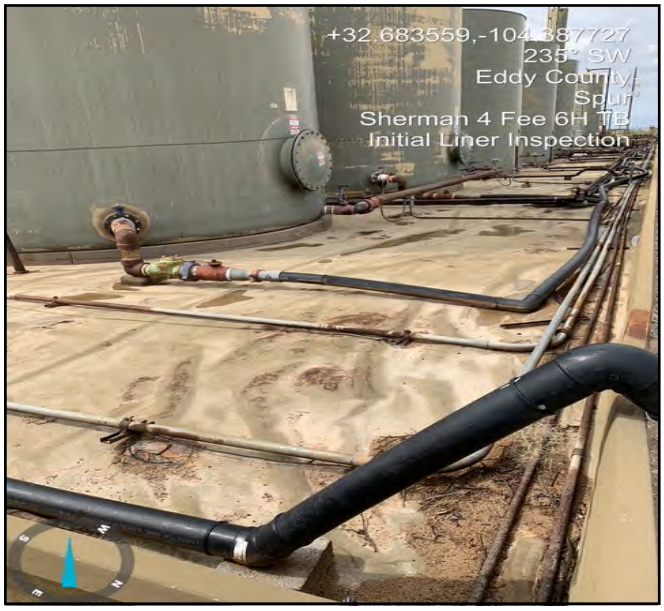
Photo of liner taken during initial liner inspection facing northeast.

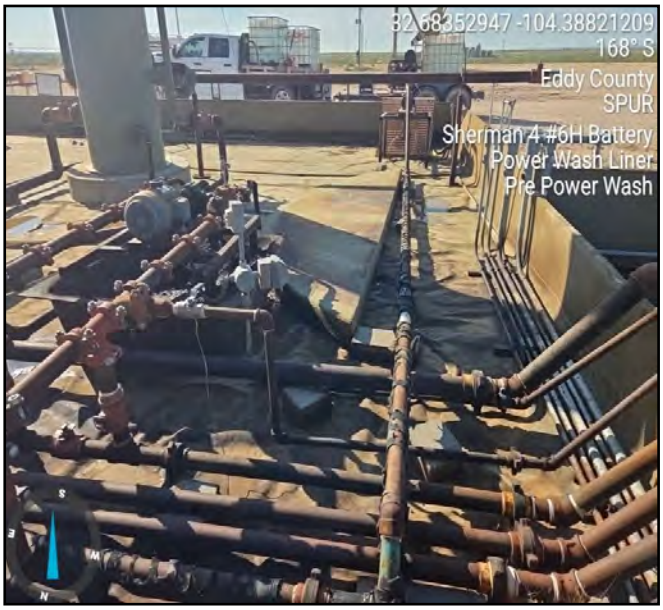
Photograph taken pre- powerwash process facing south.
