Hobbs Water Station Injection Line

nAPP2602751565

Remediation Closure Request

Facility Number: fTO1500855040

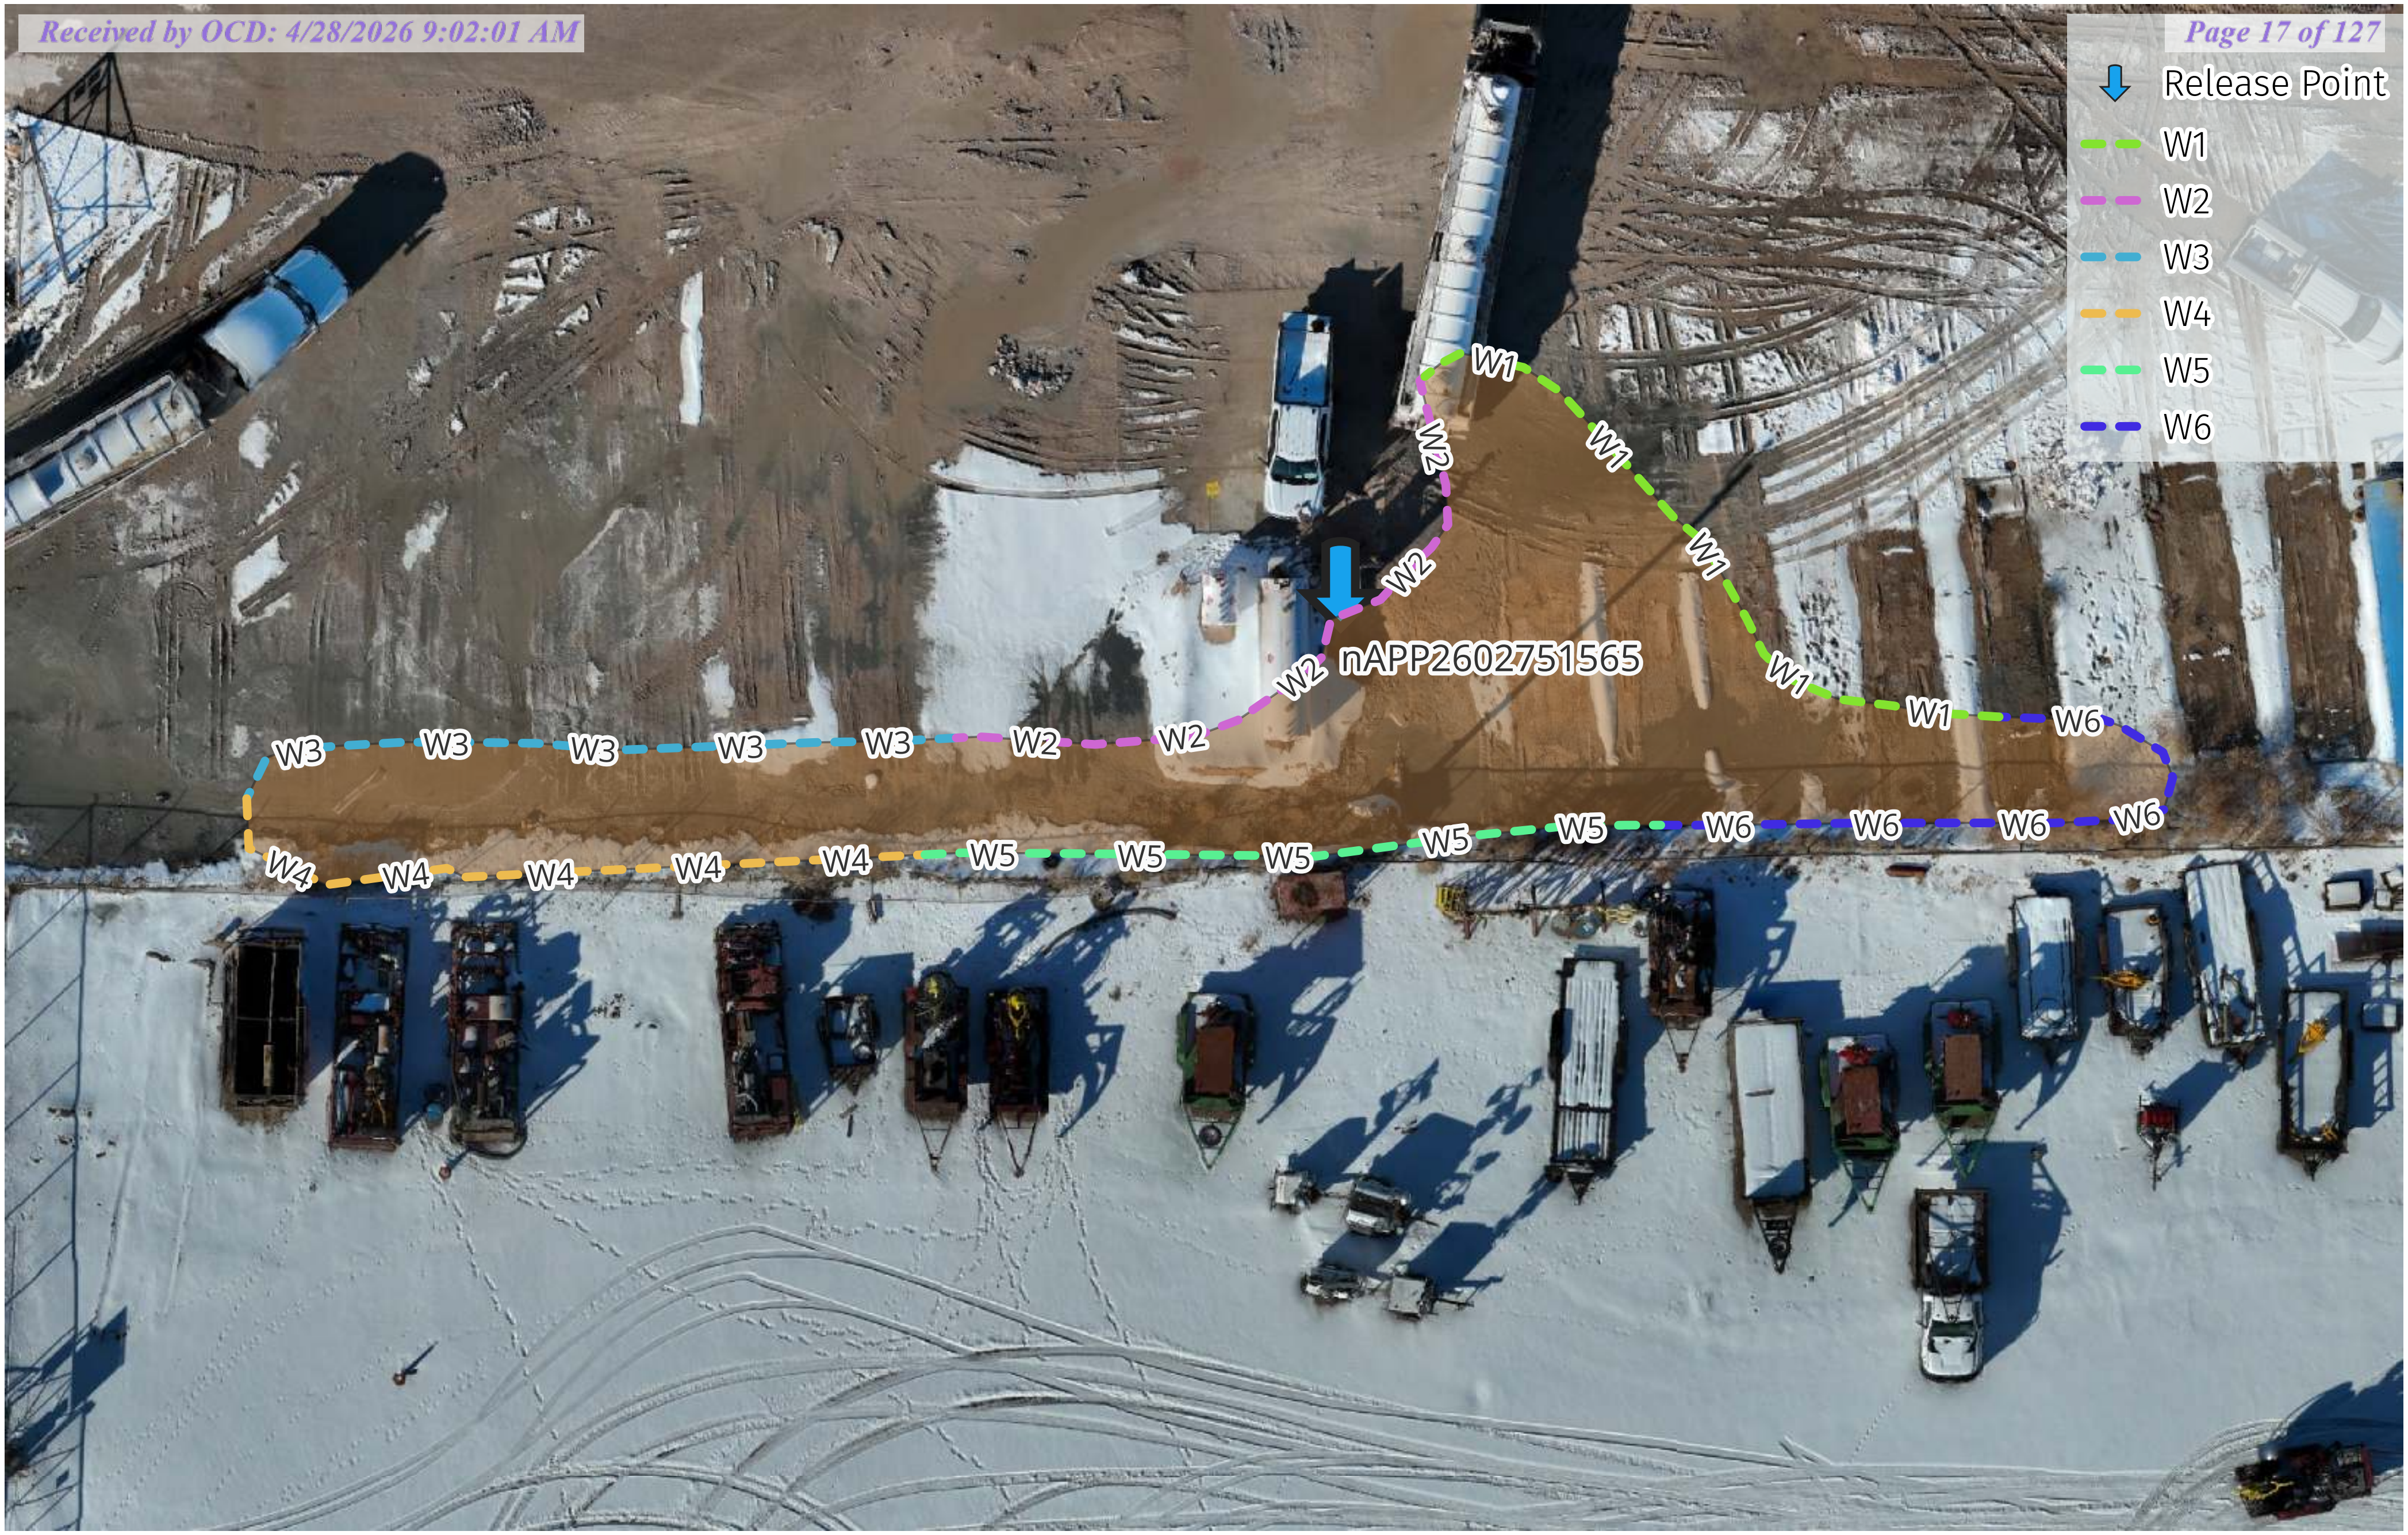
HOBBS WATER STATION INJECTION LINE – nAPP2602751565
5PC -- Side Wall Summary

Highlighted areas were above the RRALs for site closure and were excavated. All other areas remain in situ.
Red lettering indicates locations that were above the RRALs.
SP1 at 2 feet was above the RRALs during delineation, but post-excavation grid sampling showed the area was well below the applicable threshold and it was therefore left in situ.
