Pit, Below-Grade Tank, or Proposed Alternative Method Permit or Closure Plan Application

Facility or well name: Landauer 1E

Hilcorp Energy Company
San Juan Basin
Below Grade Tank Closure Report

Lease Name: Landauer 1E
API No.: 3004523791

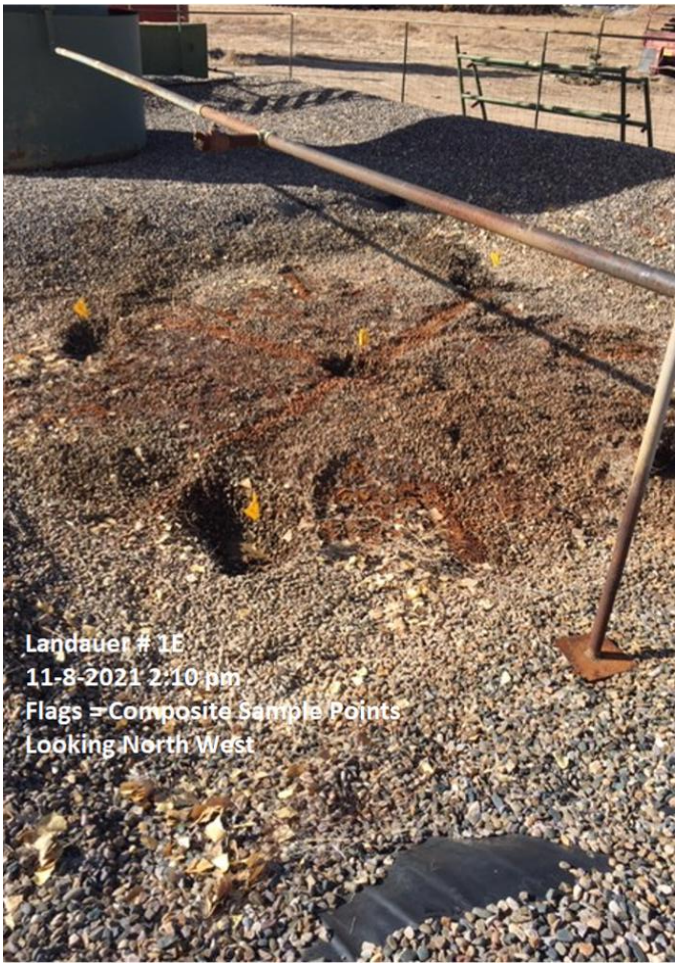
Landauer 1E
03.01.22
Flags are sample points
Looking NW toward WH
