Pit, Below-Grade Tank, or Proposed Alternative Method Permit or Closure Plan Application

1.
Operator: Hilcorp Energy Company OGRID #: 372171
Address: 382 Road 3100 Aztec, NM 87410
Facility or well name: Whitley 2
API Number: 30-045-06610 OCD Permit Number:
U/L or Qtr/Qtr M Section 9 Township 27N Range 9W County: San Juan
Center of Proposed Design: Latitude 36.584298 Longitude -107.798914 NAD83
Surface Owner: ☒ Federal ☐ State ☐ Private ☐ Tribal Trust or Indian Allotment

Hilcorp Energy Company
San Juan Basin: New Mexico Assets
Below Grade Tank Closure Report

Lease Name: Whitley 2
API No.: 30-045-06610

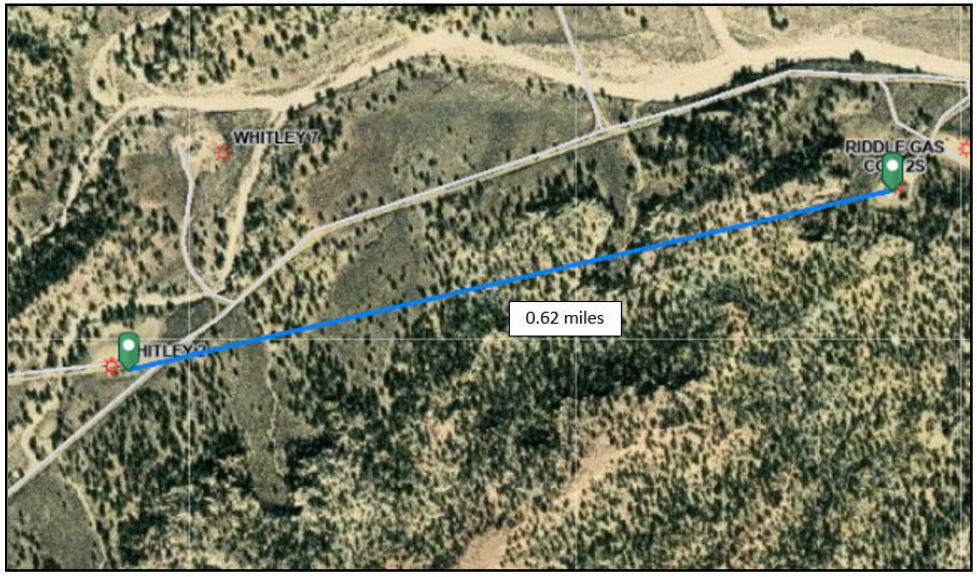
Depth to groundwater determination for well Whitley #2

- The Whitley #2 wellsite is approximately 0.6 miles southwest of the Riddle Gas Com #2S well site.
- The Whitley #2 is approximately 41 feet higher elevation than Riddle Gas Com #2S.
- Data provided in the Riddle Gas Com #2S BGT permit support the determination that depth to groundwater is estimated to be greater than 100 feet.
- Given the topographic similarities and proximity of these locations, it is believed depth to groundwater at the Whitley #2 is also greater than 100 feet.
