Form C-103
Revised July 18, 2013

Annual Report for the period from January 1 through December 31, 2022 Pursuant to NMOCC Orders R-13809 and R-14207 for Zia AGI #1 and AGI D #2, respectively.

ANALYSIS OF ANNUAL TRENDS AND REQUEST TO CONTINUE WITH APPROVED IMMEDIATE NOTIFICATION PARAMETERS FOR OPERATION OF ZIA AGI #1 AND ZIA AGI D #2 (API #s 30-025-42208 AND 30-025-42207) UNDER R-13809 and R-14207

REVIEW OF STATISTICAL ANALYSIS OF INJECTION PARAMETERS, DEVELOPMENT OF AND REQUEST TO CONTINUE WITH APPROVED IMMEDIATE NOTIFICATION PARAMETERS FOR ZIA AGI #1 AND ZIA AGI D #2 (API #s 30-025-42208 AND 30-025-42207) UNDER R-13809 and R-14207

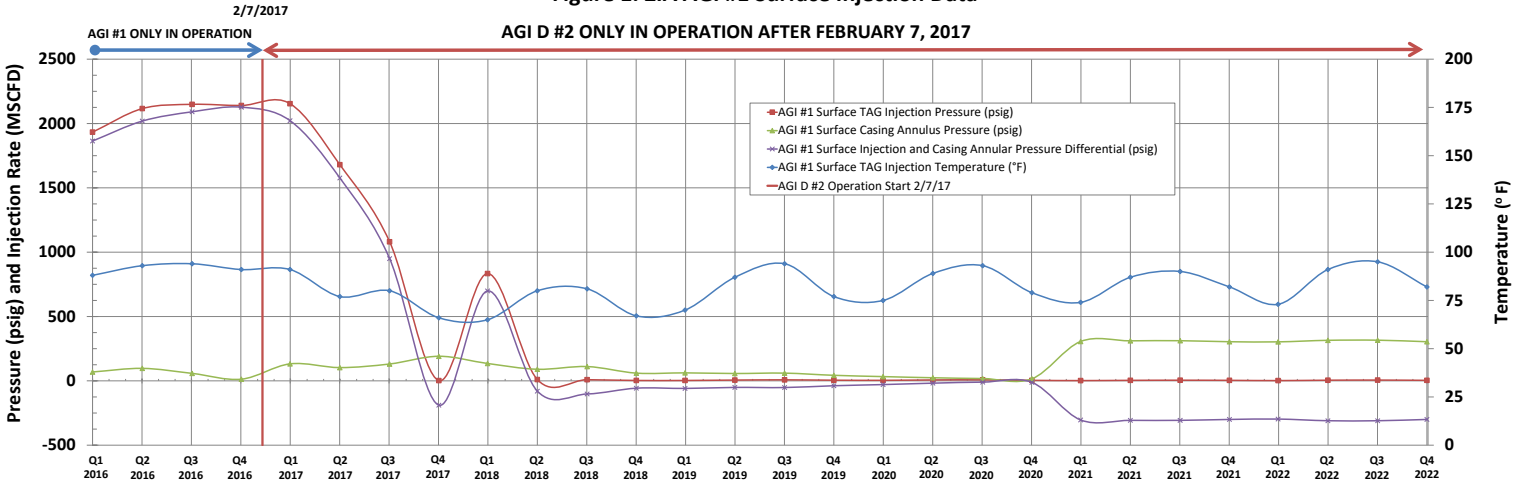
Figure 1. ZIA AGI #1 Surface Injection Data

Given the observations of the trends in the graphs and the significantly different behavior of both wells, the wells demonstrate good mechanical integrity. Minor fluctuations in the Zia AGI #1 surface data continue to demonstrate the correlative behavior of the annual pressure with flowrate, injection pressure, and temperature (Figure 1). Downhole pressure in the Zia AGI #1 reservoir has dropped slowly following cessation of injection (early 2017) and has stabilized as can be seen in Figure 3. AGI D #2 continues to exhibit a strong correlative relationship of annular pressure with injection pressure, injection temperature, and flowrate confirming the integrity of the well. Additionally, over the operational lifetime of AGI D #2, the bottom hole pressure has only increased by about 5% (300 psig) while there has been a 20% increase (0.89 MMSCFD) in injection rate indicating continued adequate reservoir conditions for TAG injection.

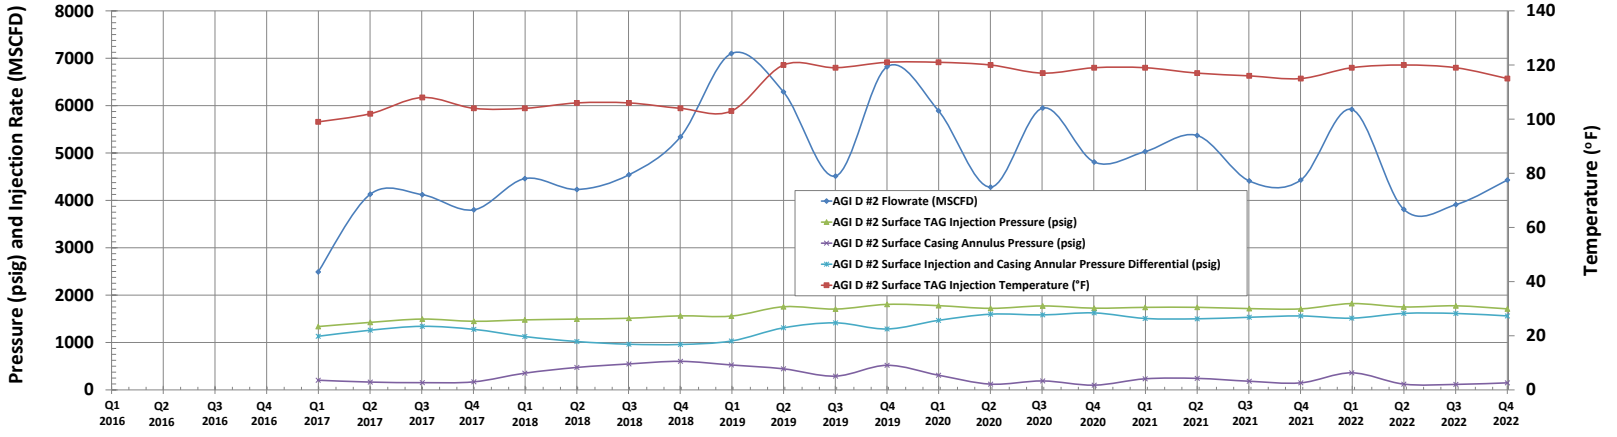
Figure 2. Zia AGI D #2 Surface Injection Data

Rapid temperature swings in the surface data of AGI D #2 were identified in the second quarter of 2022 that were attributed to a malfunction in the louvers in the compression system. Maintenance completed during a scheduled plant turnaround in October 2022 addressed this issue and the temperature appears to be stabilizing. In spite of the variations in temperature, the well behaved appropriately with concurrent changes in injection pressure and annulus pressure. The average temperature for 2022 was only one degree higher than the average temperature reported for 2021 (118 °F vs 117 °F). The trends observed in AGI D #2 are shown in Figures 2 and 4 and total flow rates are summarized on Figure 5 for the entire period.

AGI D #2 WAS BROUGHT ONLINE ON 2/7/2017 AND HAS OPERATED AS THE SOLE AGI WELL TAKING ALL THE TAG FROM THE ZIA PLANT SINCE THAT DATE. AGI #1 IS USED ONLY AS A BACKUP WELL IN THE EVENT THAT AGI D #2 REQUIRES SHUTDOWN FOR MAINTENANCE OR REPAIR.

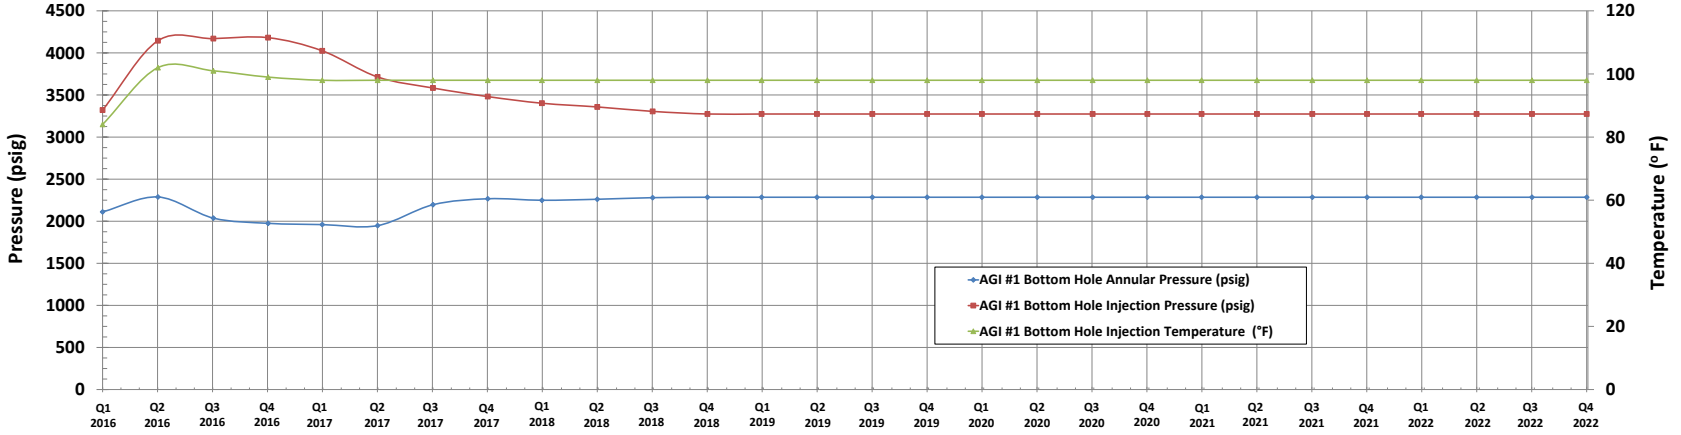
Figure 3. Zia AGI #1 Bottom Hole Data

AGI #1 WAS IN USE FROM EARLY 2016 THROUGH 2/7/2017 -- NOTE THE DROP IN BOTTOM HOLE PRESSURE AND SLIGHT INCREASE IN BOTTOM HOLE TEMPERATURE IN Q1 2017 IN RESPONSE TO CESSATION OF INJECTION INTO AGI #1. BY 2020 THE PRESSURE AND TEMPERATURE VALUES IN THE RESERVOIR HAVE STABILIZED AND RETURNED TO PRE-INJECTION CONDITIONS.

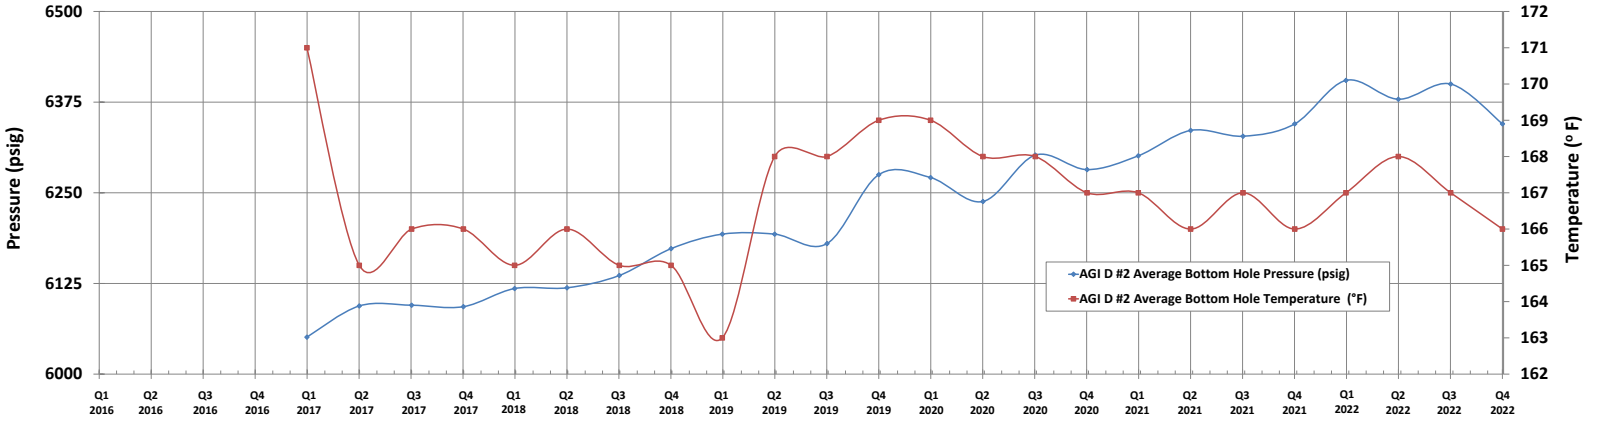
Figure 4. Zia AGI D #2 Bottom Hole Data

AGI D #2 WAS BROUGHT ONLINE ON 2/7/2017 -- NOTE THE DROP IN BOTTOM HOLE TEMPERATURE AND INCREASE IN BOTTOM HOLE PRESSURE BEGINNING IN Q1 2017 IN RESPONSE TO INITIATION OF INJECTION INTO AGI D #2. BOTTOM HOLE TEMPERATURE HAS NOW GENERALLY STABILIZED AROUND 167 ° F AND AVERAGE BOTTOM HOLE PRESSURE HAS INCREASED ABOUT 100 PSIG IN THREE YEARS.

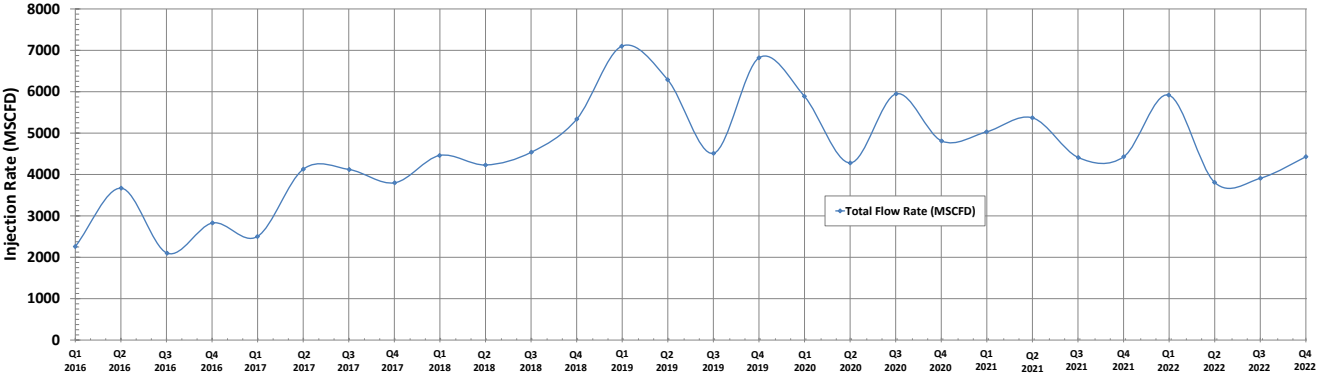
Figure 5. Zia AGI #1 and D #2 Total Flow Data

INCREASE IN TOTAL FLOW OCCURS AFTER AGI D #2 IS BROUGHT ONLINE IN FEBRUARY 2017 ALLOWING FOR PROCESSING HIGHER VOLUMES OF GAS THROUGH THE PLANT THEN WHEN IT WAS RELYING ON THE AGI #1 WELL ONLY. CURRENT INJECTION RATE HAS INCREASED NEARLY 100% SINCE THIS TIME.
