Pit, Below-Grade Tank, or Proposed Alternative Method Permit or Closure Plan Application

Hilcorp Energy Company
San Juan Basin
Below Grade Tank Closure Report

Lease Name: San Juan 29-6 Unit 81
API No.: 30-039-07528

SJ 29-6 Unit 81 - BGT Closure Photos
API 30-039-07528

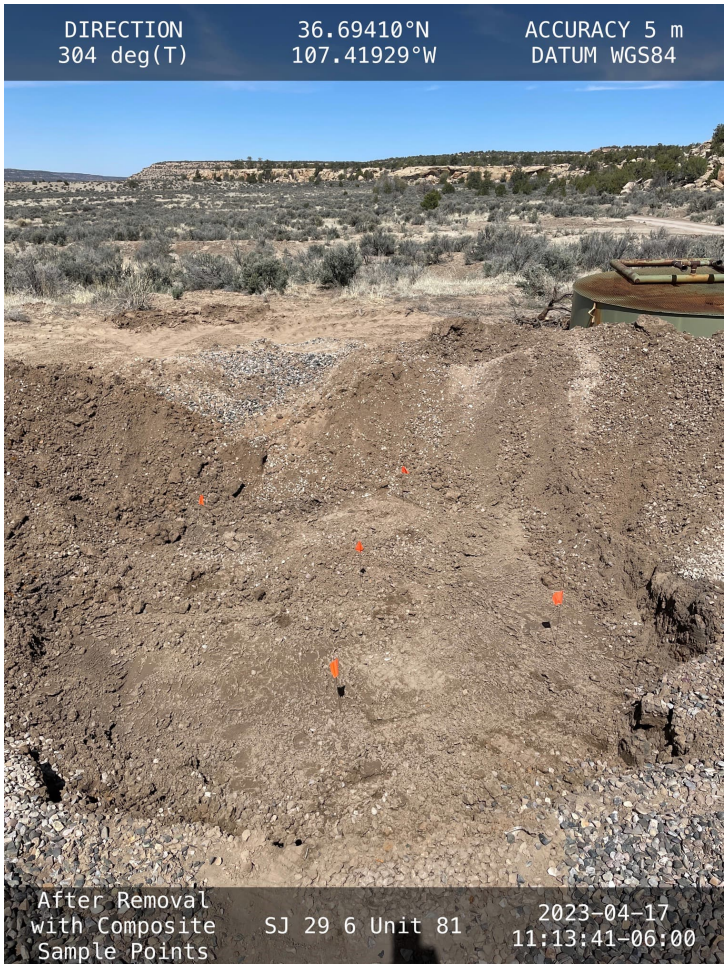
DIRECTION
304 deg(T)
36.69410°N
107.41929°W
ACCURACY 5 m
DATUM WGS84
After Removal
with Composite
Sample Points
SJ 29 6 Unit 81
2023-04-17
11:13:41-06:00
