Pit, Below-Grade Tank, or Proposed Alternative Method Permit or Closure Plan Application

1.
Operator: Hilcorp Energy Company OGRID #: 372171
Address: 382 Road 3100 Aztec, NM 87410
Facility or well name: SUNRAY E 2B
API Number: 3004530013 OCD Permit Number:
U/L or Qtr/Qtr E Section 9 Township 30N Range 10W County: San Juan
Center of Proposed Design: Latitude 36.82933 Longitude -107.89441 NAD27
Surface Owner: ☒ Federal ☐ State ☐ Private ☐ Tribal Trust or Indian Allotment

Hilcorp Energy Company
San Juan Basin
Below Grade Tank Closure Report

Lease Name: SUNRAY E 2B
API No.: 30-045-30013

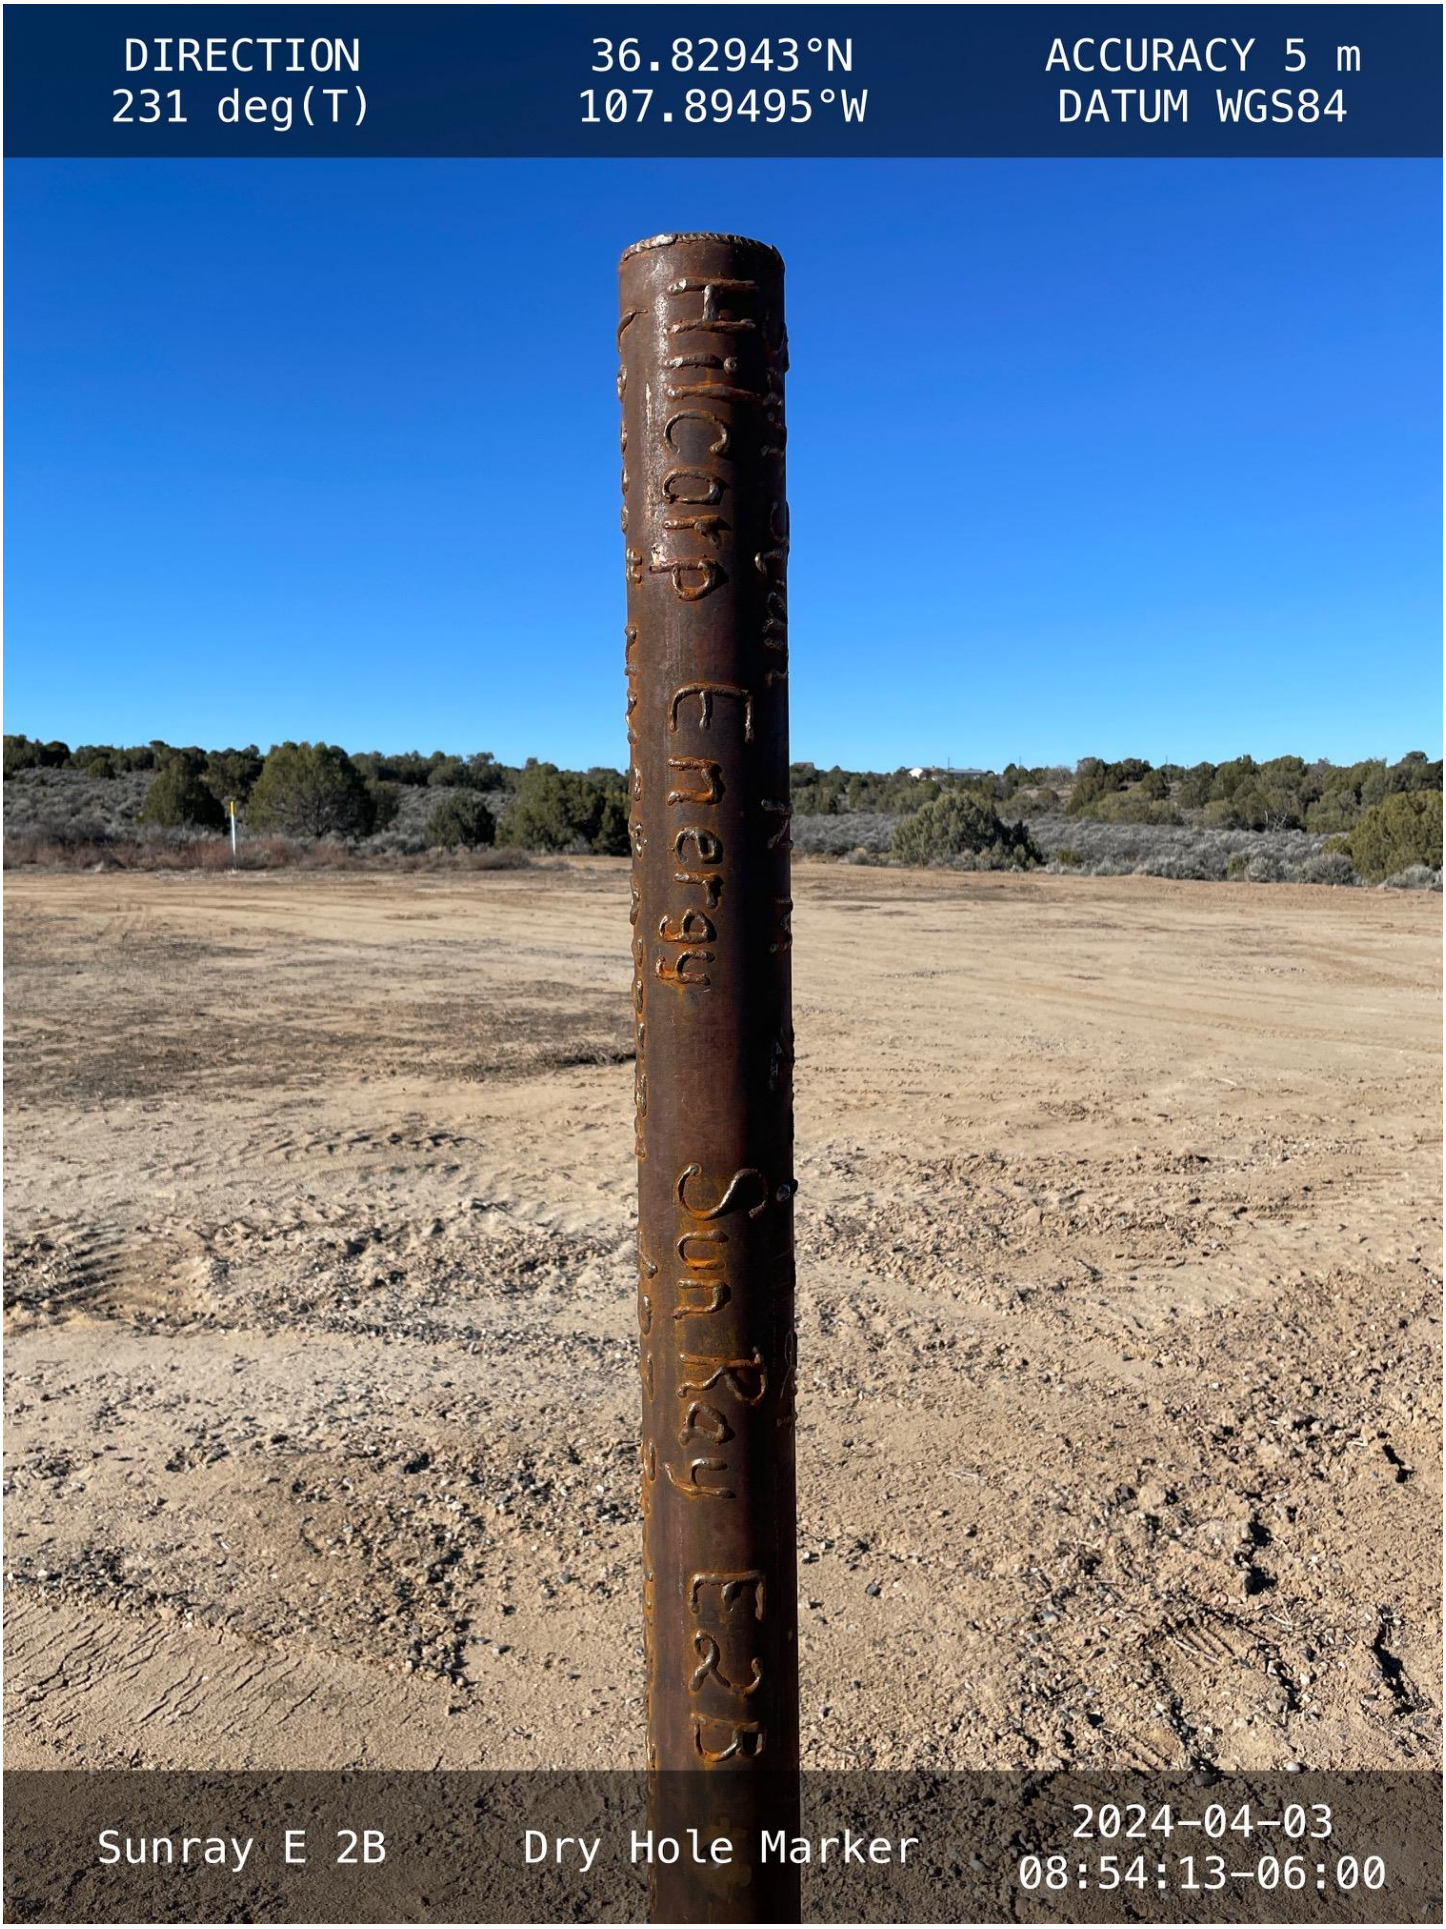
DIRECTION
231 deg(T)
36.82943°N
107.89495°W
ACCURACY 5 m
DATUM WGS84
Sunray E 2B
Dry Hole Marker
2024-04-03
08:54:13-06:00

DIRECTION
211 deg(T)
36.82954°N
107.89515°W
ACCURACY 5 m
DATUM WGS84
Sunray E 2B
Before Removal
2024-04-03
08:54:58-06:00

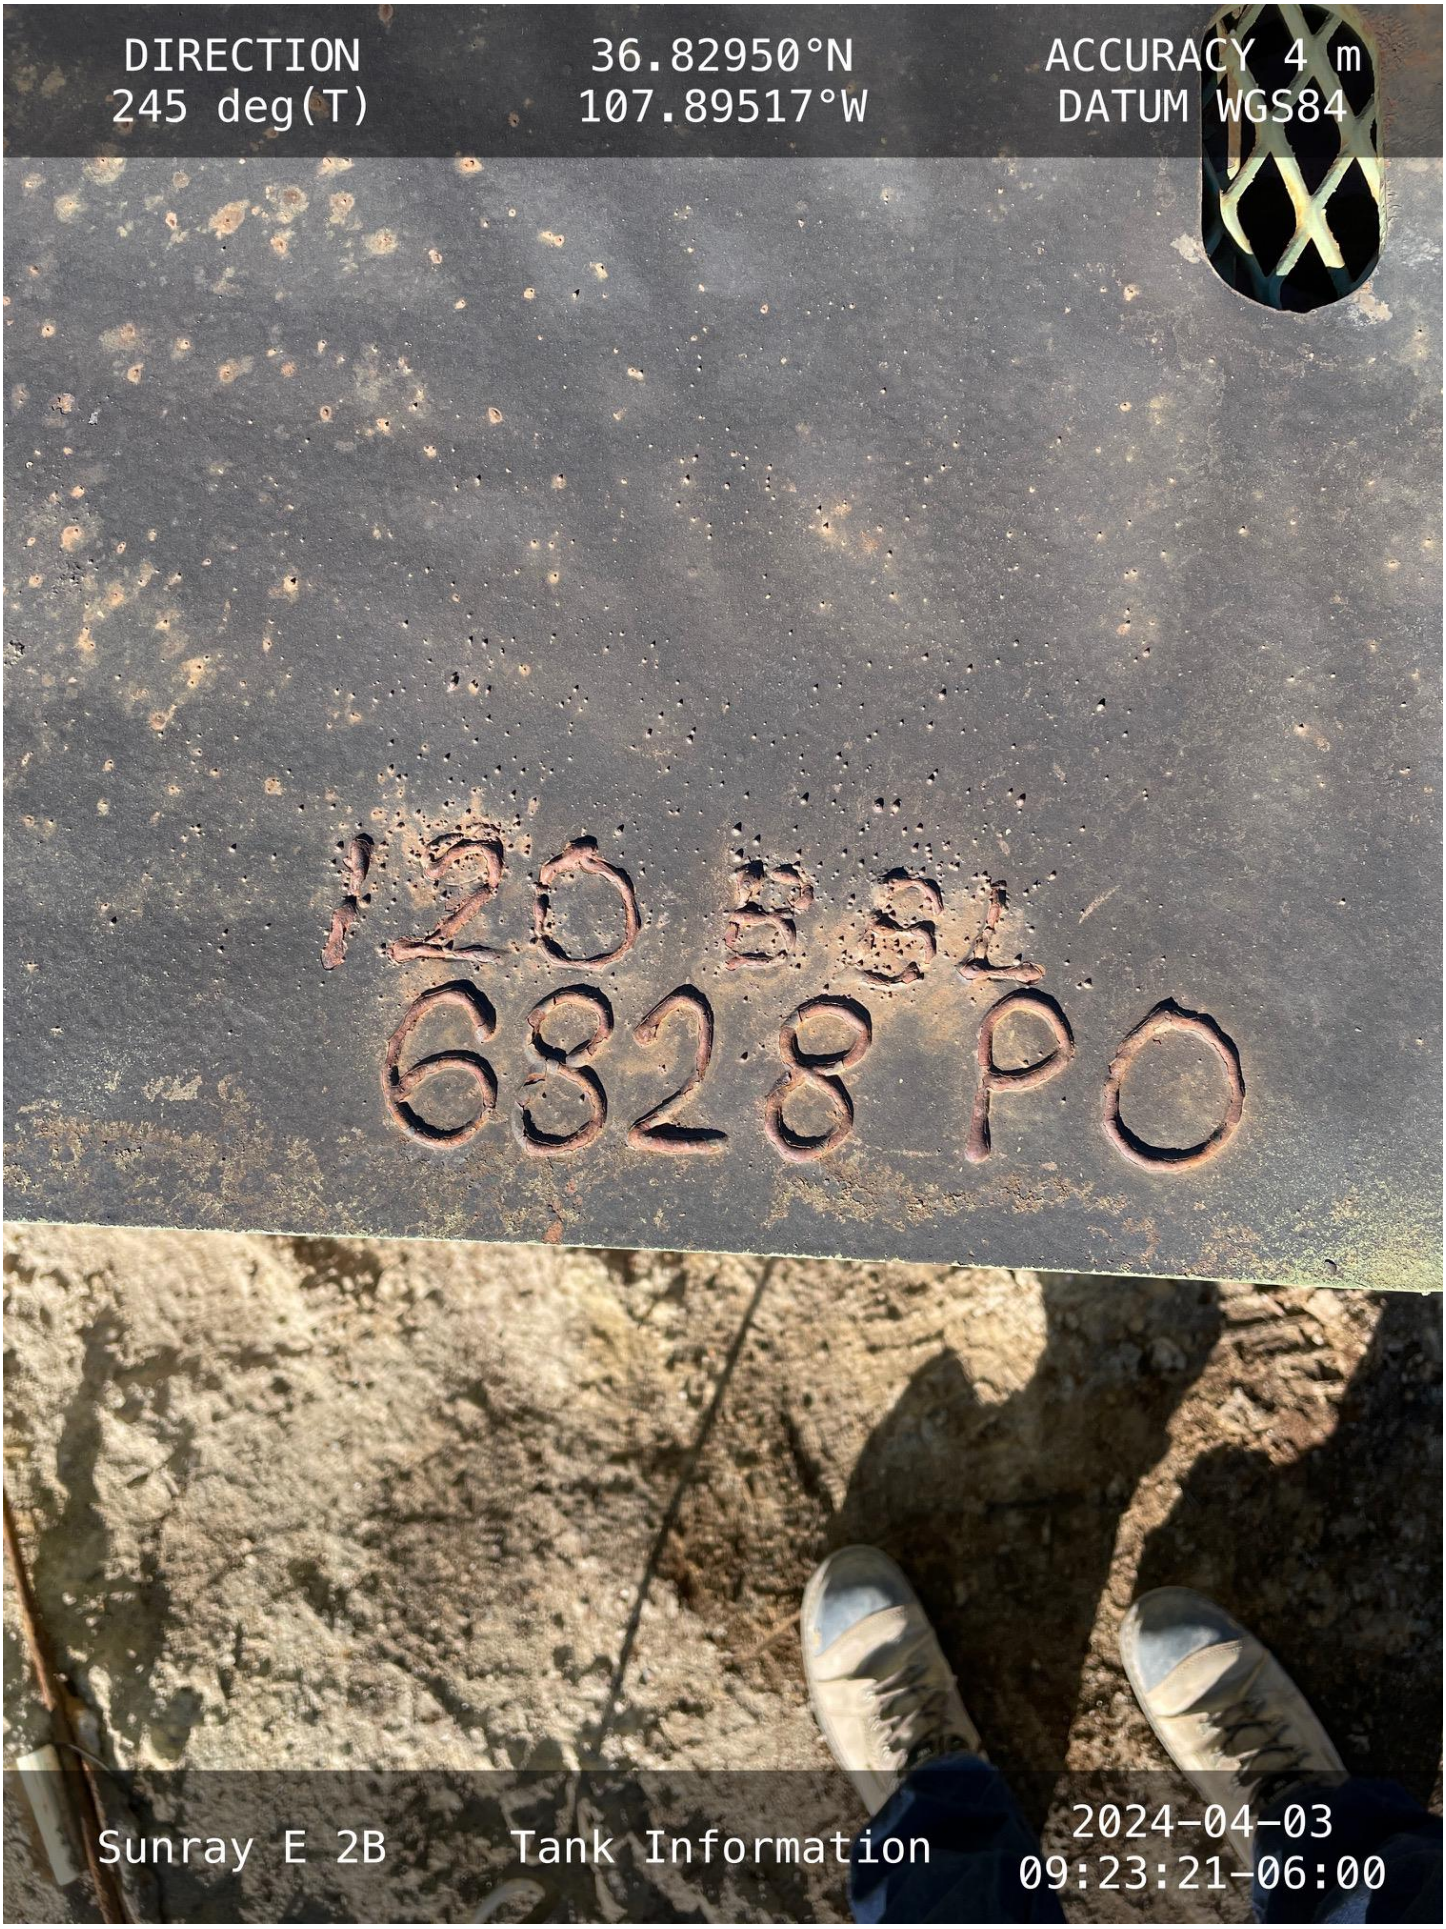
DIRECTION
245 deg(T)
36.82950°N
107.89517°W
ACCURACY 4 m
DATUM WGS84
120 BBL
6828 PO
Sunray E 2B
Tank Information
2024-04-03
09:23:21-06:00

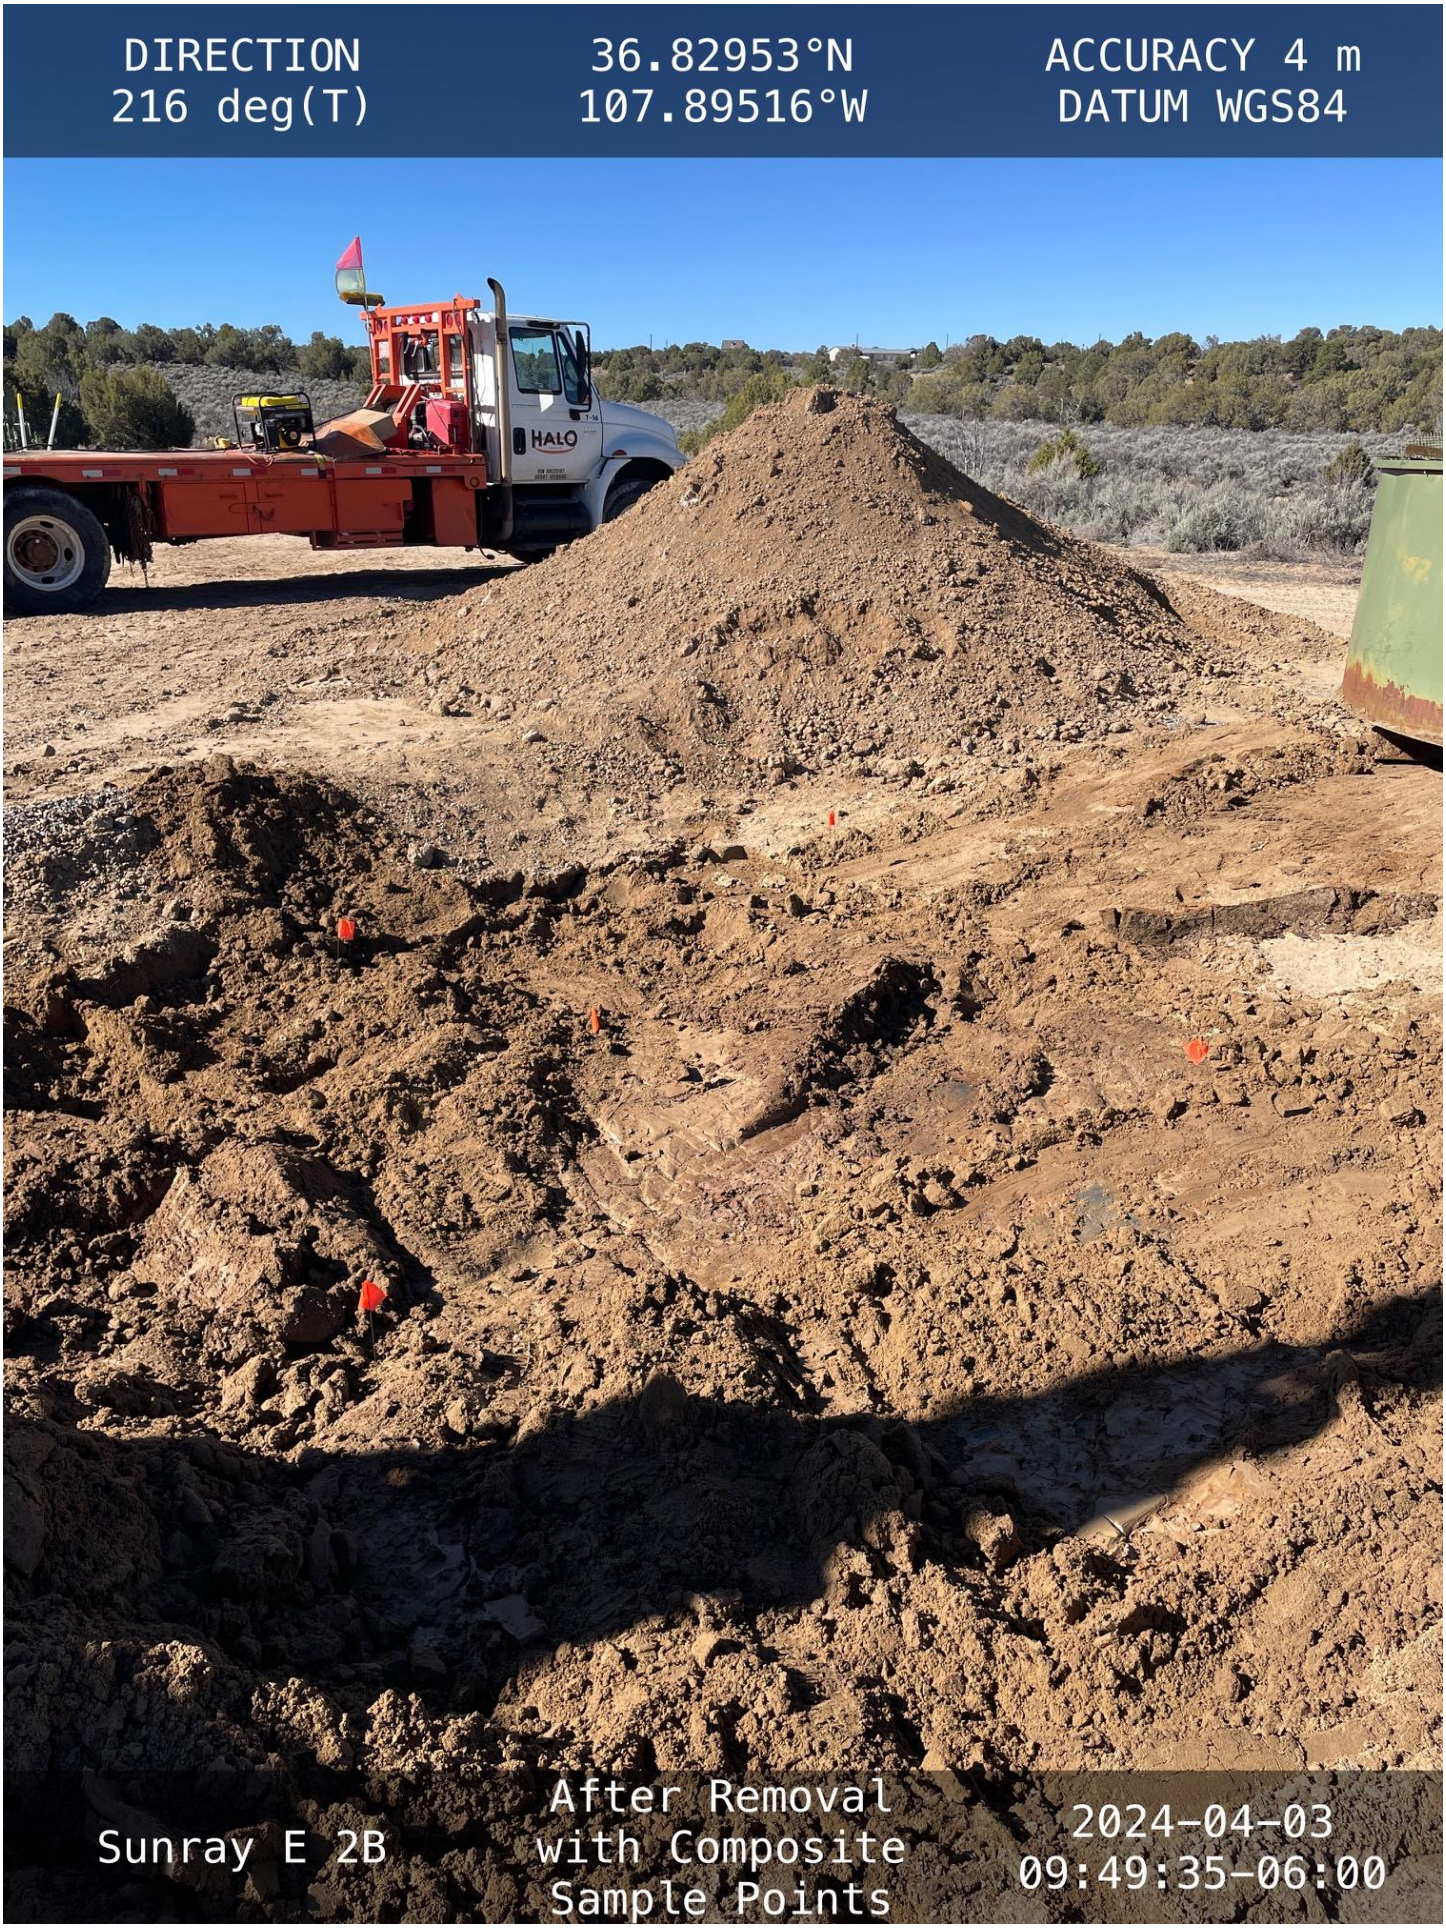
DIRECTION
216 deg(T)
36.82953°N
107.89516°W
ACCURACY 4 m
DATUM WGS84
HALO
Sunray E 2B
After Removal
with Composite
Sample Points
2024-04-03
09:49:35-06:00
