Pit, Below-Grade Tank, or Proposed Alternative Method Permit or Closure Plan Application

Facility or well name: HUERFANO UNIT 174E

Hilcorp Energy Company
San Juan Basin: New Mexico Assets
Below Grade Tank Closure Report

Lease Name: Huerfano Unit 174E
API No.: 30-045-26263

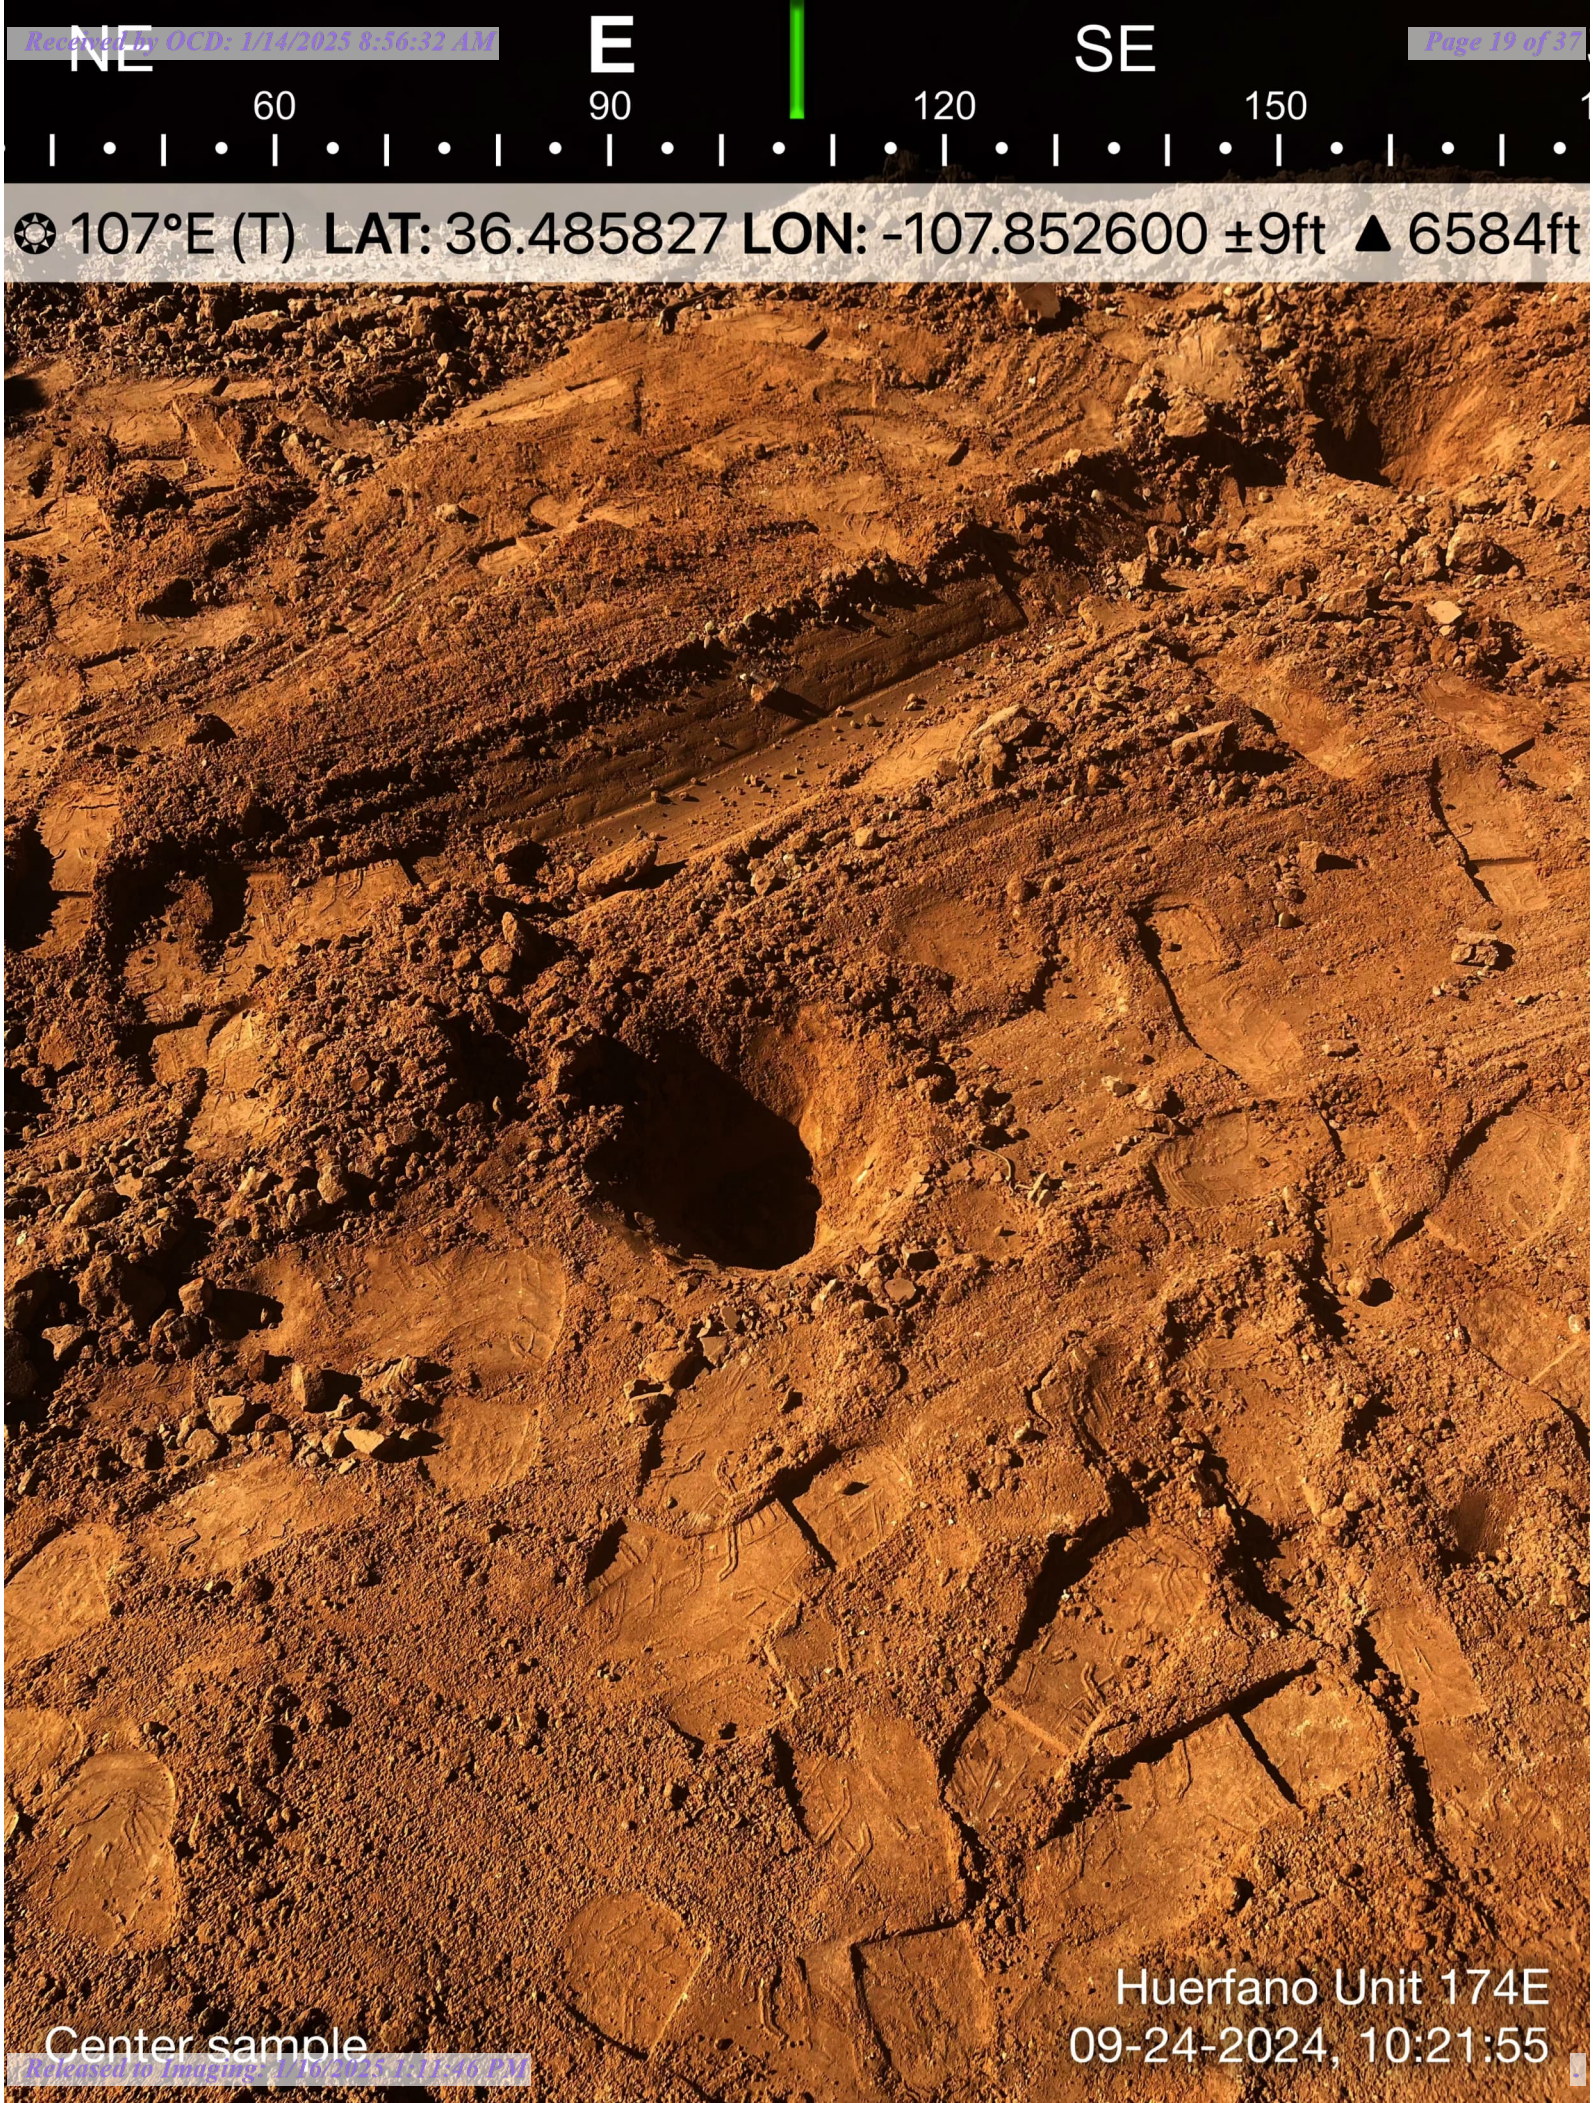
E
SE
S
SW
60
90
120
150
180
210
240
149°SE (T) LAT: 36.485767 LON: -107.852569 ±42ft ▲ 6604ft
09-24-2024, 10:31:30

The tank removal area passed all requirements of Table I of 19.15.17.13 NMAC and was backfilled with compacted, non-waste containing, earthen material which included at least one foot of suitable material to establish vegetation at the site.
