EME B-19 EOL

RE: Termination Request
EME B-19 EOL: UL/B, Sec. 19, T19S, R37E
RICE Operating Company – Eunice Monument Eumont SWD System

RICE OPERATING COMPANY
JUNCTION BOX FINAL REPORT

RE: JUNCTION BOX UPGRADE REPORT for 2013
EME SWD SYSTEM
Lea County, New Mexico

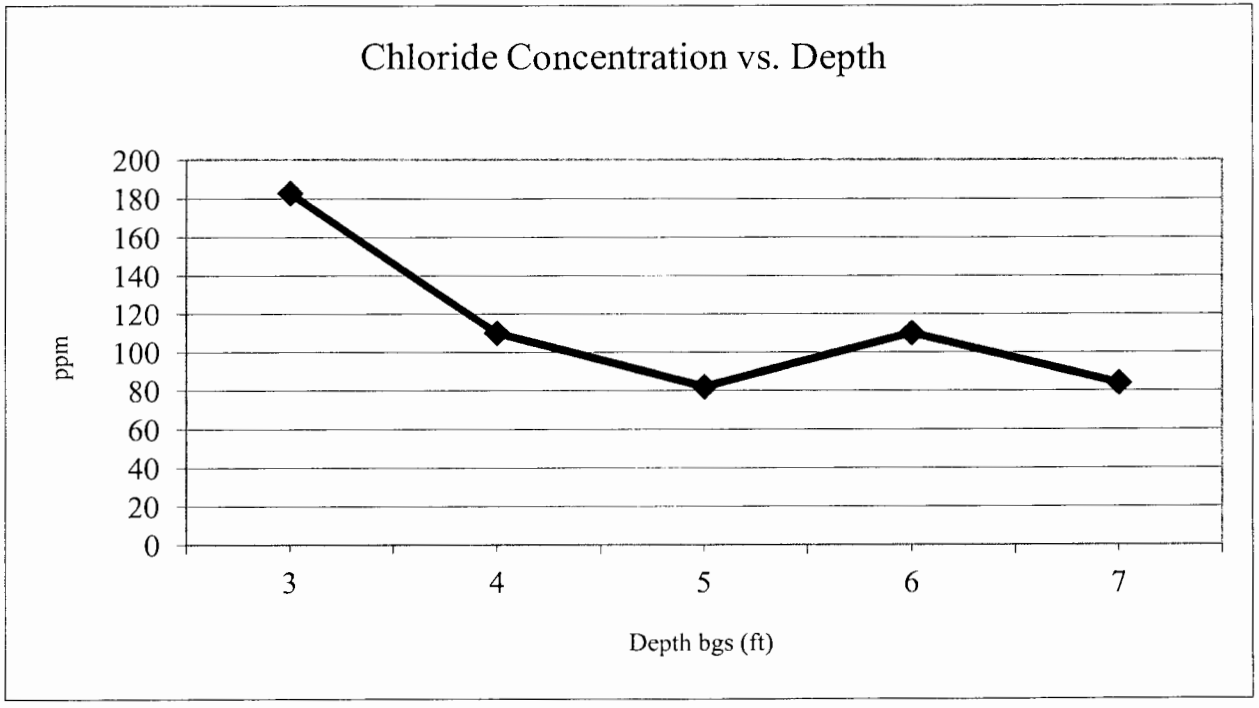
EME B-19 EOL

Backhoe samples at junction (source)

Depth bgs (ft)	Cl⁻ ppm
3	183
4	110
5	82
6	110
7	84
8	85
9	142
10	82

Groundwater = 42 ft

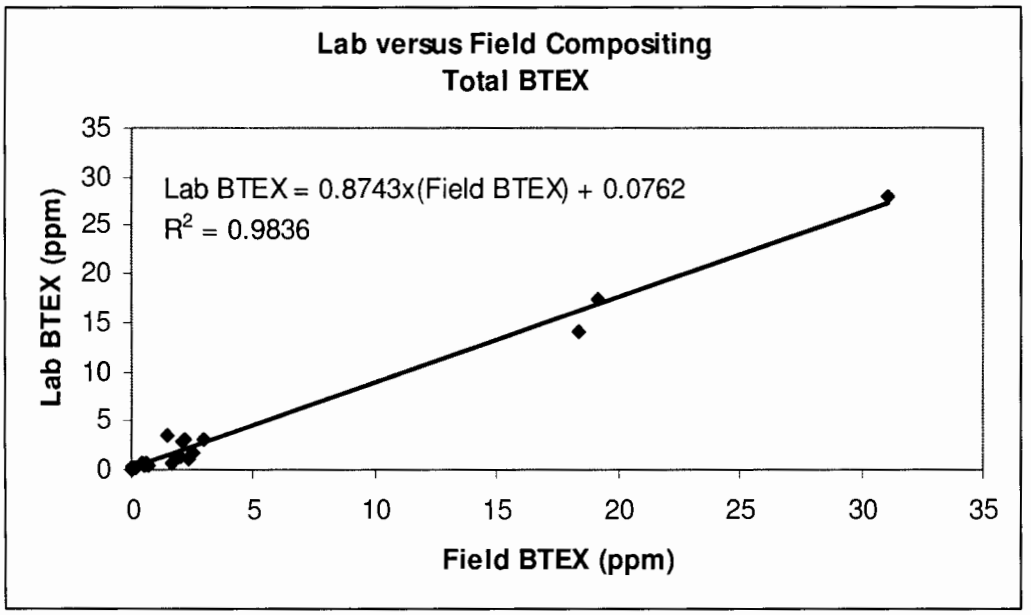
Figure 1 - Laboratory versus field-composited soil samples analyzed for BTEX.

The high R^2 value (0.9836) of the best-fit statistical regression line indicates a high degree of reliability in using the field-compositing method over the range of values observed. Below a "field-composited BTEX" value of 0.61 ppm the "lab-composited BTEX" values are slightly lower. However, above a field-composited BTEX value of 0.61 the lab-composited values run slightly lower. In other words, the field-composited values tended to produce slightly higher BTEX numbers above the point at which BTEX concentrations become significant.

There is a reason for this. BTEX is volatile and quickly biodegradable. The compositing and "packaging" of soil samples in the field minimize the handling and aeration that occur in the laboratory. Thus, field-composited soil samples lose less BTEX to evaporation and/or biodegradation prior to laboratory analysis. In other words, the field compositing and packaging of soil samples better preserves sample integrity, and for this reasons would appear to represent the better method of procuring soil samples for subsequent analysis of BTEX.

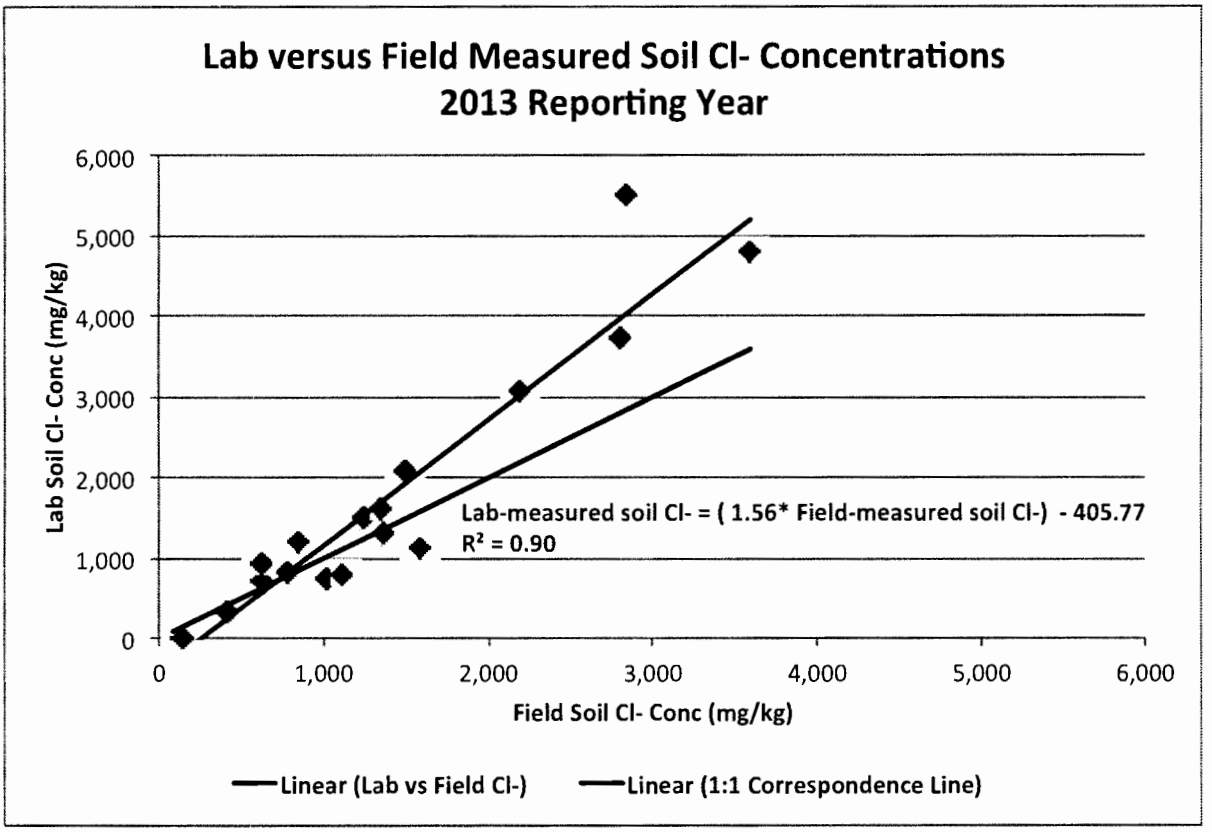
Figure 1 – Laboratory versus field measured soil chloride measurements (n = 29 paired sets).

A straight line fit to the data confirms a general linear trend over a wide range of soil chloride concentrations, and the R^2 value (0.90) indicates that field measurements provide a reliable approximation of laboratory-measured values. Based on the best-fit line of lab vs field measured values, field measured values overestimate lab measure values below a field measured value of 723 mg/kg and above this underestimate the lab-measured values. This is indicated in the graph where the (blue) best-fit line of lab vs field measured chlorides crosses the (black) line which would indicate a 1:1 correspondence.
