Report Type: Work Plan

July 5, 2011

Re: Work Plan for the COG Operating LLC., State SRO #101 SWD, Unit G, Section 5, Township 26 South, Range 28 East, Eddy County, New Mexico.

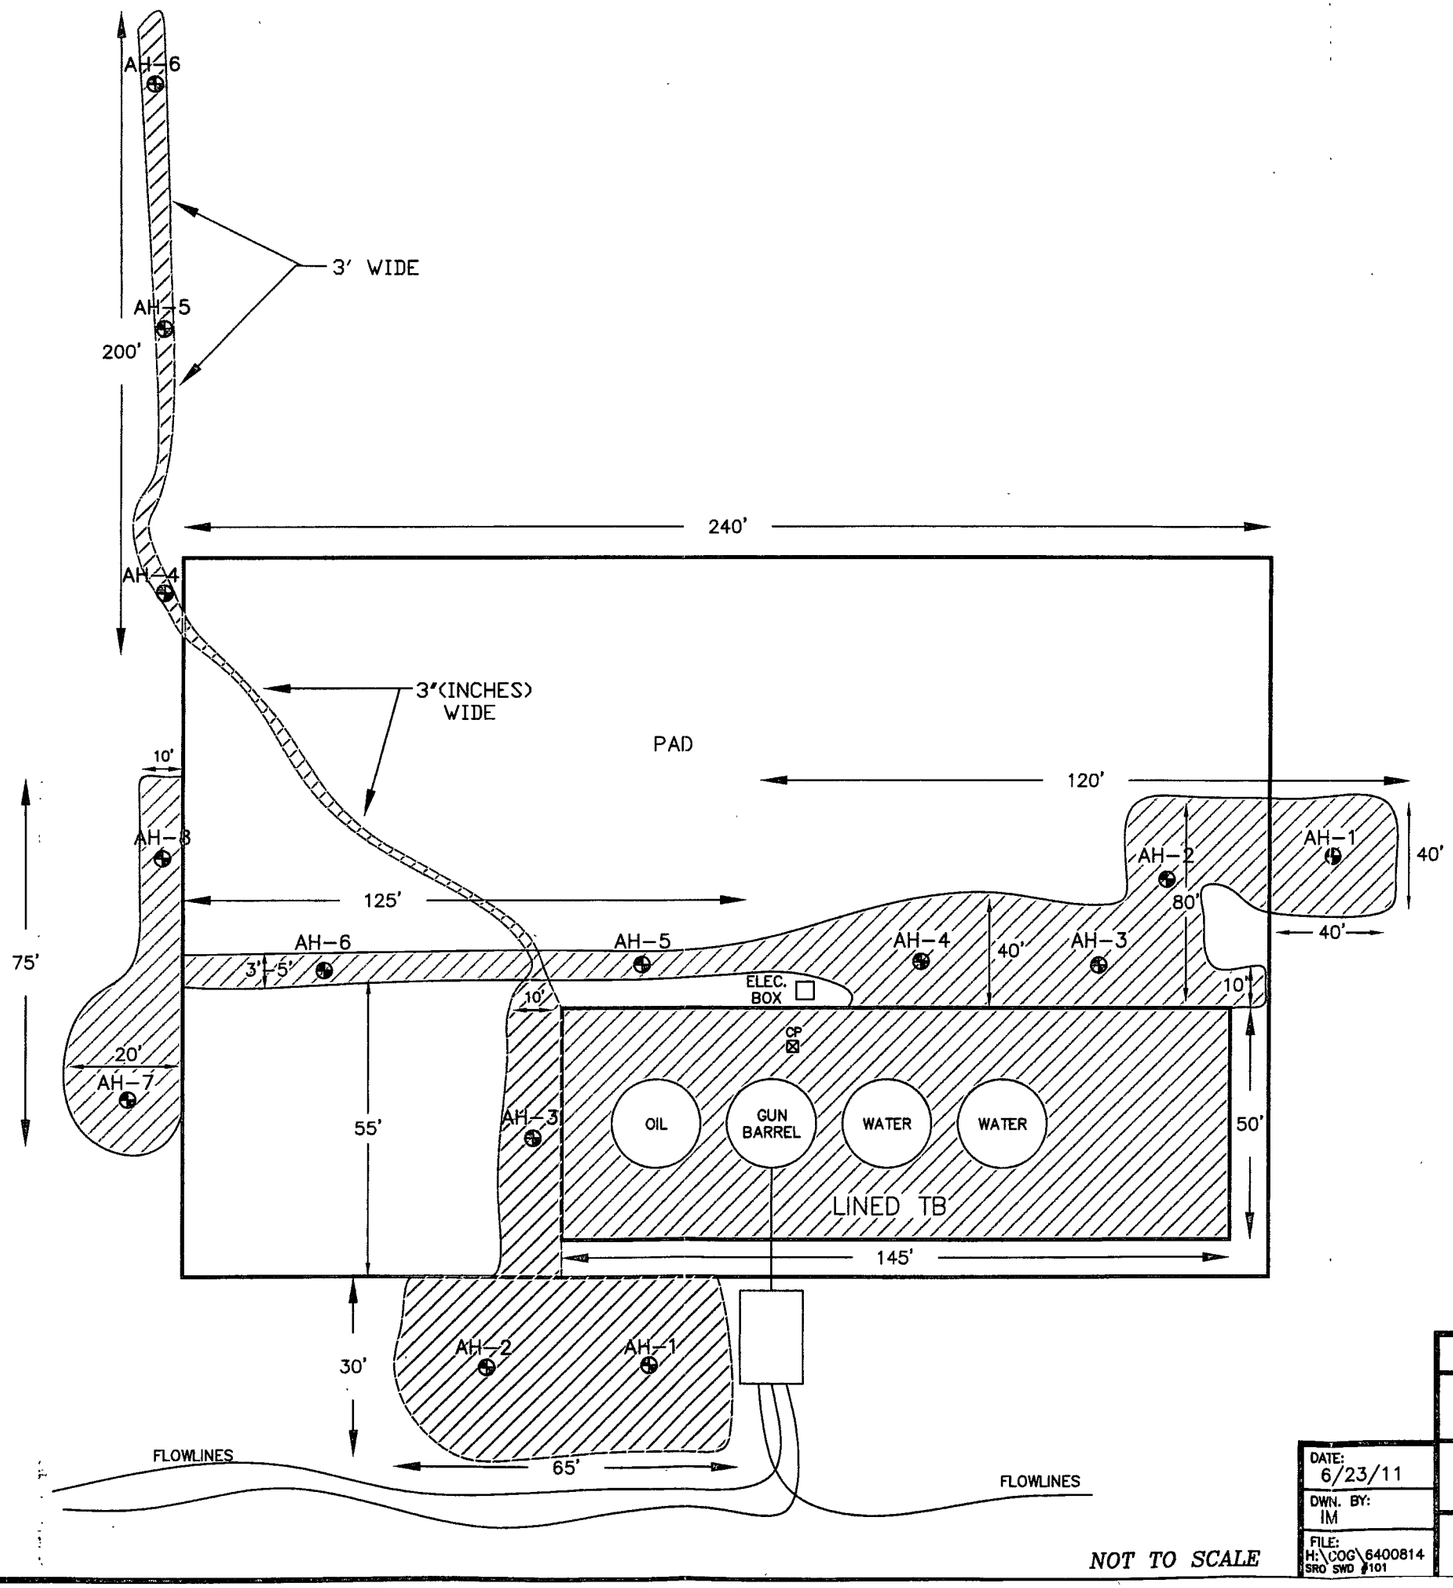
FIGURE NO. 3

EPA Method 8021B and chloride by EPA method 300.0. Copies of laboratory analysis and chain-of-custody documentation are included in Appendix C. The results of the sampling are summarized in Table 1. The auger hole locations are shown on Figure 3.

On May 3, 2011, Tetra Tech personnel inspected and sampled the second spill area. Six auger holes (AH-1 through AH-6) were installed using a stainless steel hand auger to assess the impacted soils. Selected samples were analyzed for TPH analysis by EPA method 8015 modified, BTEX by EPA Method 8021B and chloride by EPA method 300.0. Copies of laboratory analysis and chain-of-custody documentation are included in Appendix C. The results of the sampling are summarized in Table 2. The auger hole locations are shown on Figure 3.

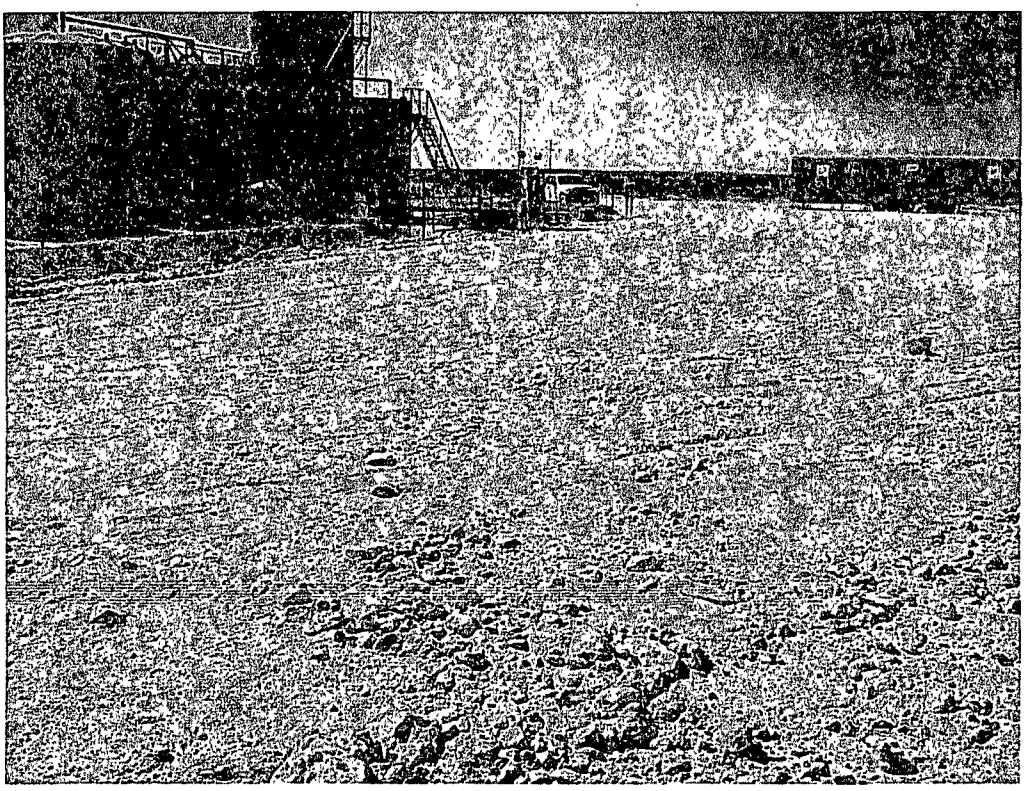
View west – Front of battery near AH-3

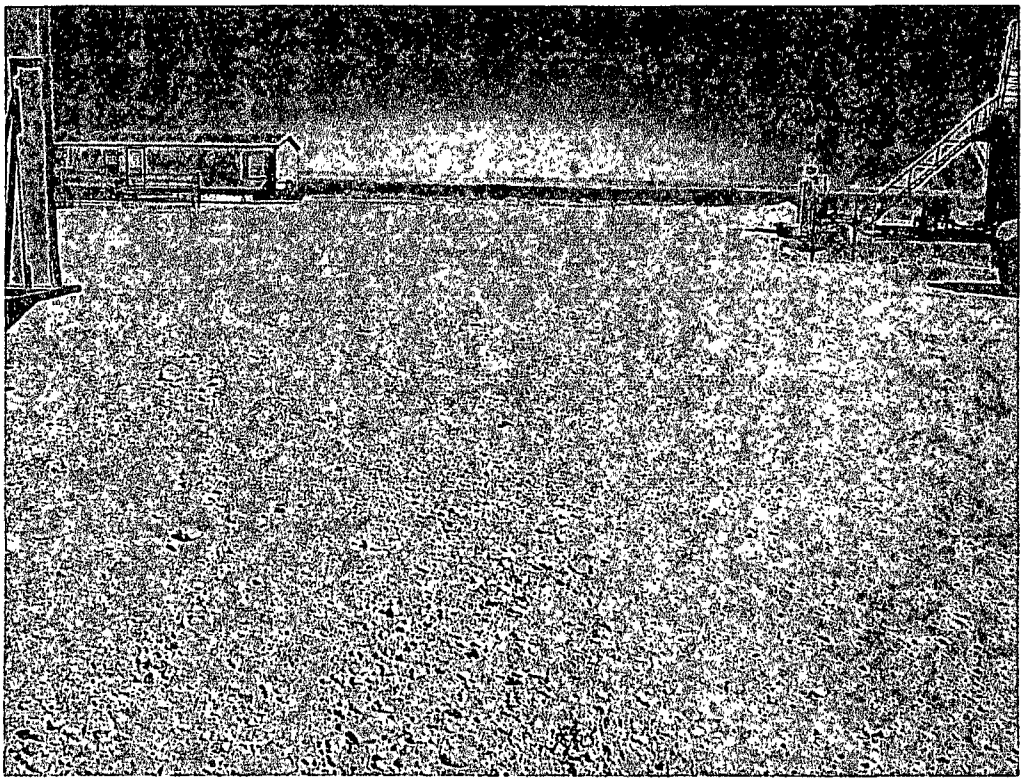
View east – Near AH-6

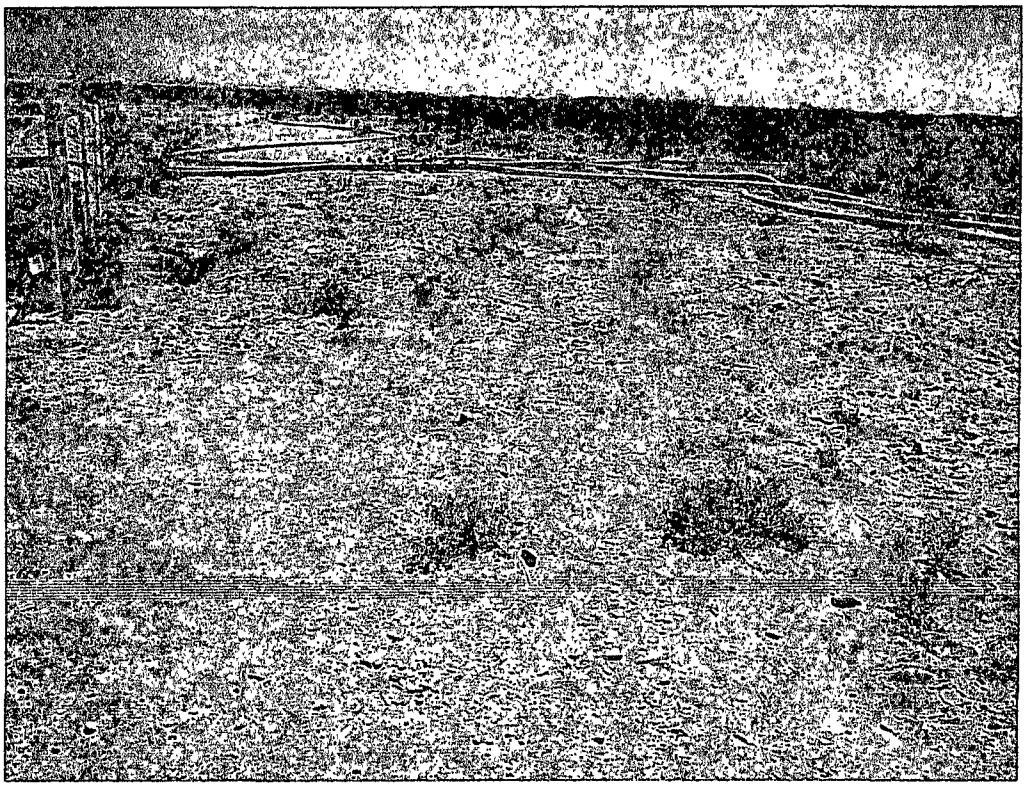
View east – Behind battery near AH-1 and AH-2

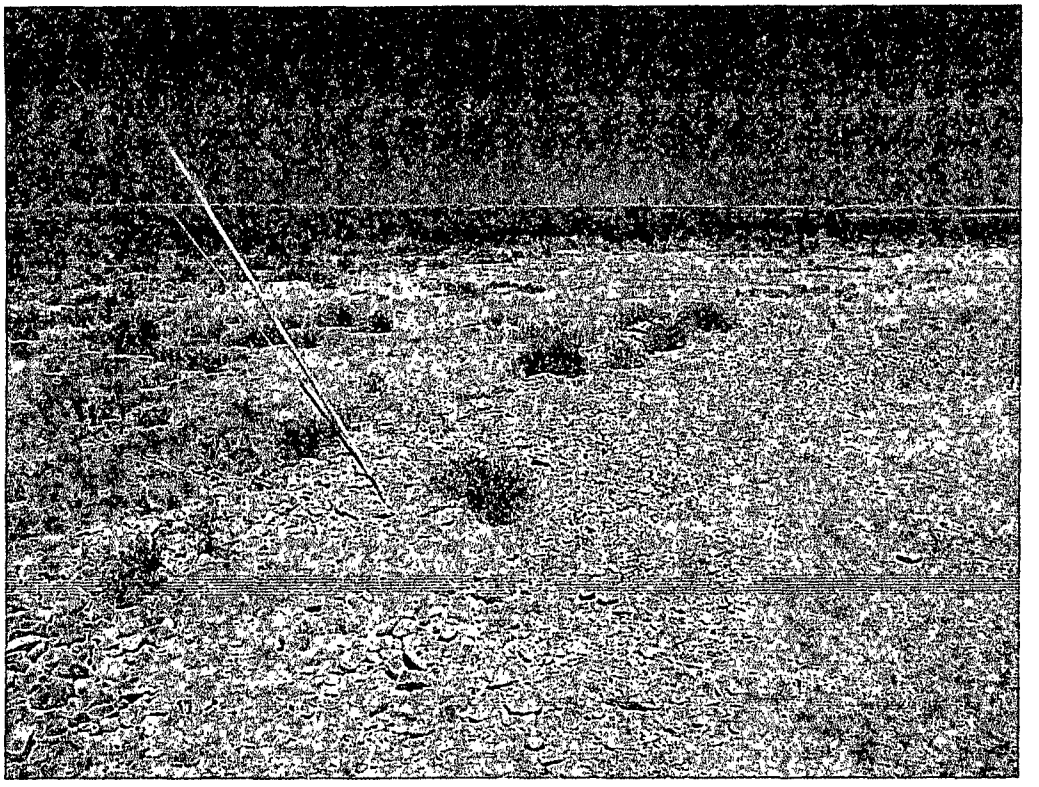
View north – Pasture area off pad, near AH-5 and AH-6

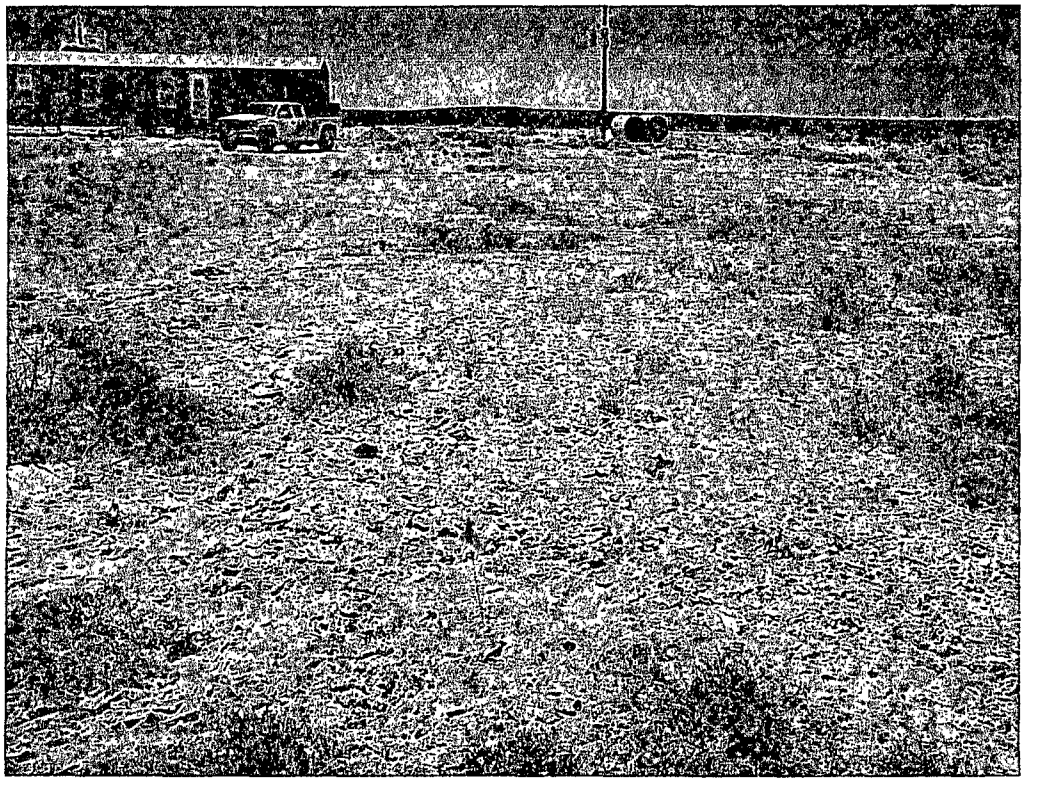
View south – North edge of spill near AH-6
