3R - 194

RE: Jaquez Site Excavation Report and Case Closure Request
Jaquez Com C#1 and Jaquez Com E#1 Site
NMOCD Case No.: 3RP-194

SOIL EXCAVATION REPORT
JAQUEZ COM. C#1 AND JAQUEZ COM. E#1
SAN JUAN COUNTY, NEW MEXICO

MWH - Denver
1801 California St., Suite 2900
Denver, Colorado 80202
(303) 291-2222

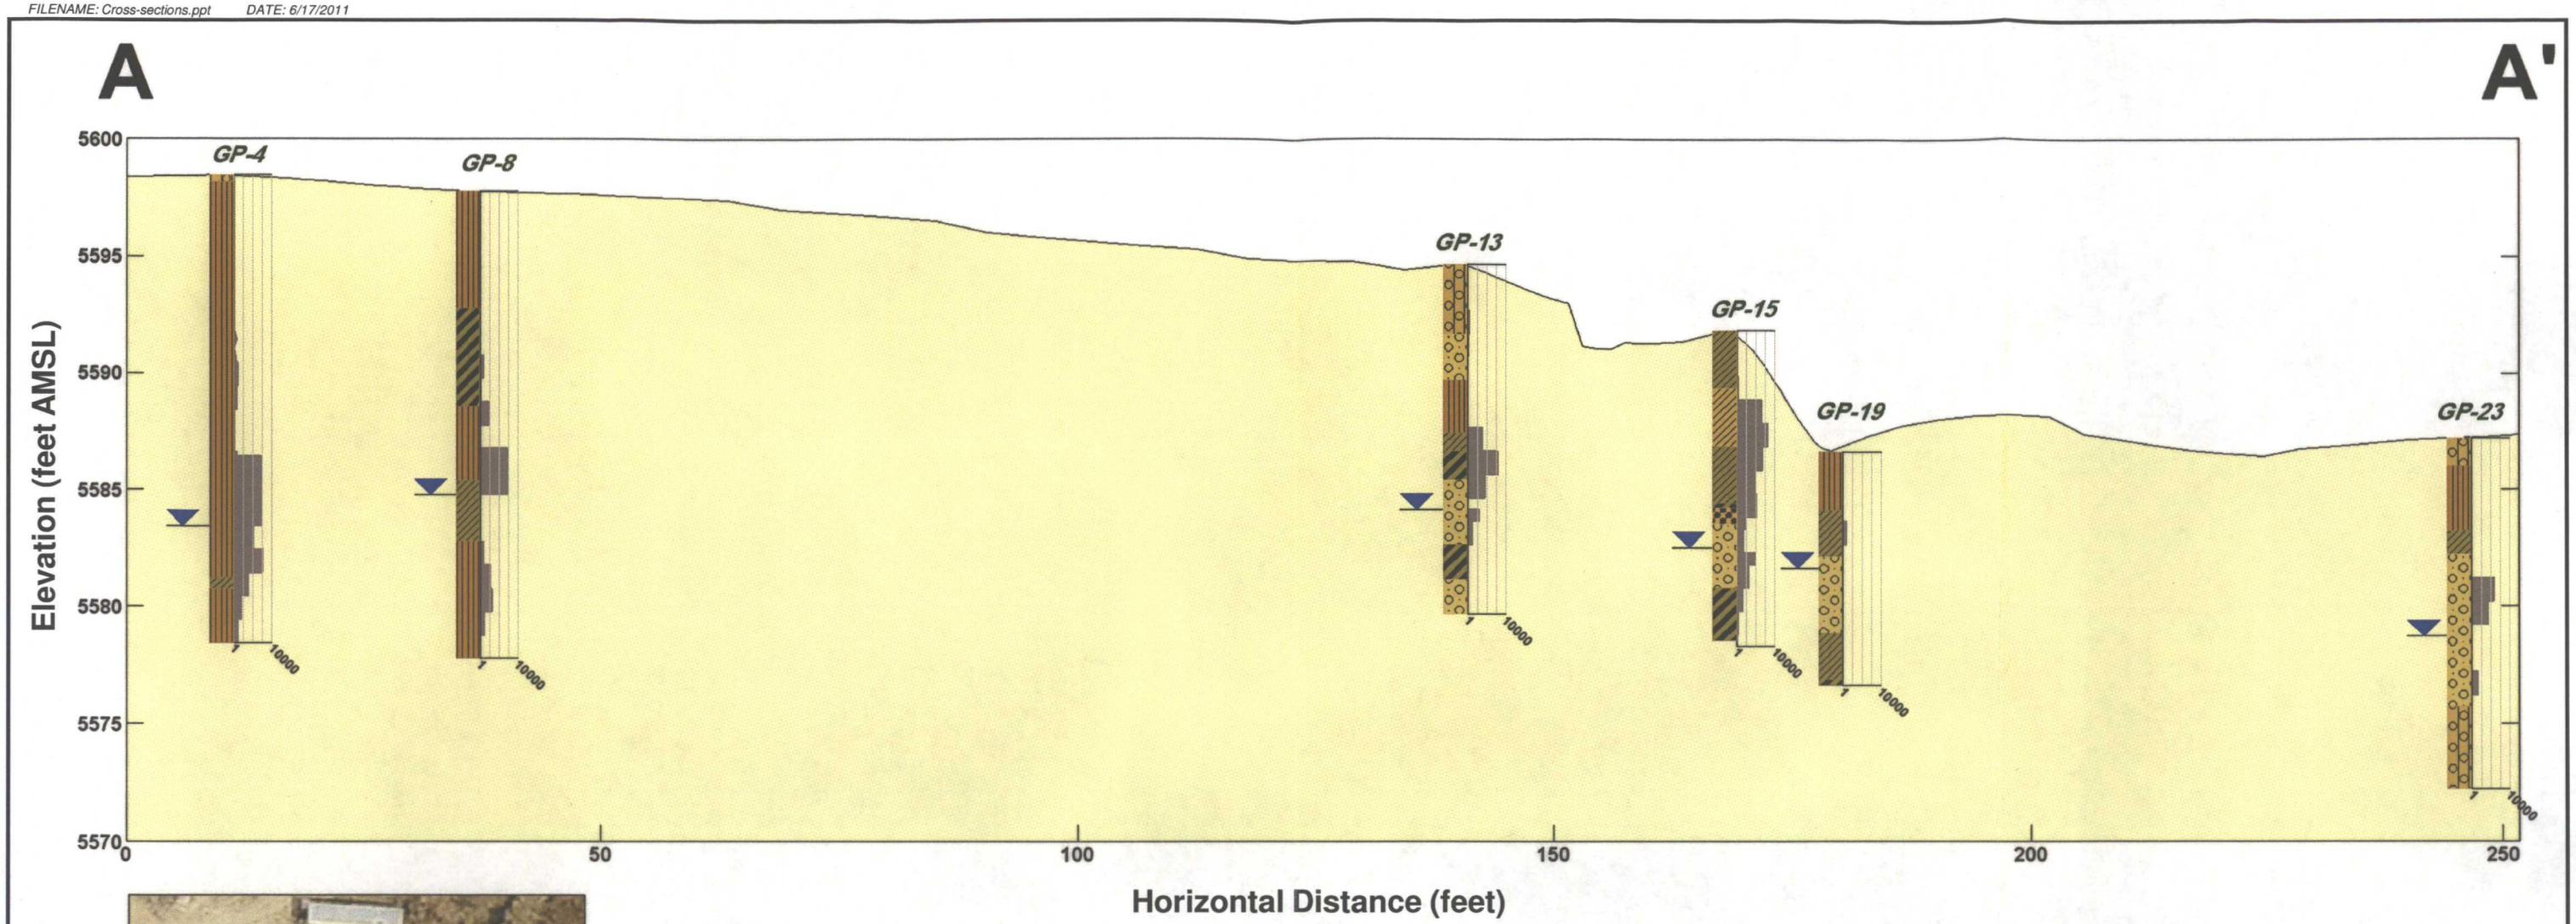
PROJECT:	Jaquez Site	FIGURE:
TITLE:	2010-2011 Excavation Area and Sample Locations	3

Significant petroleum hydrocarbon impacts were observed in the excavation sidewall north of the Jaquez property boundary. These impacts extend off-site to the north in an area which could not be further excavated due to the presence of an old trailer (i.e., apparently an old mobile home) and the adjacent property owner's stated desire to not move it. These left-in-place impacted soils are located along a 50-foot section of the excavation sidewall just in front of the old trailer (see **Figure 3**, *2010-2011 Excavation Limits and Sample Locations* and **Appendix A-5**, *Documentation of Soils Left-In-Place*).

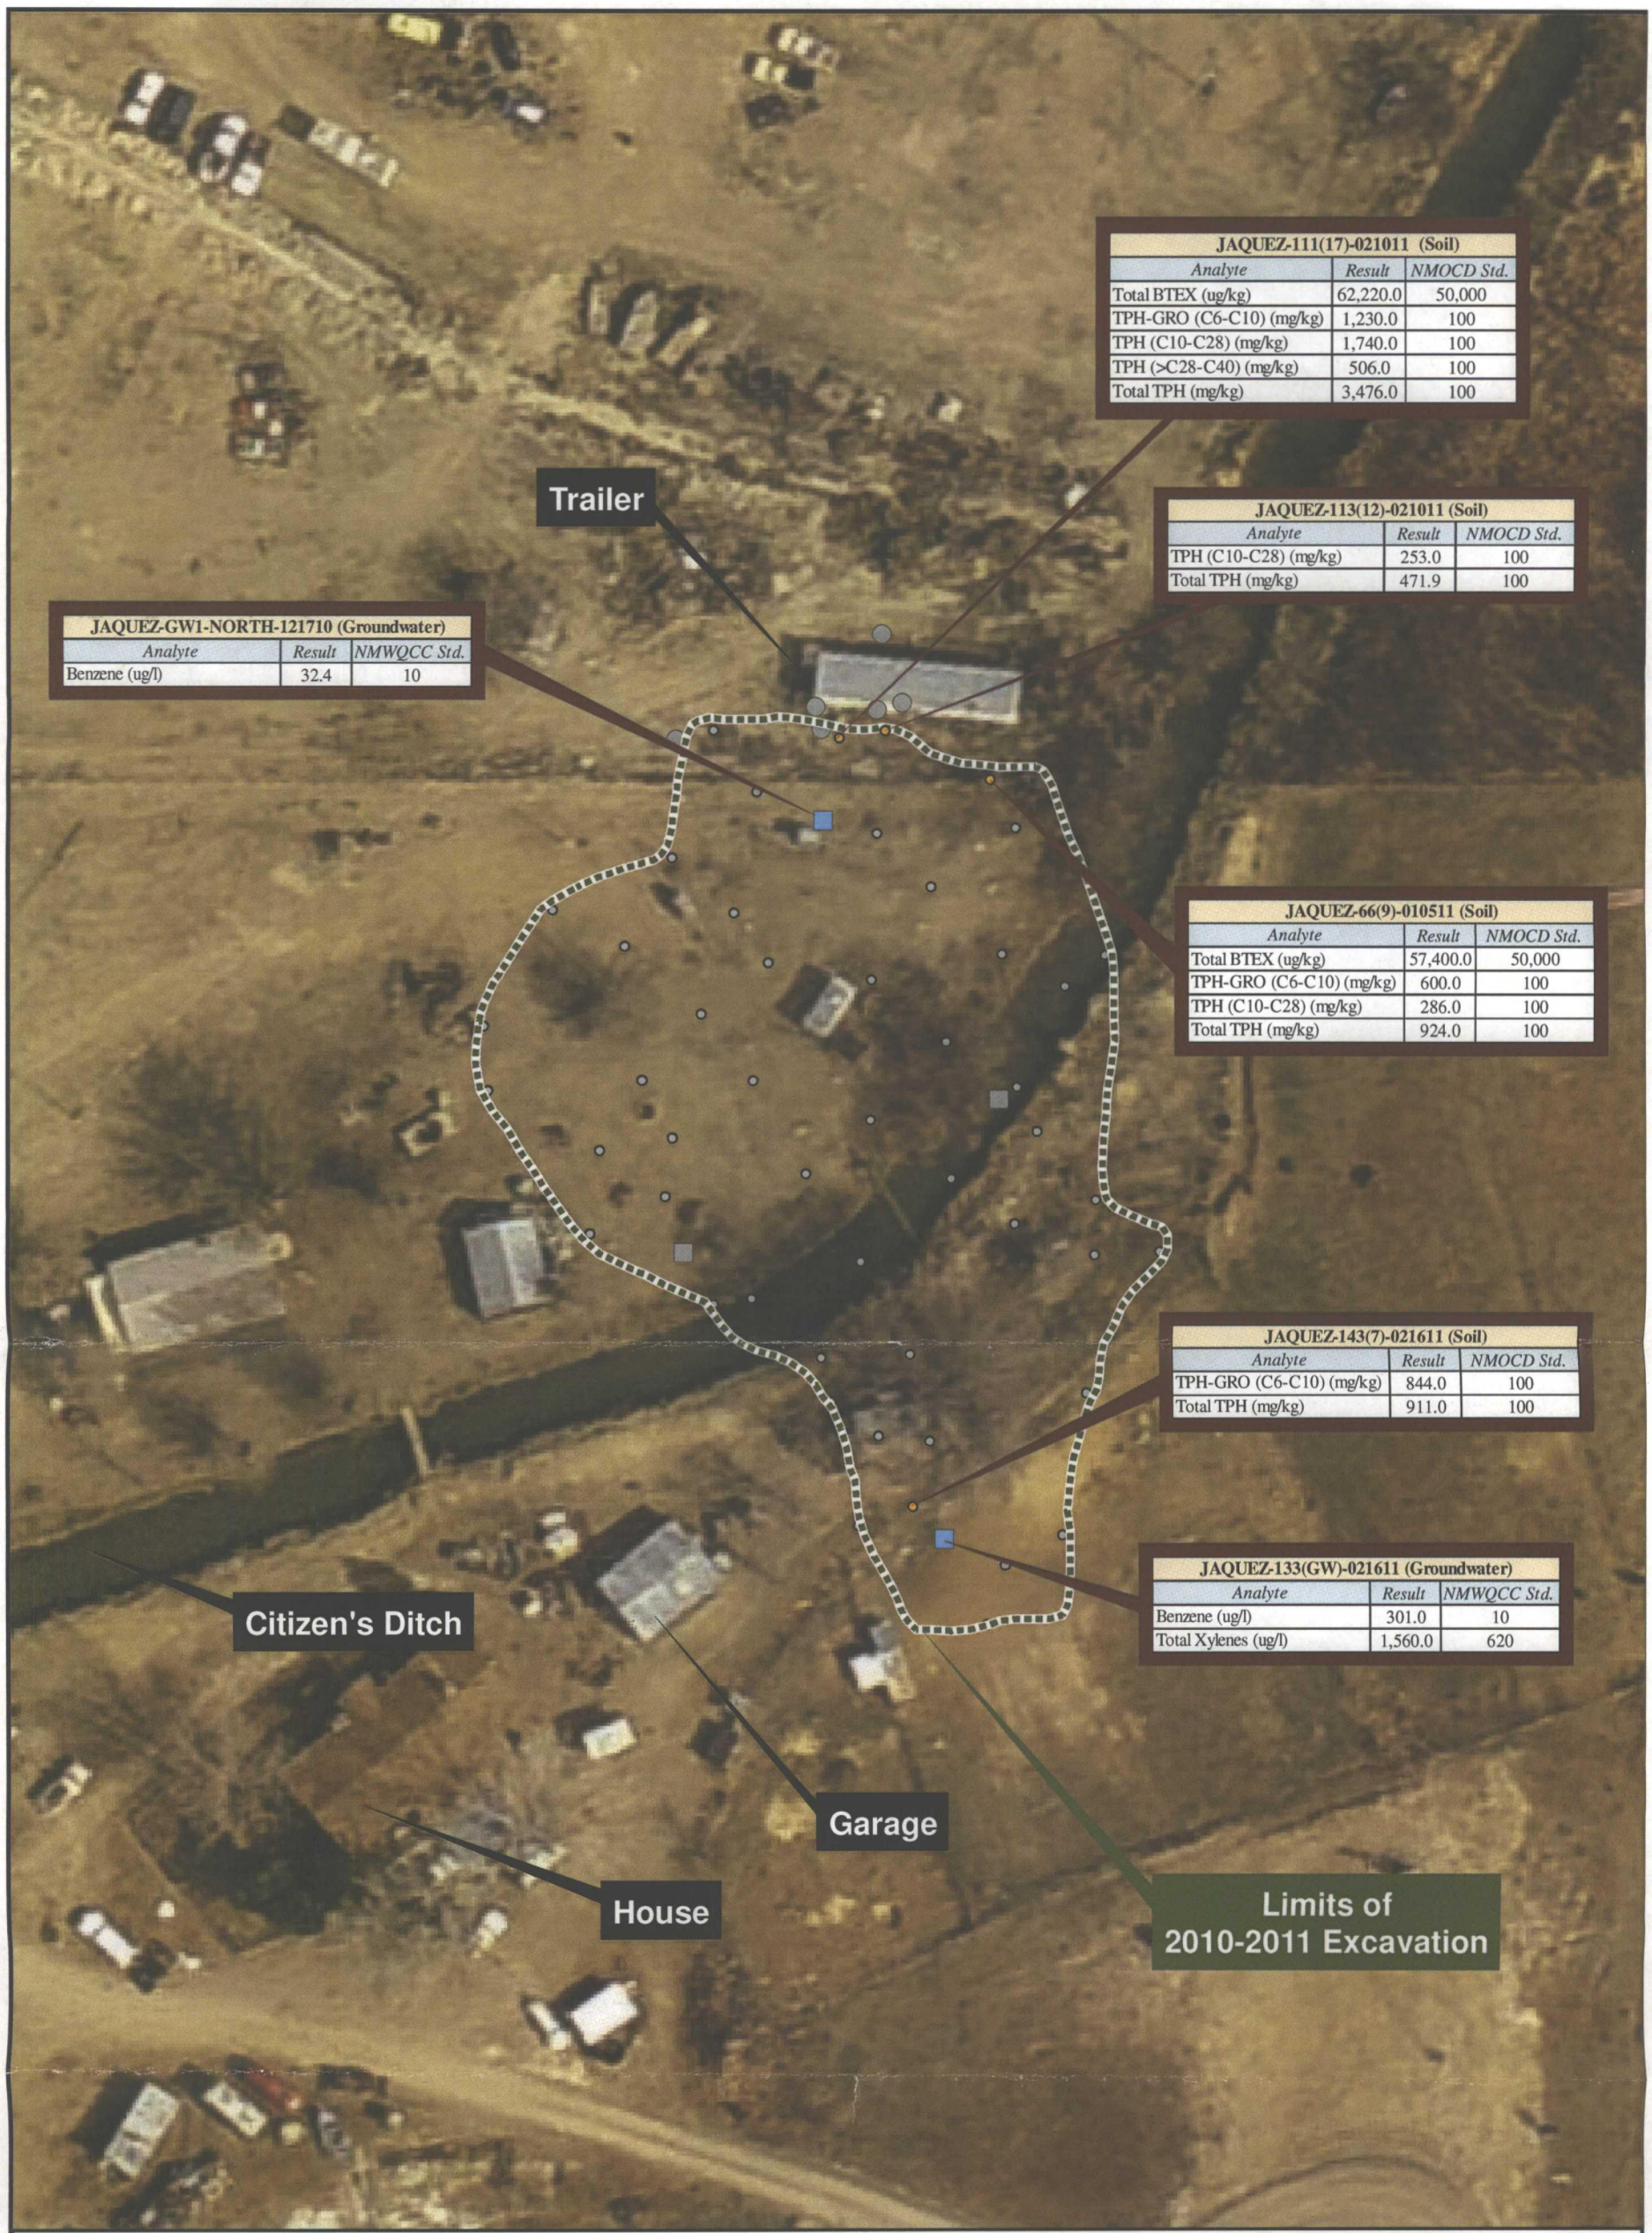
FIGURE **4**

JAQUEZ-111(17)-021011 (Soil)		
Analyte	*Result*	*NMOCD Std.*
Total BTEX (ug/kg)	62,220.0	50,000
TPH-GRO (C6-C10) (mg/kg)	1,230.0	100
TPH (C10-C28) (mg/kg)	1,740.0	100
TPH (>C28-C40) (mg/kg)	506.0	100
Total TPH (mg/kg)	3,476.0	100

JAQUEZ-113(12)-021011 (Soil)		
Analyte	*Result*	*NMOCD Std.*
TPH (C10-C28) (mg/kg)	253.0	100
Total TPH (mg/kg)	471.9	100

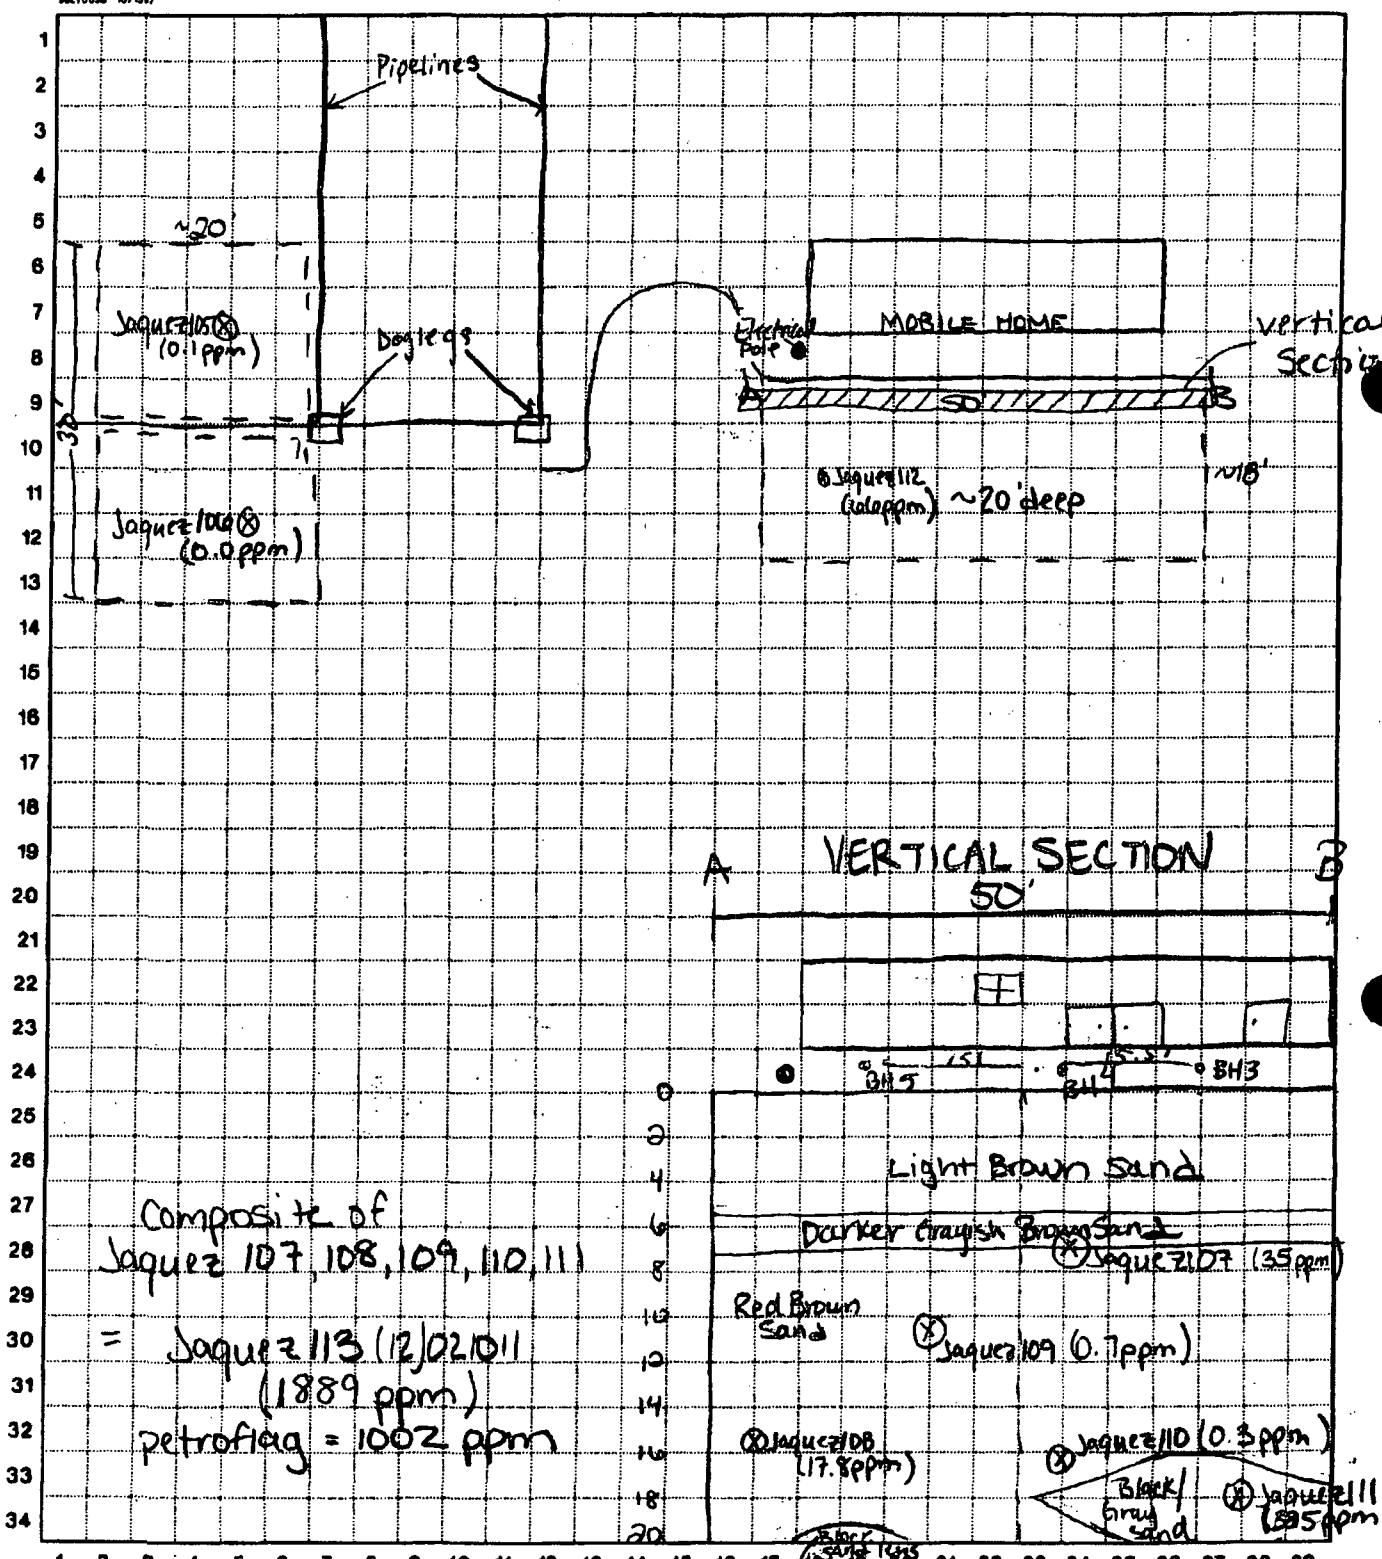
PROJECT	Jaquez	DATE	2/10/2011
PROJECT MANAGER	ALA	CONT. No.	
JOB No.	MWH 1005	BY BDH	CHK'D
LOCATION	Jaquez	SHEET No.	OF

Composite of Jaquez 107, 108, 109, 110, 111 = Jaquez 113 (12/02/2011) (1889 ppm)
petroflag = 1002 ppm

Contamination ~3.5' at Thickest

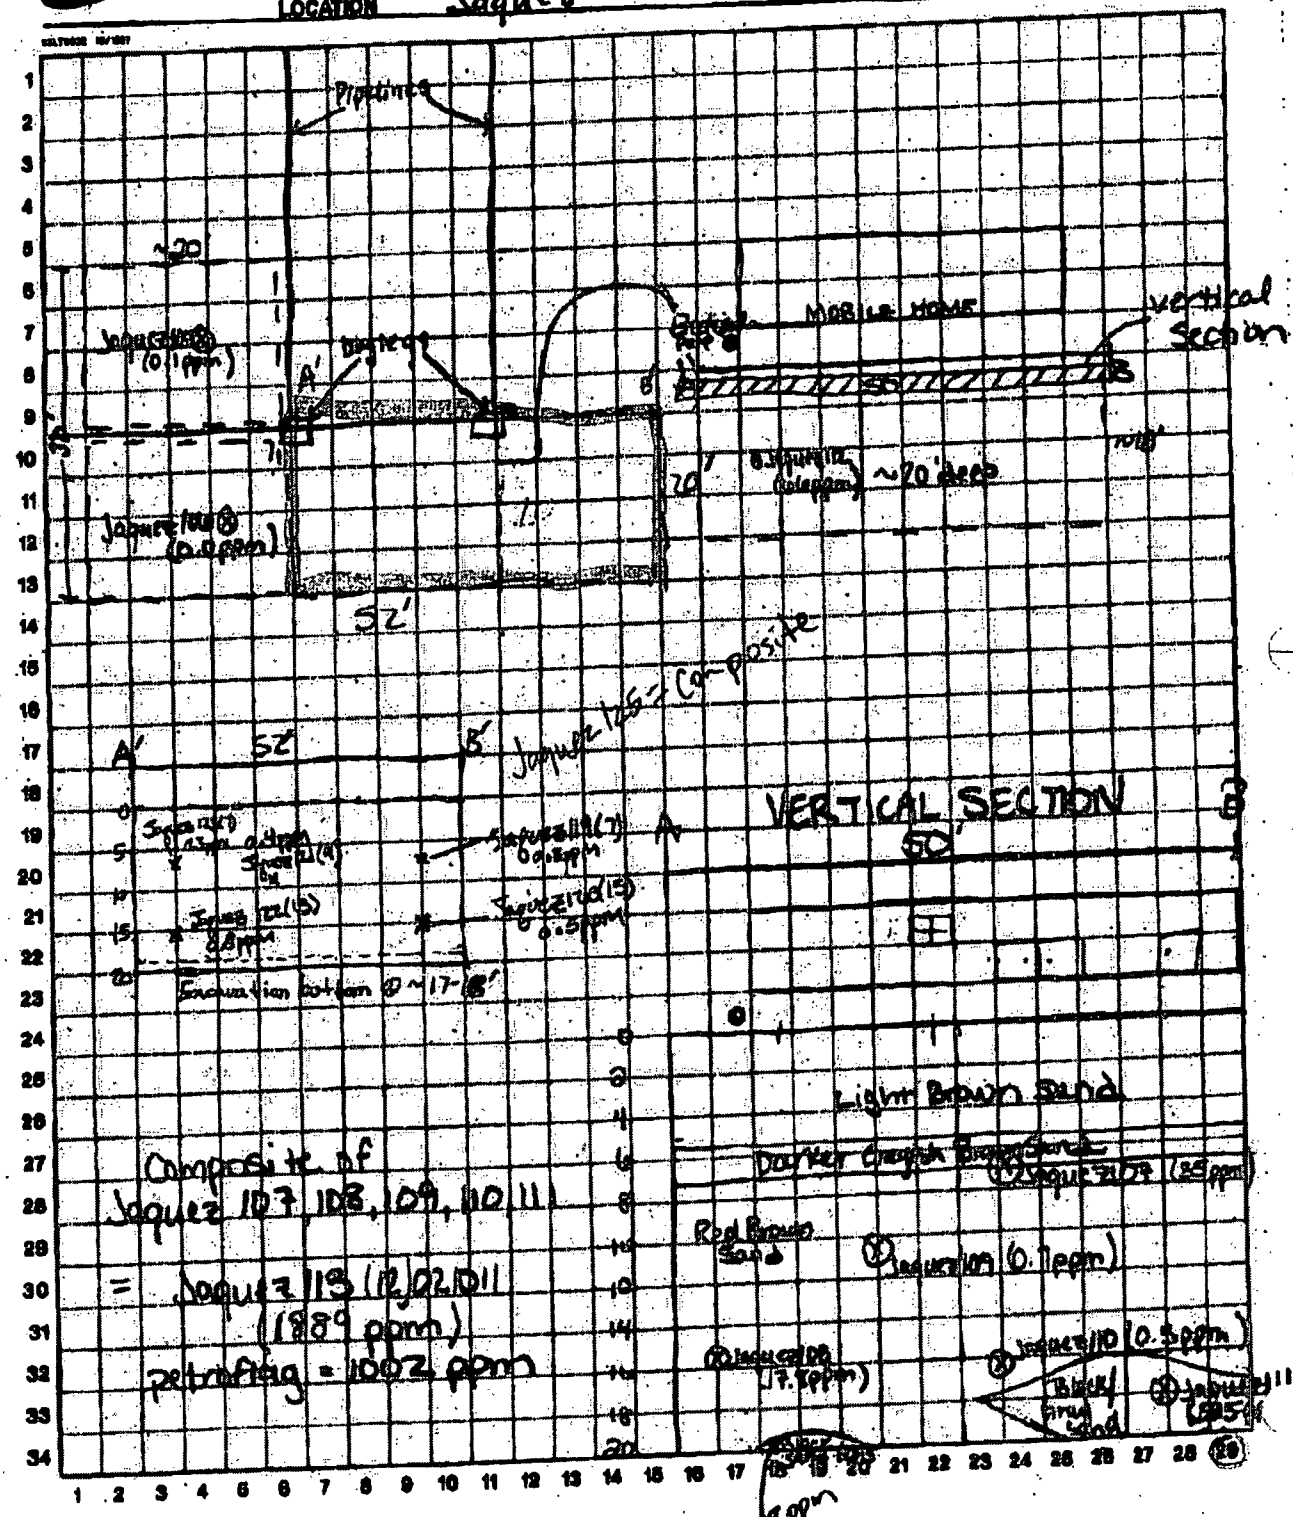
DATE 2/13/2011
CONT. No.
BY RDH CHK'D
SHEET No. 1 OF 2

Composite of
Jaquez 107, 108, 109, 110, 111
= Jaquez 119 (12/02/2011)
(1889 ppm)
petroflag = 1002 ppm

Contamination ~3.5' at Thickest

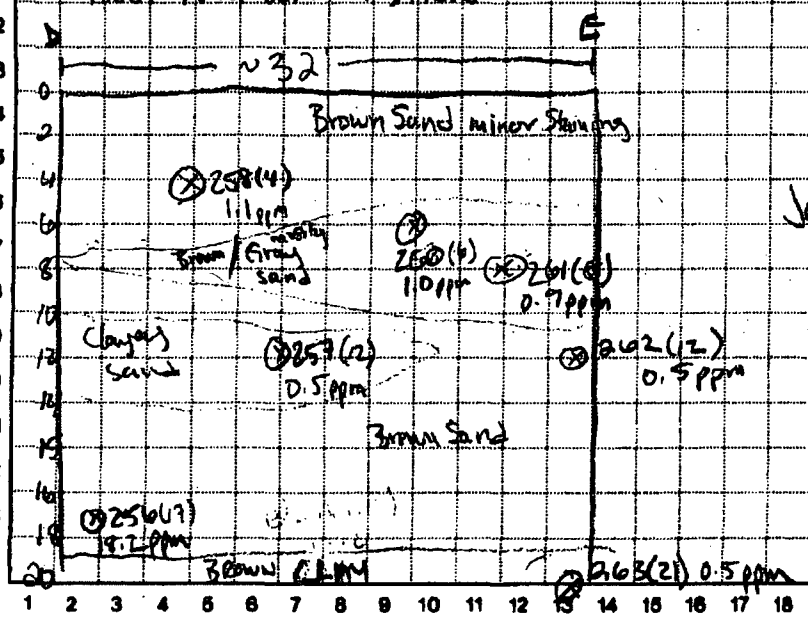
West Wall under Ditch

Jaquez 265 (125) 022571 = composite of 256(17), 258(4), 257(12), 261(8), 263(21), 1.6 ppm

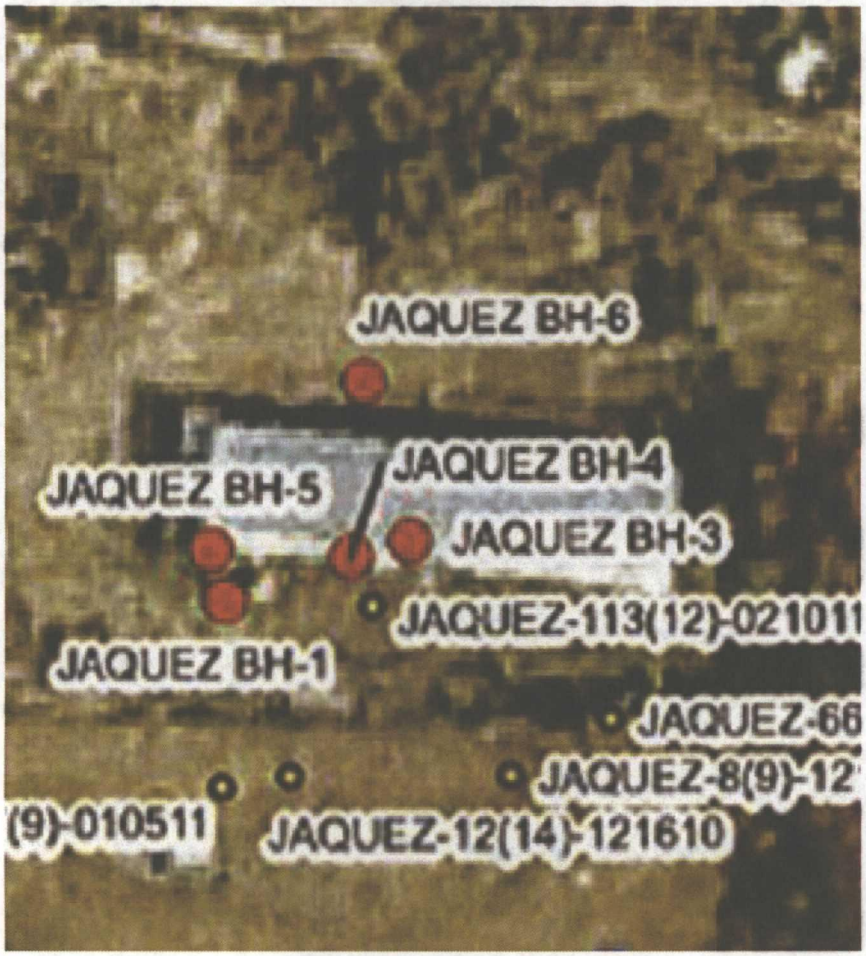
Location of Soil Samples and Borings Used To Assess Impacted Soils "Left-In-Place"

In order to further delineate the extent of the impacted soil, four borings (BH-3, BH-4, BH-5, and BH-6) were advanced using a hand auger in locations surrounding the trailer. Boring BH-3 was located at the front of the trailer and due north of the east edge of the 50' section. There was no evidence of significant hydrocarbon impacts in this borehole. The second borehole, BH-4, was located at the front of the trailer and due north of the highly impacted soil lens sample. Groundwater was encountered at 15 feet bgs in boring BH-4, and slightly impacted soil was observed at depths of 12 feet and 17 feet bgs. The 12-foot depth soil was sampled and was found to meet the cleanup standards. Field screening of the deeper, saturated soil showed a minimal level of impact (i.e., 1.6 - 18 ppmv bag headspace vapors and 3.2 ppm TPH) and a sample was not submitted for laboratory analysis. Two additional boreholes, BH-5 and BH-6, advanced respectively at the southwest corner and behind the trailer, showed no evidence of petroleum impacts. The soil borings provided the intended delineation of the remaining impacts that could not physically be excavated. The volume of the impacted soils left-in-place in the vicinity of the northern excavation sidewall is approximately 30 yds^3. The volume calculations are provided in **Appendix A-5**, *Documentation of Soils Left-In-Place.*

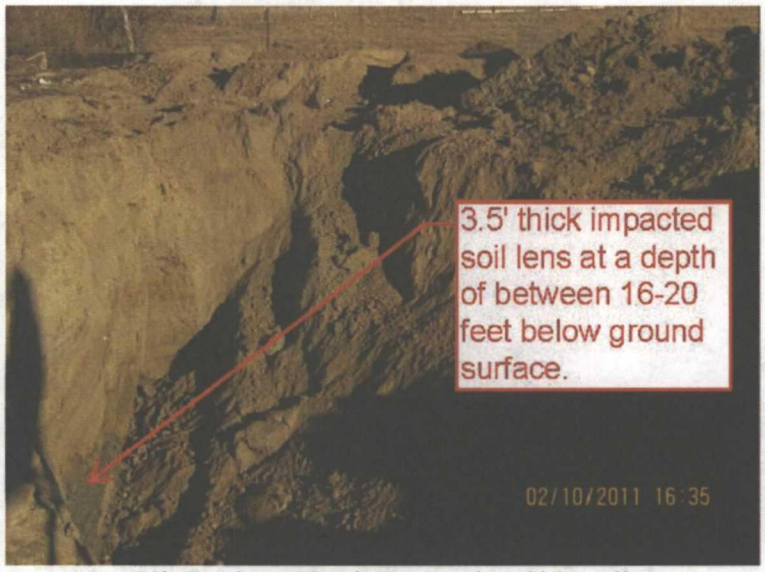
Impacted soils observed along the northern most sidewall of the excavation had to be left-in-place as further excavation onto adjacent property was not possible. The remaining volume of the impacted soils along the northern excavation boundary was estimated to be 30 yards. This estimate was based on observations of soil staining in the northern excavation sidewall, analyses of samples Jaquez 111(17)-021011 and Jaquez BH-4(12)-021111, along with additional data obtained from the advancement of soil borings B-3 through B-6.

Impacted Soil Left-In-Place

View Along North Excavation Sidewall

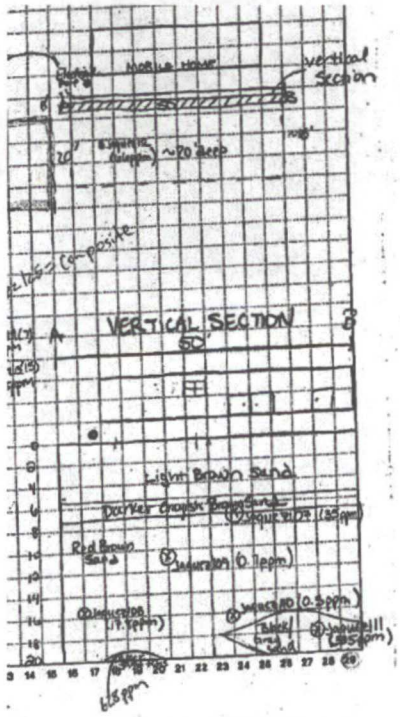
Hand Drawn Cross Section of North Excavation Sidewall with PID Field Screening Results

From LTE Field Notes

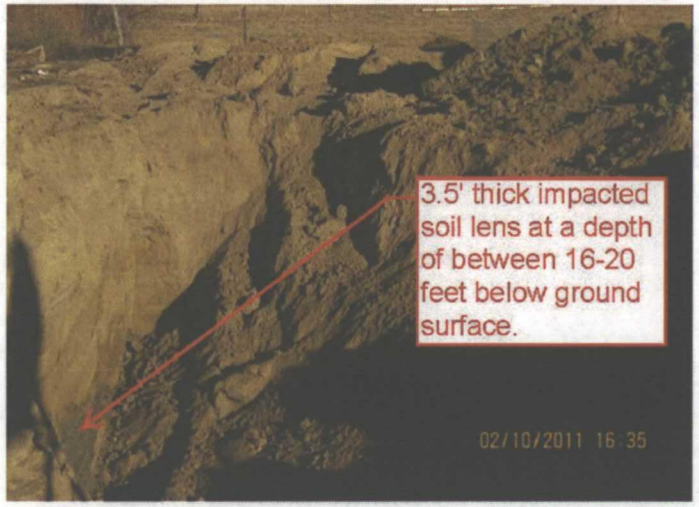
February 14, 20011 - North Excavation Sidewall
View From the SW Looking NE

North Excavation Sidewall
Showing Impacted Soil Left-In Place
