HYDRO-GEOLOGICAL REPORT

MARCH 2012

HYDROGEOLOGY OF
NEW MEXICO SALT WATER DISPOSAL COMPANY SPILL SITES
SECTIONS 15, 21 & 22, TOWNSHIP 10 SOUTH, RANGE 34 EAST
LEA COUNTY, NEW MEXICO

Prepared by: Atkins Engineering Associates, Inc.
P.O. Box 3156
Roswell, New Mexico 88202-3156
(575) 624-2420

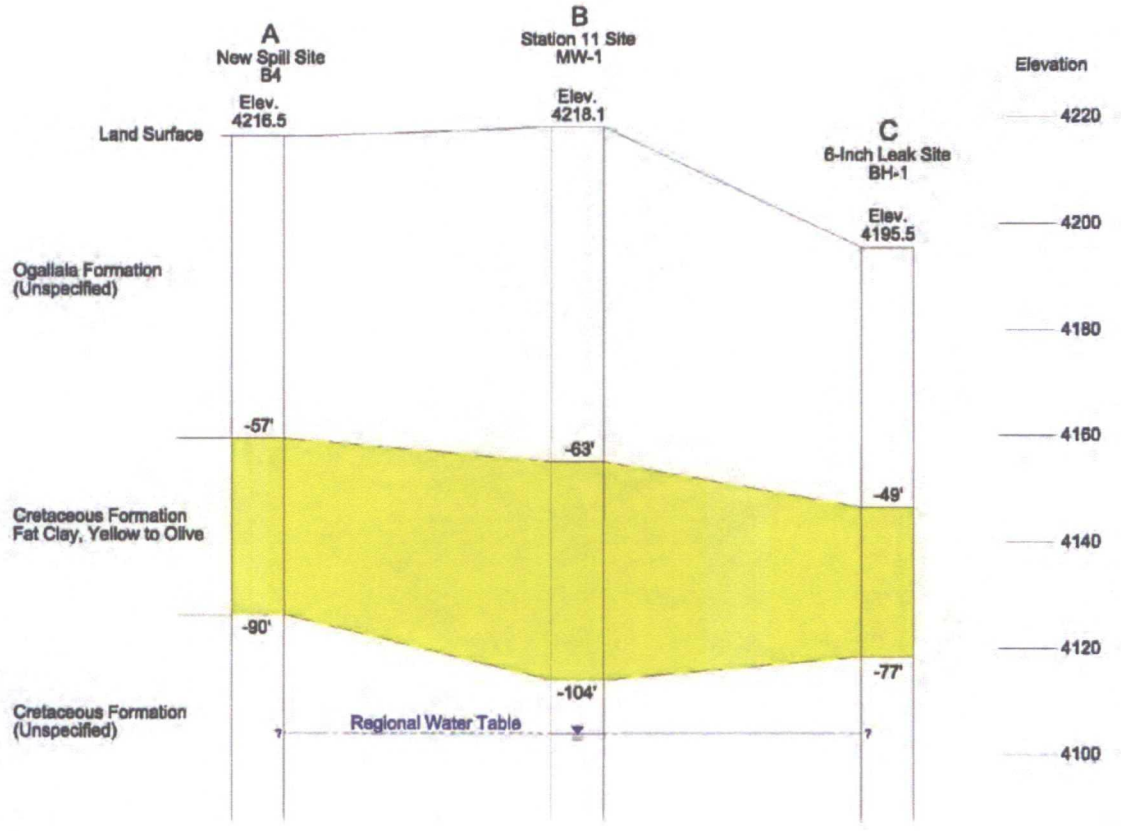
Three separate zones of groundwater appear in the study area: the regional shallow aquifer and two upper perched zones. Water level data for the regional shallow aquifer is available for the Station 11 and 6-Inch Leak sites. Three soil borings at Station 11 were completed as monitoring wells MW-1, M-2 and MW-3 so as to draw water from this aquifer. One unnamed monitoring well at the 6-Inch Leak site was completed in the regional shallow aquifer as well, but due to imprecise location information, the well is not shown on the attached figures. It is understood to be near or adjacent to the 6-Inch Leak site's MW-3. All other soil borings within the study area do not reach this aquifer. Figure 3 shows groundwater elevation contours for the regional aquifer using water level data presented in Barnhill (2007), which show groundwater to be relatively flat with a slight downward gradient towards the northeast at the Station 11 site. Upon completion the 6-Inch Leak site's regional water table monitoring well in September, 2011, the water level in said well was measured at 102.05 feet below top of casing; the water table elevation in the

Figure A Geologic cross section A-B-C depicting upper Cretaceous fat yellow clay in relationship to the regional water table.

well at that time is estimated to have been 4,095 feet, which is similar to the elevations noted for Station 11 in 2007. Elevations of nearby lakes shown on USGS topographic maps (Figure 1) are also comparable to the regional water table elevations at Station 11 and 6-Inch Leak sites; it is likely that these lakes are occurring where the regional water table is exposed to land surface. Figure A below also gives an estimation of the regional water table elevation across the study area.

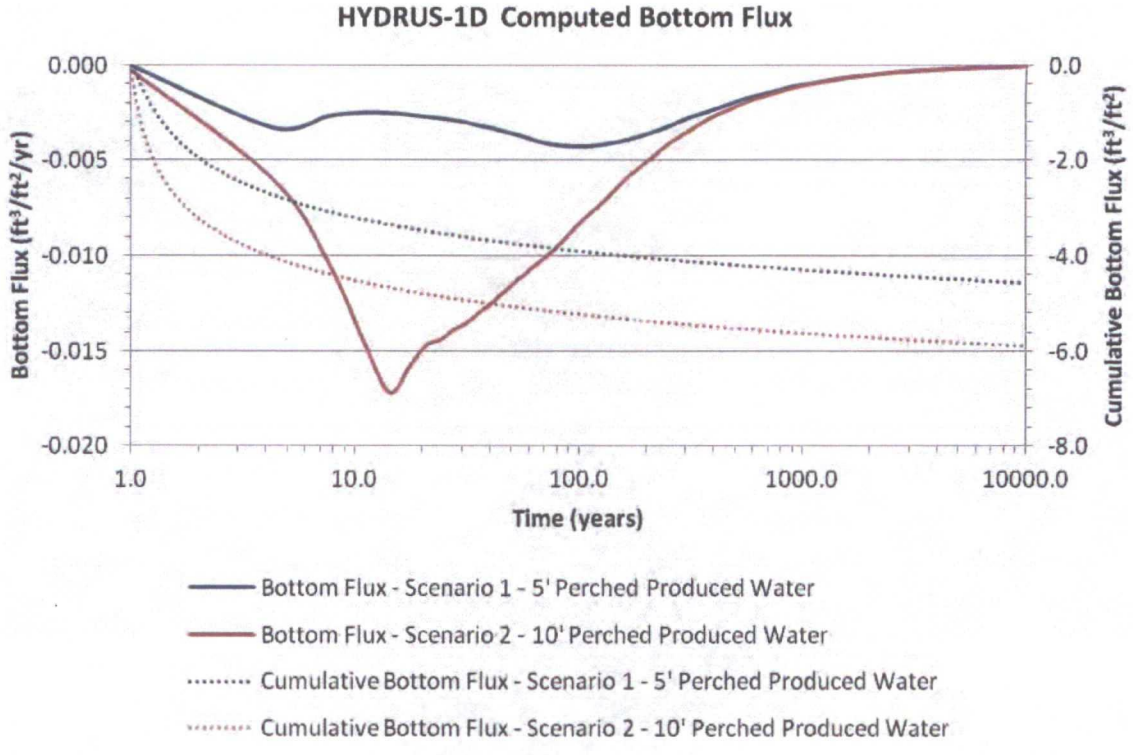
Figure B below gives the model-computed bottom flux over time and cumulative bottom flux over time, respectively, for Simulations 1 and 2. As the model is one-dimensional, flux has the dimensions of volume per unit area per unit time ($L^3/L^2/T$) and cumulative flux has the dimension of volume per unit area (L^3/L^2). Negative numbers indicate a downward flux out of the bottom of the fat yellow clay.

Figure C Model-computed flux and cumulative flux through the bottom of the fat yellow clay over time.

The bottom flux is the rate at which water is exiting the bottom of the fat yellow clay. In order to determine if the bottom flux includes any of the perched produced water, one must examine the cumulative bottom flux. The cumulative bottom flux can be described as the amount of water that would exit the fat yellow clay after a given period of time. These amounts can be divided by the moisture content to determine a thickness of the fat yellow clay layer through which moisture is displace by the perched produced water. Once the thickness of displaced moisture equals the thickness of the fat yellow clay, the bottom flux begins to be perched produced water. In other words, perched produced water begins passing through or exiting the fat yellow clay after displacing all moisture in that clay. The 10 feet of fat yellow clay with 33% moisture content would have an equivalent water amount of 3.3 ft^3/ft^2, while the 20 feet of fat yellow clay with 15% moisture content would have an equivalent water amount of 3 ft^3/ft^2, for a total of 6.3 ft^3/ft^2 of water that must be displaced before the perched produced water begins exiting the bottom of the fat yellow clay. Cumulative fluxes at Year 10,000 were computed as 4.57 and 5.88 ft^3/ft^2, respectively, in Simulations 1 and 2. In both cases, after 10,000 years, the model-predicted flux of perched produced water through the fat yellow clay layer is zero.

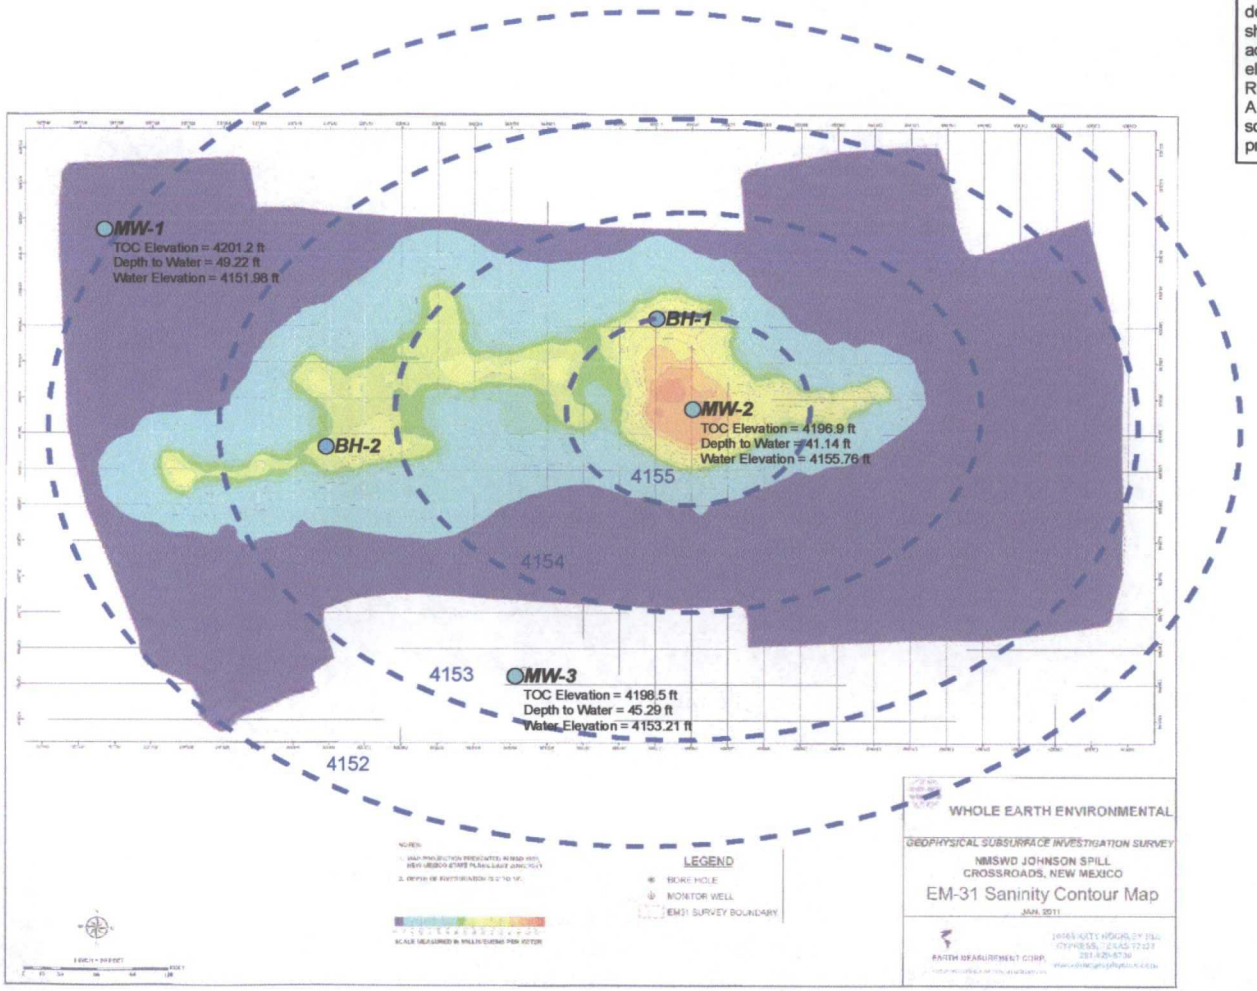
Figure 6 Perched Produced Water Surface at 6-Inch Leak Site (aka Johnson Spill) Salt Water Disposal Company Secs. 15 & 22, Township 10S, Range 34 E March 2012

Groundwater elevation data within the lower perched groundwater zone are available at the 6-Inch Leak site and shown as a contour map in Figure 6. The figure shows the groundwater zone to be mounded, with the highest point at monitoring well MW-2, which based on soil conductivity mapping appears to be at the center of the spill at this site. Coupling the measured water level data with boring log information, the thickness of the lower perched groundwater zone at this site appears to be from 6 to 14 feet. However, it should be noted that available boring logs for the 6-Inch Leak and New Spill sites were prepared by the well driller as opposed to the Station 11 site logs, which were prepared by a geologist. Well driller logs are likely not nearly as precise in establishing depths to varying geologic layers. The gradient of the lower perched groundwater at the 6-Inch Leak site indicates that the perched groundwater dissipates a short distance from the spill site.

Note: Perched ground water elevation contours determined from monitoring well and water level data shown on survey of January 2011 by Basin Surveys, adjusted to NVD27 using reported MW-3 ground elevation and USGS 7.5' quadsheet topo Johnson Ranch 4195' contour next to the MW-3 location.
A comparison of driller's logs for the monitoring well soil borings with water level data indicates the perched produced water thickness to vary from 6 to 14 feet.
