STAGE 2 ABATEMENT PLAN (AP-78)
SOUTH FOUR LAKES #15 SITE
TOWNSHIP 12 SOUTH, RANGE 34 EAST, SECTION 2, UNIT G
LEA COUNTY, NEW MEXICO

OCTOBER 1, 2008

Pride Energy Company
P. O. Box 701950
Tulsa, OK 74170

TRIDENT ENVIRONMENTAL

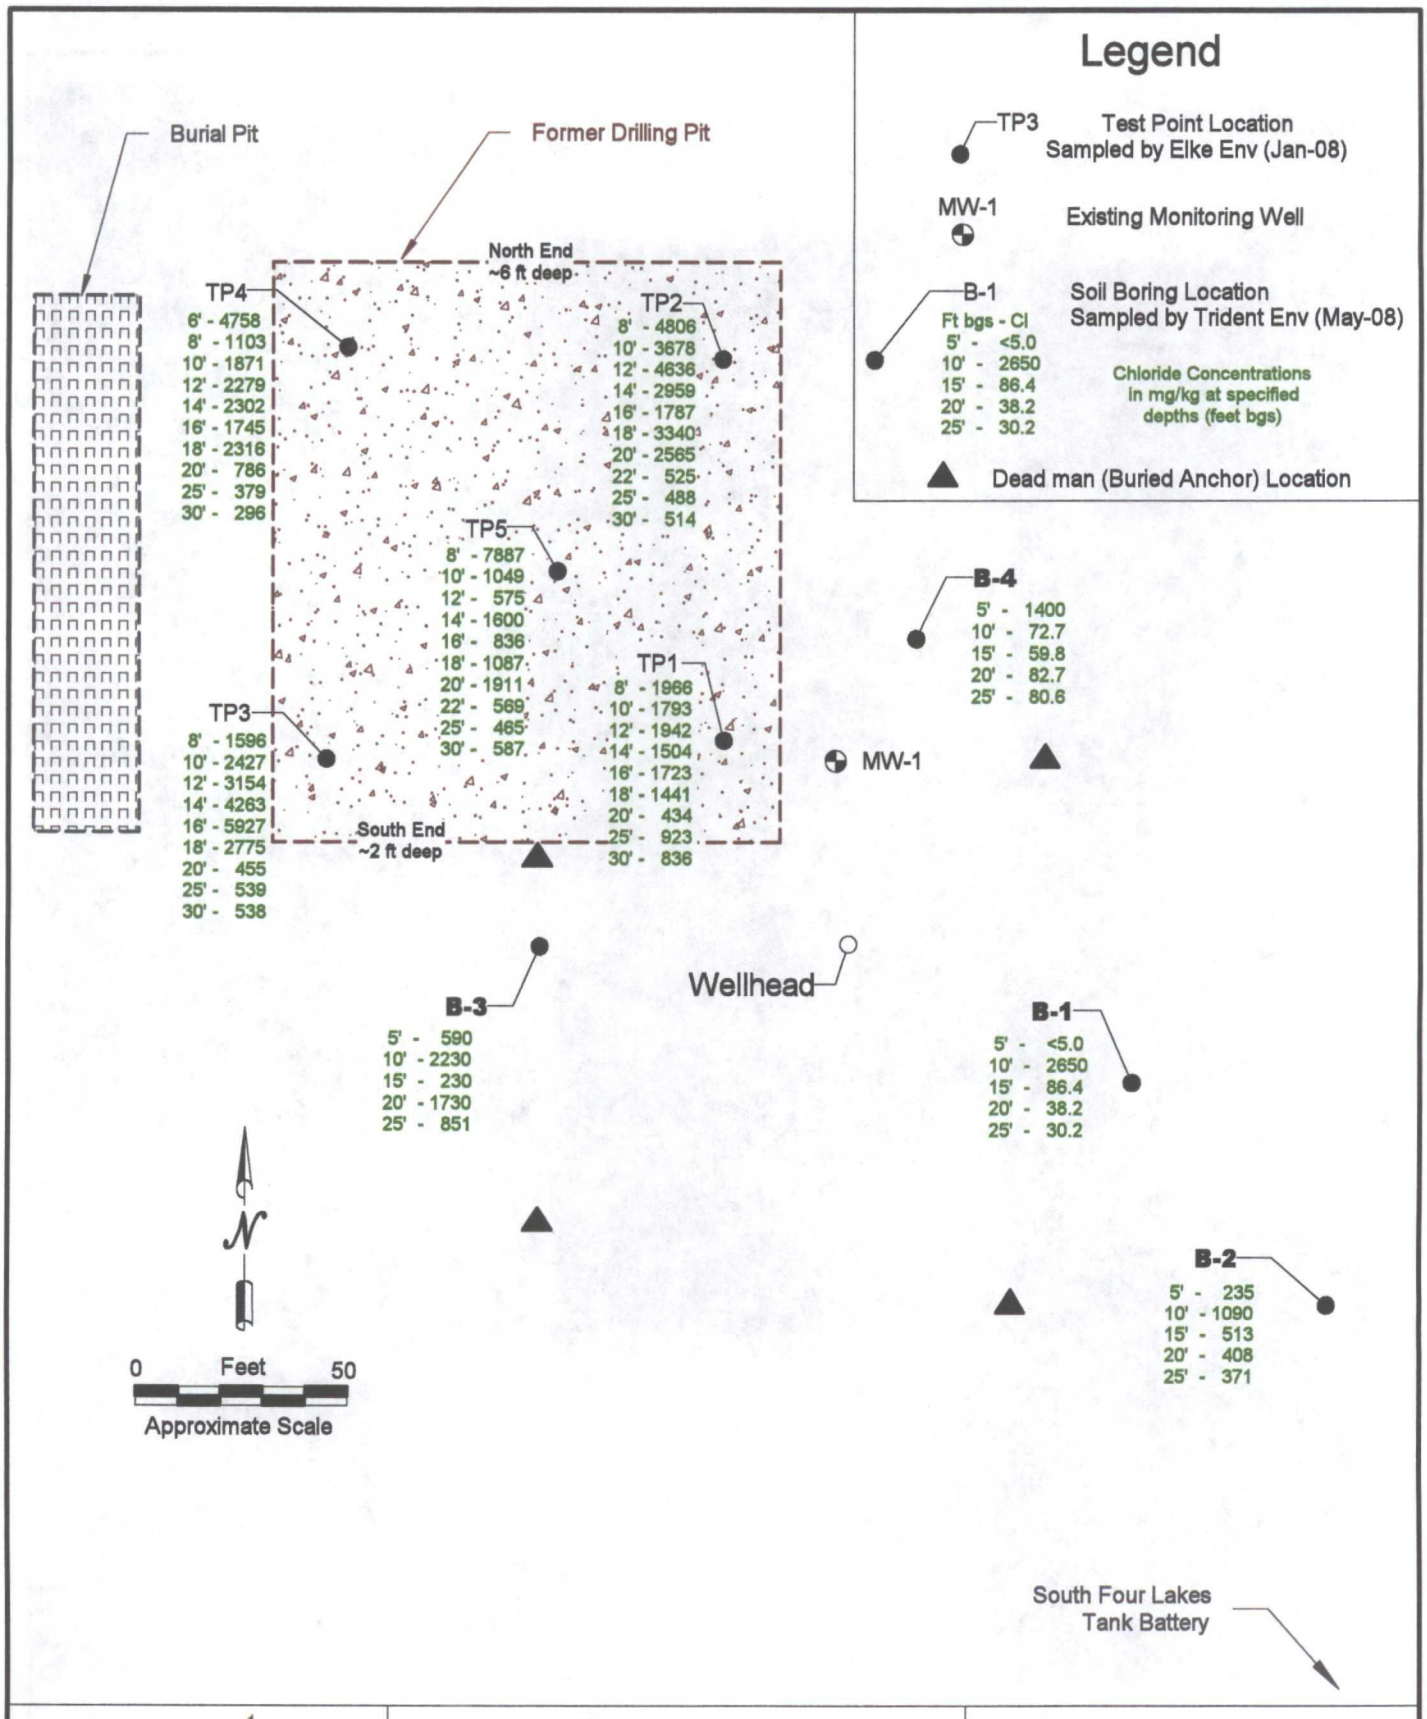
Figure 3
Choride Concentrations in Vadose Zone

Generally, the first few feet of subsurface soils consisted of a clayey loam. Below this layer, silty clayey fine sand and fine sands with interbeds of caliche and indurated sands were encountered until a depth of approximately 25 feet where groundwater was reached. Below this depth fine sands continued to a depth of approximately 51 feet where a very hard sandstone/quartzite layer was encountered. Below the approximately 1- to 2-foot thick sandstone/quartzite layer, loose and unconsolidated fine-grained flowing sands were encountered. Groundwater was encountered at approximately 25 feet bgs. A more detailed description of each soil boring is provided on the lithologic logs in Appendix B. Laboratory analysis of chloride concentrations for each soil sample is summarized in Table 2 below, depicted on Figure 2, and shown on the individual lithologic logs in Appendix B. Field and laboratory analysis of groundwater samples from the soil boring program are summarized in Table 3 below and depicted on Figure 3.

Based on the soil boring data obtained by Elke Environmental in January 2008 (TP-1 through TP-5) and Trident Environmental in May 2008 (B-1 through B-4) the chloride impact to the vadose zone is limited to within the perimeter of the former drilling pit. The greatest chloride mass was observed at the TP-2 (northeast corner) and TP-3 (southwest corner) of the pit.

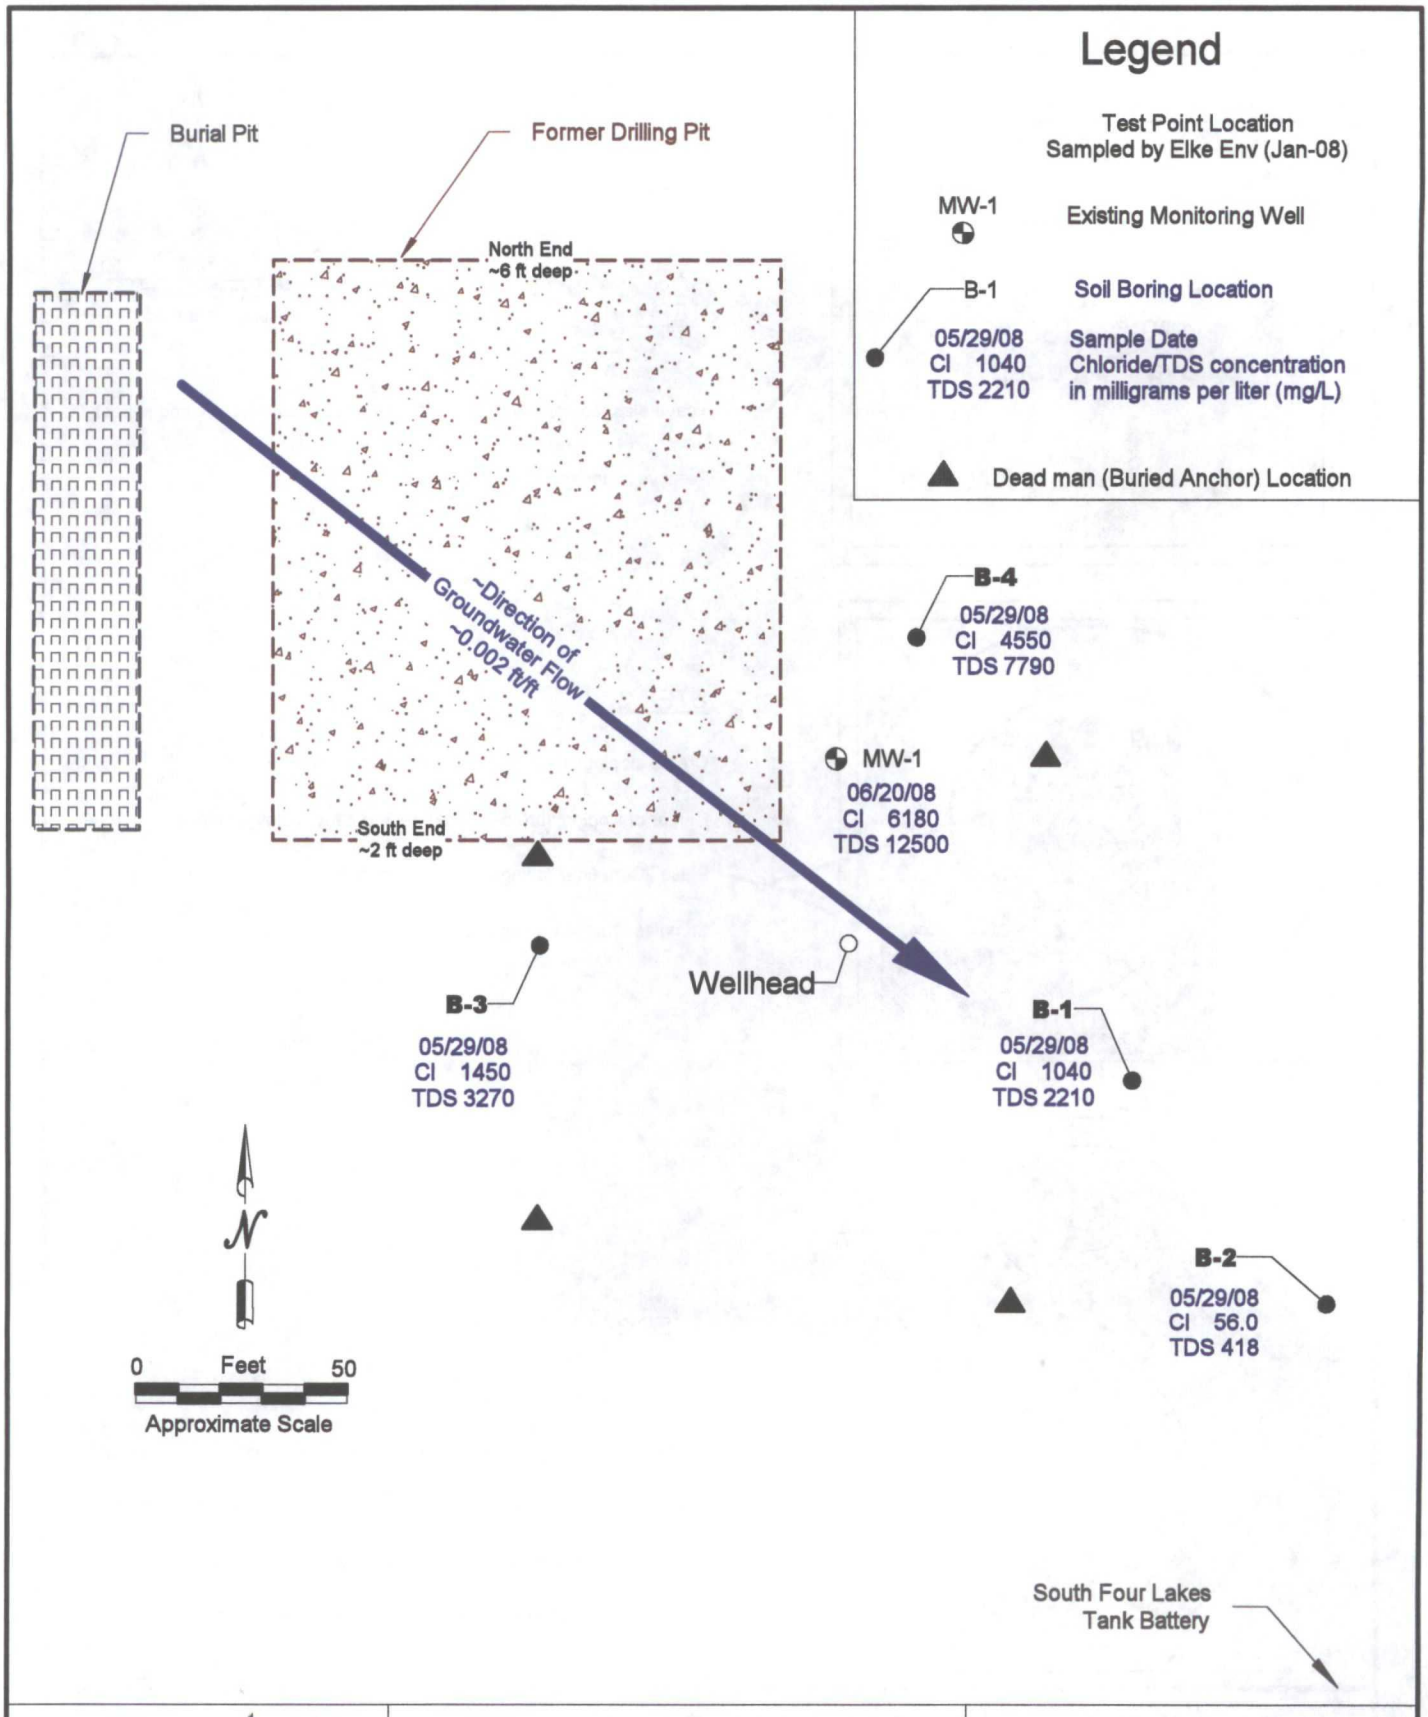
Figure 4
Choride and TDS
Concentrations
in Groundwater

Chloride and TDS concentrations in groundwater at monitoring well MW-1, and soil borings B-1, B-3, and B-4 exceeded WQCC standards. The highest chloride (6,180 mg/L) and TDS (12,500 mg/L) levels were at MW-1 which is expected due to it's immediately downgradient location with respect to the former drilling pit. Horizontal dispersion of the chloride and TDS in groundwater does not exceed beyond approximately 150 feet downgradient (southeast) of the southeast corner of the pit as evidenced by the results of boring B-2 where background chloride and TDS levels were observed in groundwater.

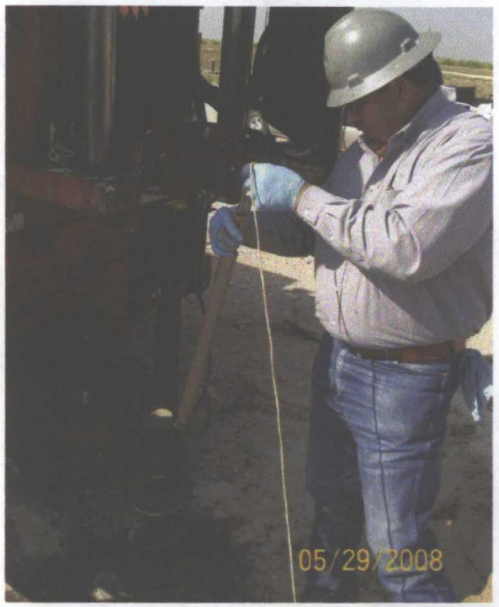
Retrieving trip bailer from hollow-stem augers.

Collection of groundwater water samples from trip bailer.
