SEPTEMBER 2012 ANNUAL GROUNDWATER MONITORING REPORT

CONOCOPHILLIPS FAYE BURDETTE No. 1
SAN JUAN COUNTY, NEW MEXICO

NMOCD# 3R-434

DECEMBER 2012

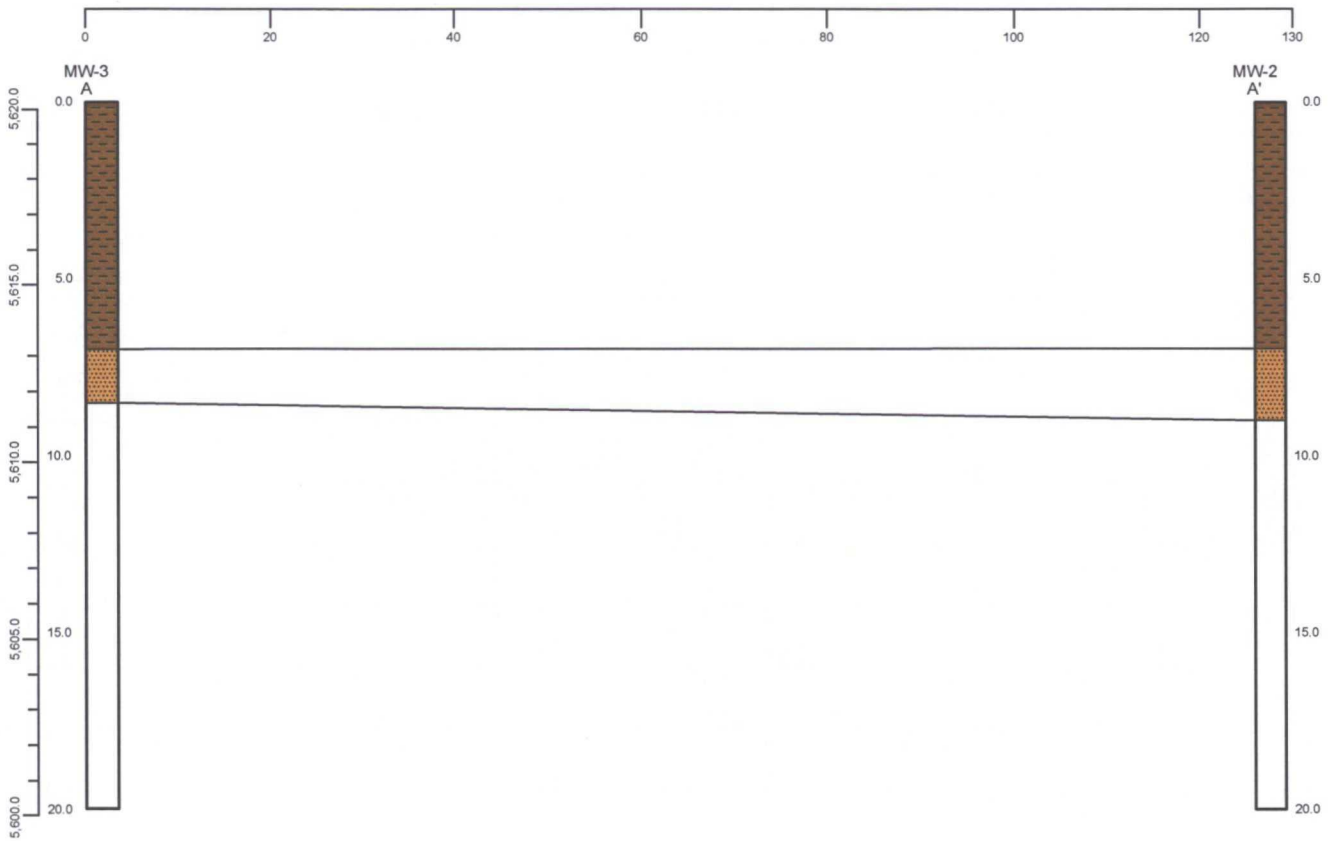
Figure 3

GEOLOGICAL CROSS SECTION
FAYE BURDETTE No. 1 GAS WELL SITE
SECTION 09, T30N-R11W, SAN JUAN COUNTY, NEW MEXICO
ConocoPhillips Company

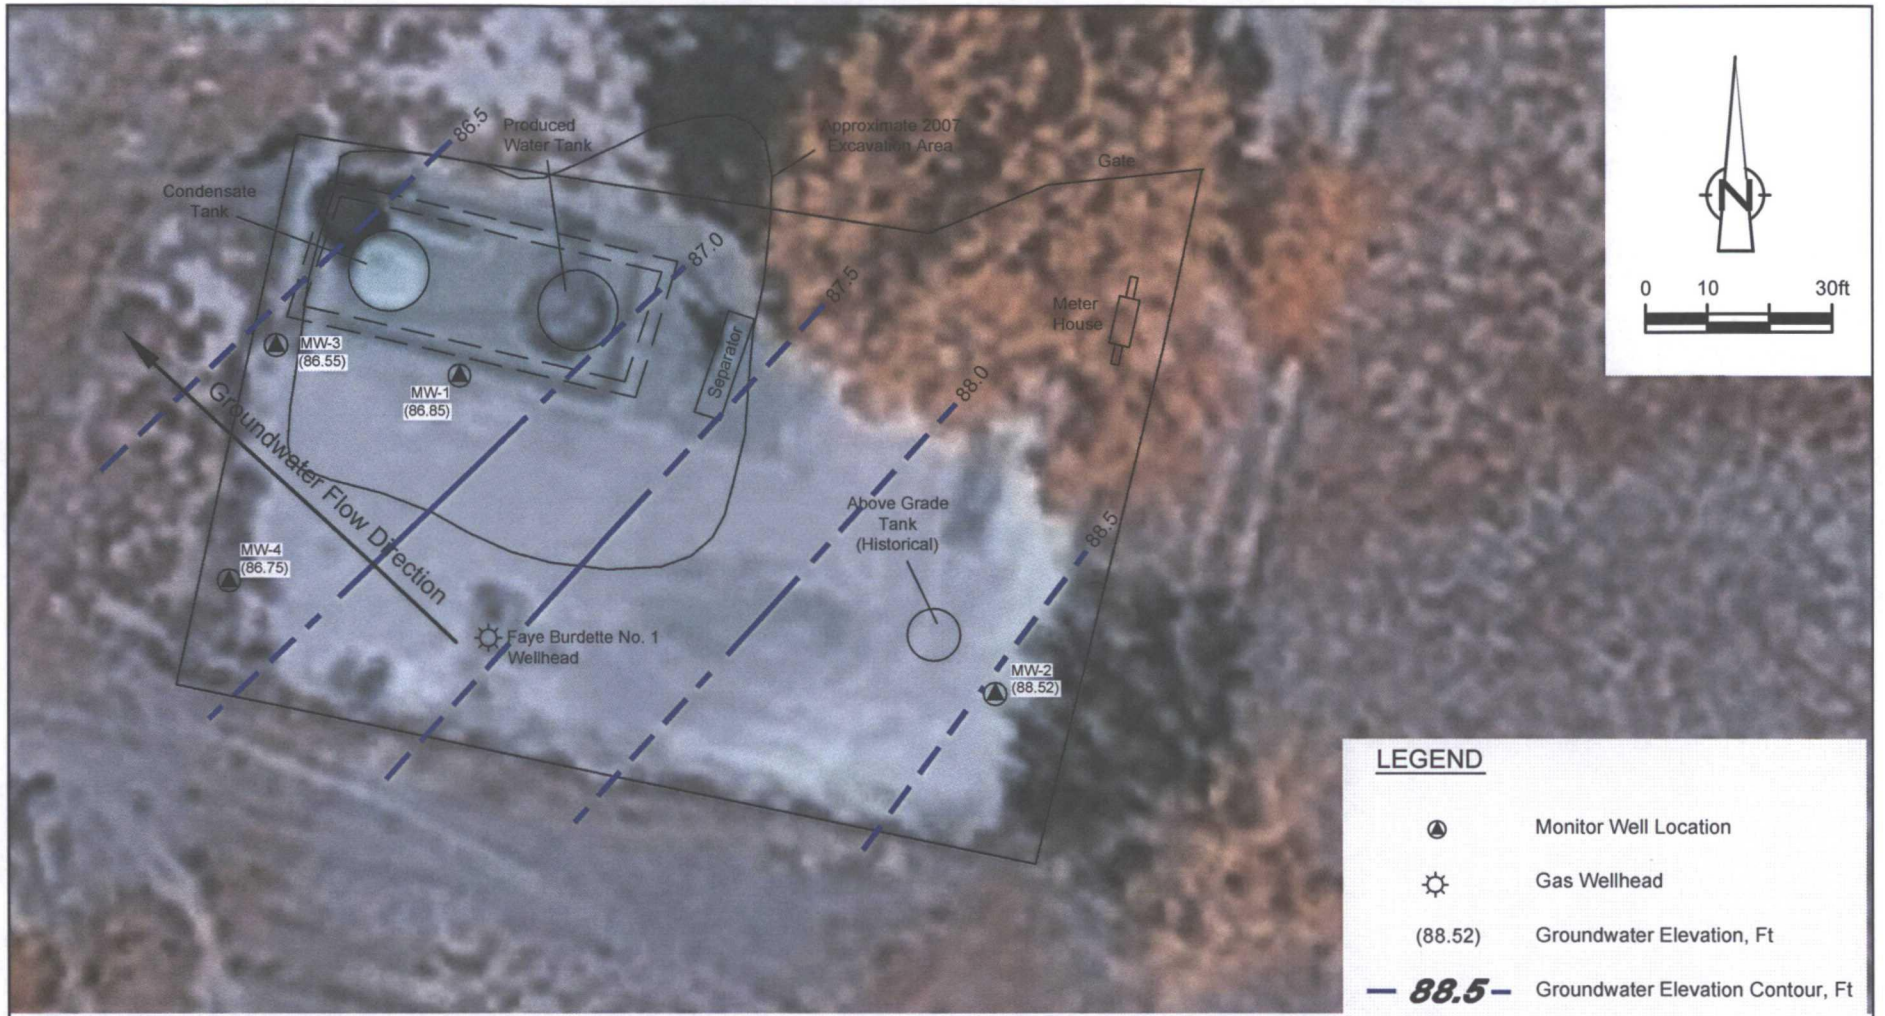
Figure 4

Prior to sampling on September 17, 2012, groundwater elevation measurements were obtained for Monitor Wells MW-1, MW-2, MW-3, and MW-4 using an oil/water interface probe. Groundwater elevations are detailed in **Table 2**. A groundwater potentiometric surface map is presented as **Figure 4.** Based on the September 2012 monitoring event data, groundwater flow is to the northwest and is consistent with historical monitoring event records for this Site. The Animas River is approximately 1/3 mile from the site and flows west.

SEPTEMBER 2012 GROUNDWATER POTENTIOMETRIC SURFACE MAP
FAYE BURDETTE No. 1 GAS WELL SITE
SECTION 09, T30N-R11W, SAN JUAN COUNTY, NEW MEXICO
ConocoPhillips Company
