RE: **ICP Report and Termination Request**
Rice Operating Company – EME SWD System
EME Jct. J-36 vent (1R427-281): UL/J, Sec. 36, T20S, R36E
Formerly EME Jct. H-36 vent

EME Jct. J-36 vent (1R427-281)

UL/J, Sec. 36, T20S, R36E

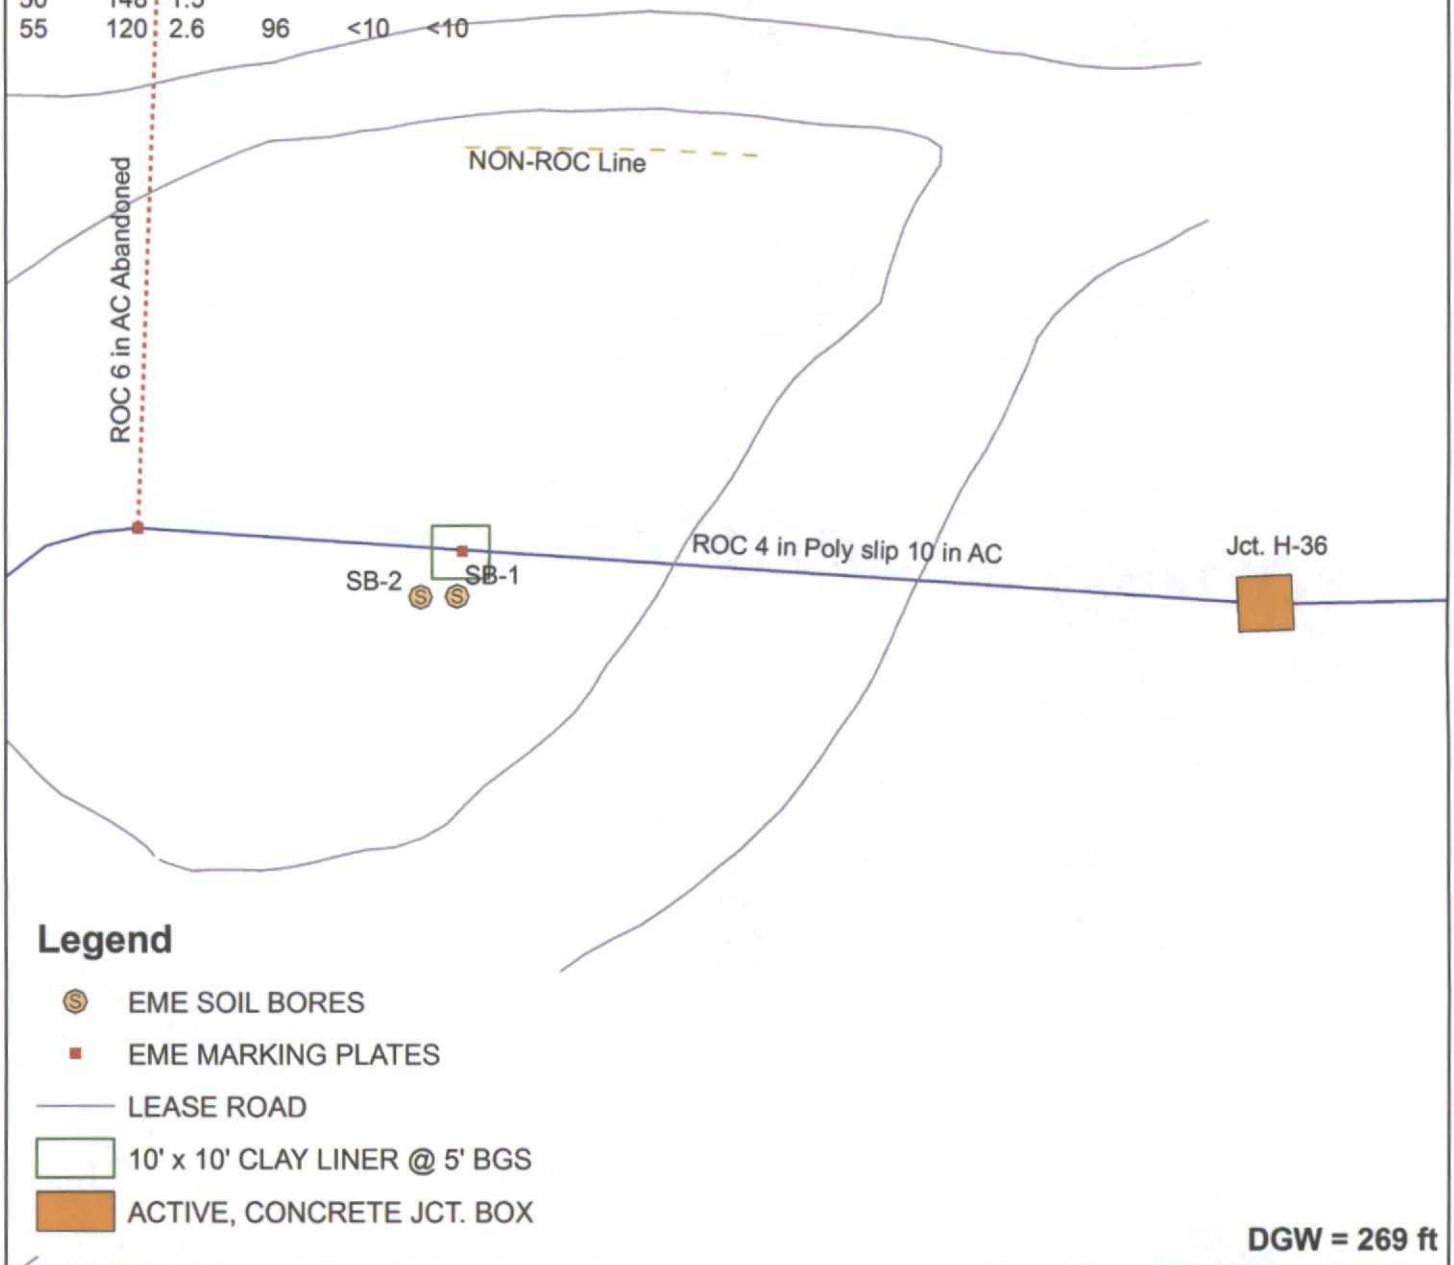
Figure 3

On March 27th, 2013, ROC submitted an Investigation and Characterization Plan (ICP) to NMOCD, which was approved on April 22nd, 2013. As part of the ICP, RECS personnel were on site to conduct soil bores installations on June 19th, 2013. A total of two soil bores were installed (Figure 3). Samples were taken at regular intervals and field tested for chlorides and hydrocarbons. Representative samples were taken to a commercial laboratory for analysis (Appendix A). SB-1 returned laboratory chloride readings of 224 mg/kg at 40 ft bgs and 96 mg/kg at 55 ft bgs. SB-2 returned laboratory chloride readings of 176 mg/kg at 25 ft bgs, 240 mg/kg at 40 ft bgs and 128 mg/kg at 45 ft bgs. GRO and DRO returned results of non-detect at all depths in both bores.

All of the soil bore data shows laboratory reading below 250 mg/kg. Therefore, it is evident that the residual chlorides in the vadose zone will not adversely affect groundwater beneath the site. In addition, the 10 ft x 10 ft clay liner will also inhibit the downward migration of constituents at the site. The site has returned to normal vegetative capacity (Appendix B). Vegetation above the liner will also provide a natural infiltration barrier for the site since plants capture water through their roots thereby reducing the volume of water moving through the vadose zone to groundwater.

Soil Bore Installation

Depth	Cl-	PID	SB-1 Lab Cl-	GRO	DRO
15	142	3			
20	181	2.1			
25	202	2.5			
30	209	2.9			
35	238	1.3			
40	283	3.7	224	<10	<10
45	176	3.1			
50	148	1.5			
55	120	2.6	96	<10	<10

Depth	Cl-	PID	SB-2 Lab Cl-	GRO	DRO
15	118	2.2			
20	179	1.3			
25	236	3.1	176	<10	<10
30	226	3.7			
35	246	1.7			
40	280	1.8	240	<10	<10
45	141	1.5	128	<10	<10

Given that the residual constituents in the vadose zone will not in any way affect groundwater beneath the site and that the clay liner and vegetation will inhibit further migration of constituents to groundwater, ROC respectfully requests 'remediation termination' or similar closure status of the site.

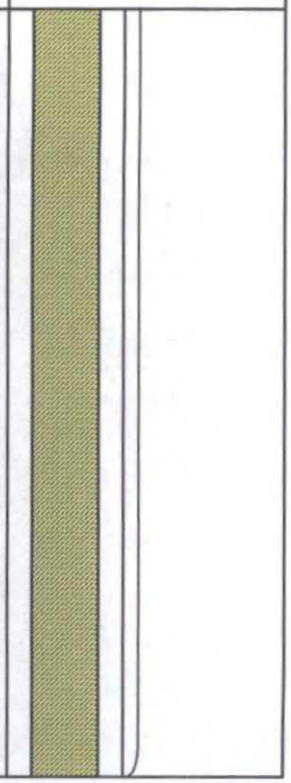
Driller:	Harrison & Cooper, Inc.		
Drilling Method:	Air Rotary		**Project Name:** EME Jct. J-36 Vent **Well ID:** SB-1
Start Date:	6/19/2013		
End Date:	6/19/2013		**Project Consultant:** RECS
Comments: SB-1 is located 8 ft south of the former junction box site. All samples were from cuttings. **DRAFTED BY: L. Weinheimer** TD = 55 ft GW = 269 ft			**Location:** UL/J, Sec. 36, T20S, R36E **Lat:** 32°31'46.374"N **Long:** 103°18'13.952"W **County**: Lea **State**: NM

Depth (feet)	Chloride field tests	LAB	PID	Description	Lithology	Well Construction
				Brown Sand		
SS						
5 ft						
10 ft						
15 ft	142		3.0			
				Brown Caliche		
20 ft	181		2.1			
25 ft	202		2.5			bentonite seal
30 ft	209		2.9			
35 ft	238		1.3

Depth (feet)	Chloride field tests	LAB	PID	Description	Lithology	Well Construction
				Brown Caliche

40 ft	283	CI-224	3.7			
		GRO <10		Brown Sand		
		DRO <10				
45 ft	176		3.1			
50 ft	148		1.5			
55 ft	120	CI-96	2.6			
		GRO <10				
		DRO <10
