Holly Energy Partners
Monument Section 35 Junction
Section 35, Township 19S, Range 37E
Lea County, New Mexico

Delineation-Work Plan Report

BL-1554
May 27, 2016

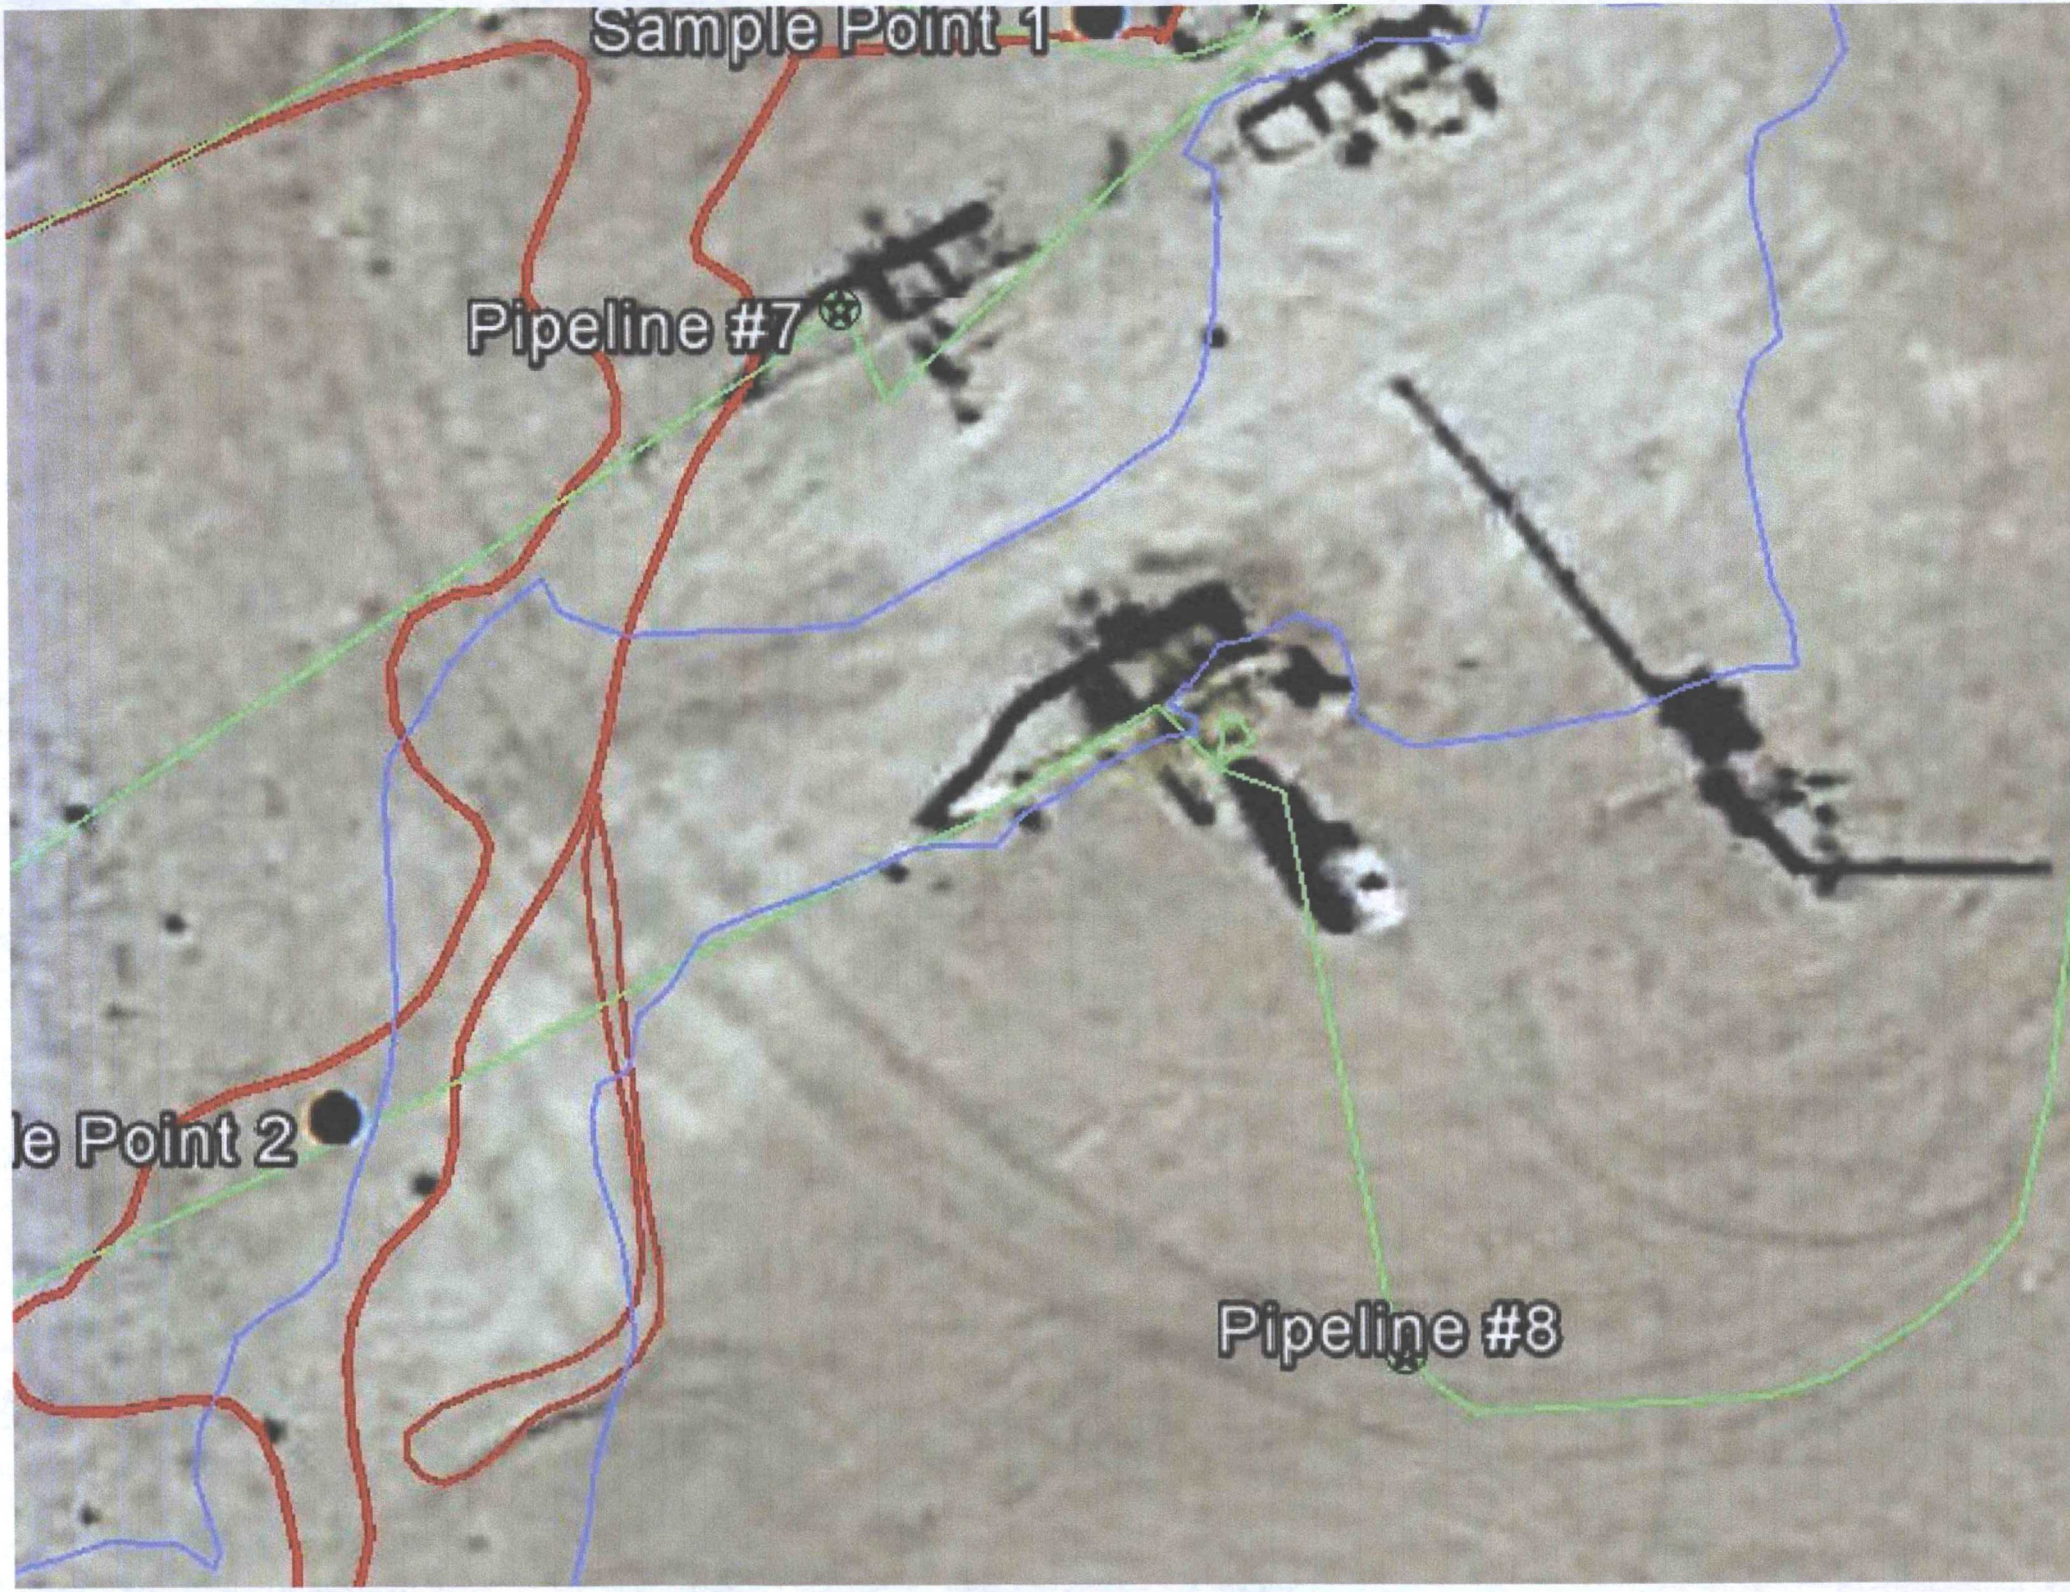
Figure 2
Site Plan

Sample Point 1
Pipeline #7
le Point 2
Pipeline #8
