Release Notification and Corrective Action

SOIL AND GROUNDWATER INVESTIGATION REPORT
MUDGE LS 6 WELLSITE

September 13, 2016

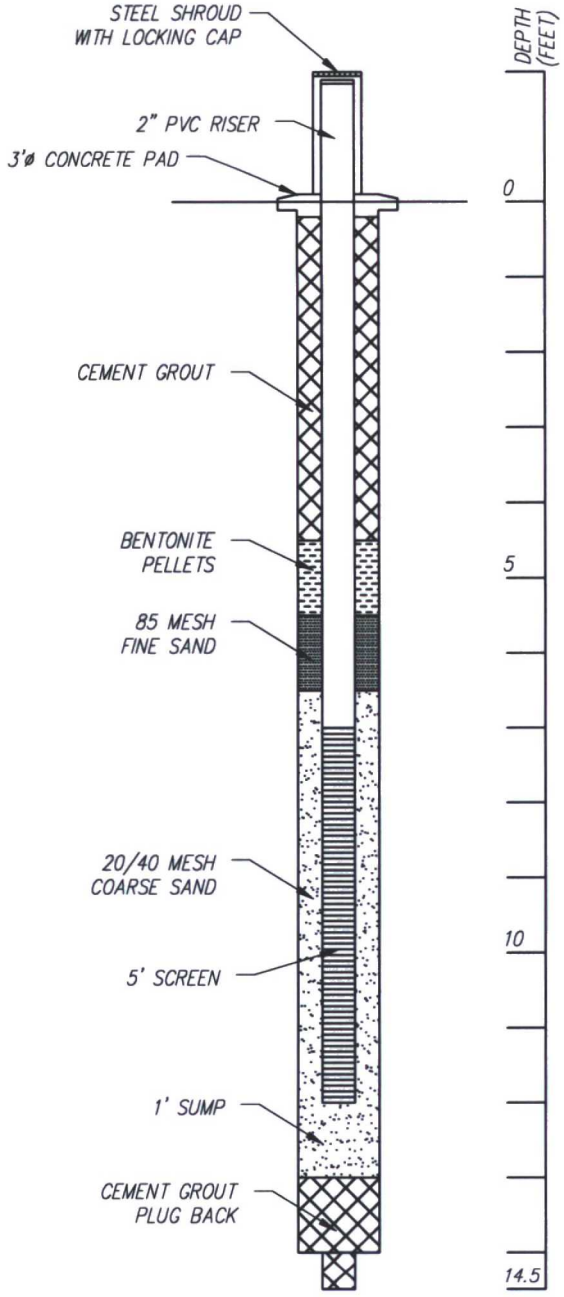
Date: September 2016
Scale: Horiz: NA Vert: NA
Project No: 5124371
Sheet: 4

DEPTH (FEET)	SOIL TYPE	PID (PPM)	COLOR	SAMPLE DESCRIPTION
0				BROWN UNCONSOLIDATED SAND BACKFILL NO SAMPLE COLLECTED, OBSERVED DRILLING RETURNS
5		0.4	5YR 4/3	DARK BROWN SAND, POOR TO MODERATE SORTING, MEDIUM TO FINE, UNCONSOLIDATED, SLIGHTLY PLASTIC, CLAYEY, SLIGHTLY CALCAREOUS, 80–90% QUARTZ SPLIT SPOON SAMPLE #1 (17 blows, 12")
				BROWN UNCONSOLIDATED SAND, NO SAMPLE COLLECTED OBSERVED, DRILLING RETURNS
10		1.1	5YR 4/3	DARK BROWN SAND, MODERATE SORTING, MEDIUM TO FINE, WITH SOME PEBBLES, UNCONSOLIDATED, SLIGHTLY CALCAREOUS, 80–90% QUARTZ SPILT SPOON SAMPLE #2 (14 blows, 16")
				NO SAMPLE COLLECTED

0.3	5YR 4/3	DARK BROWN SAND, MODERATE POORLY SORTED, MEDIUM TO FINE, CLAYEY, SLIGHTLY PLASTIC, SLIGHTLY CALCAREOUS, TOP OF SPILT SPOON SAMPLE #3 (7 blows, 16")

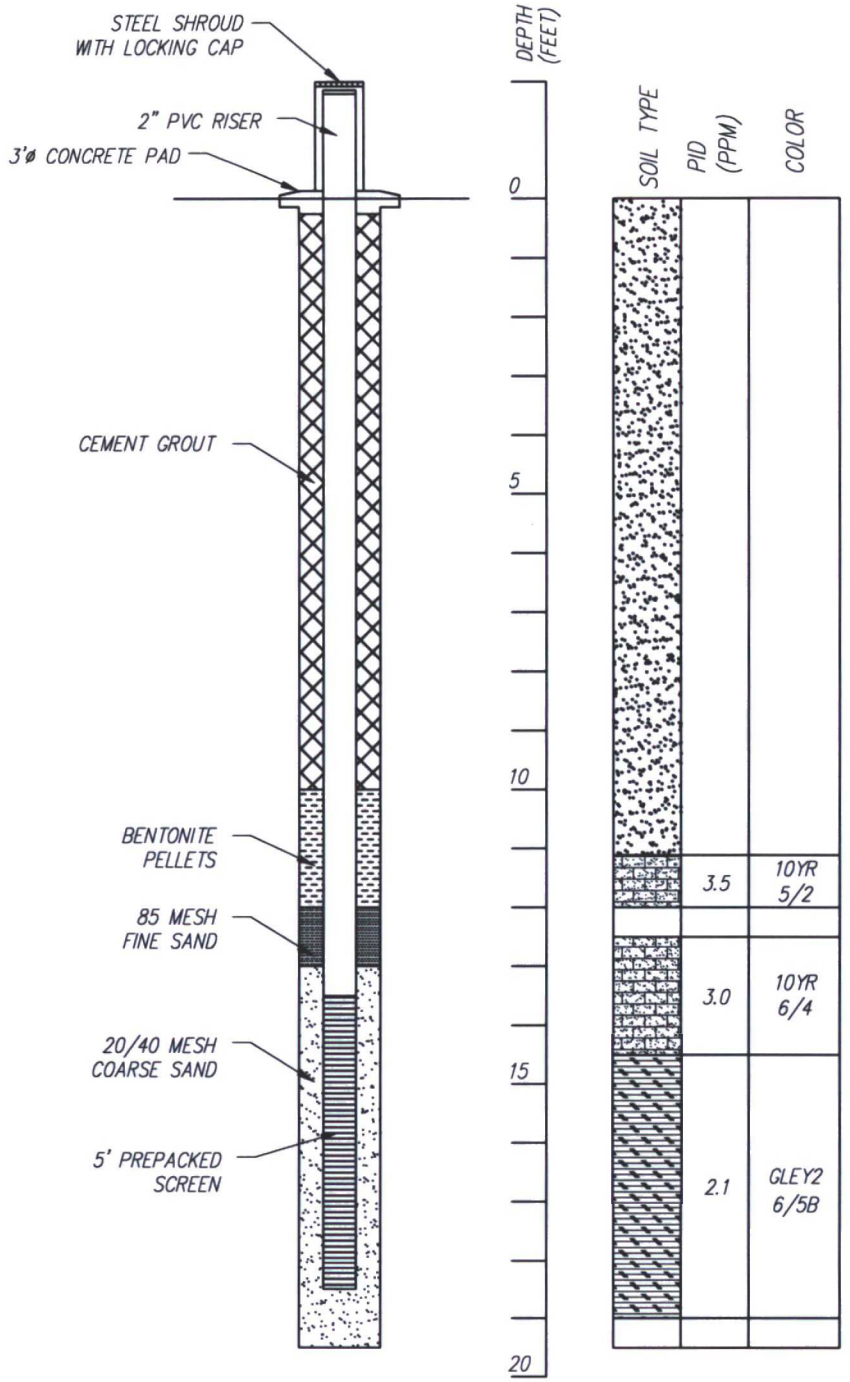
Date: September 2016
Scale: Horiz: NA Vert: NA
Project No: 5124371
Sheet: 5

BROWN UNCONSOLIDATED SAND BACKFILL
NO SAMPLE COLLECTED, OBSERVED DRILLING RETURNS

BROWN SAND/BLUE SAND CONTACT
OBSERVED WHILE DRILLING TO CORE POINT

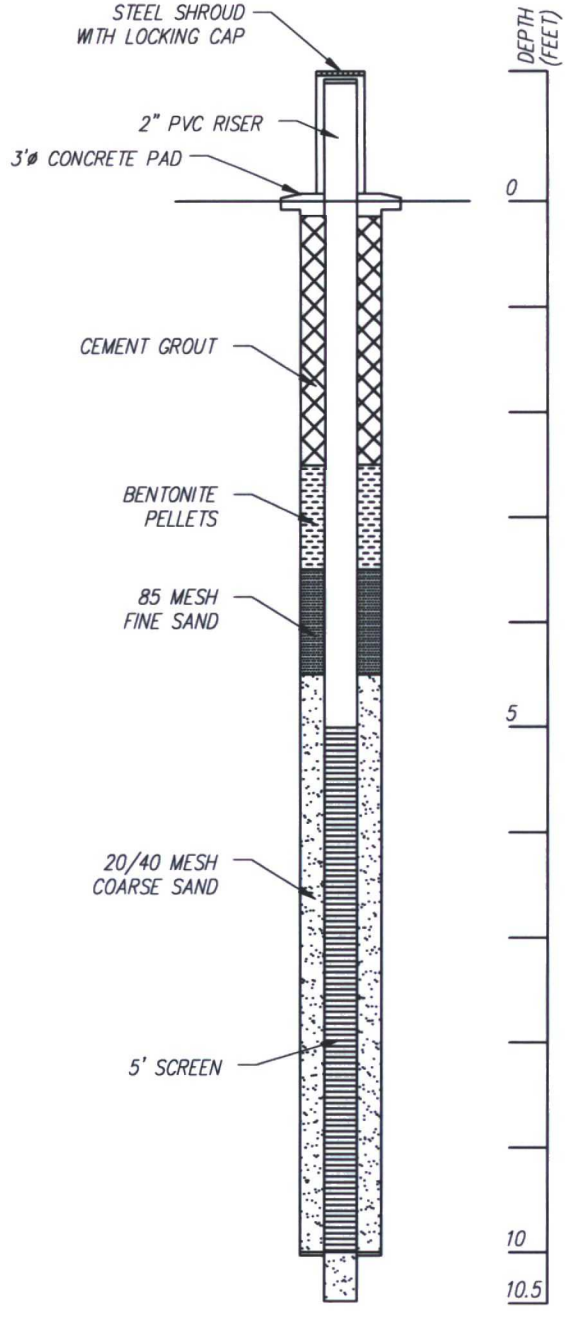
Date: September 2016
Scale: Horiz: NA Vert: NA
Project No: 5124371
Sheet: 6

DEPTH (FEET)	SOIL TYPE	PID (PPM)	COLOR	SAMPLE DESCRIPTION
0				BROWN UNCONSOLIDATED SAND NO SAMPLE COLLECTED, OBSERVED DRILLING RETURNS
5		2.0	10YR 4/3	BROWN SAND, POORLY SORTED, COARSE TO VERY FINE, UNCONSOLIDATED, SOME PEBBLES, SUBROUNDED SPLIT SPOON SAMPLE #1 (8 blows, 18")
				BROWN UNCONSOLIDATED SAND NO SAMPLE COLLECTED, OBSERVED DRILLING RETURNS
10		3.1	2.5Y 5/2	BROWN SAND, POORLY SORTED, MEDIUM TO VERY FINE, UNCONSOLIDATED, SOME WHAT PLASTIC, HIGH CLAY CONTENT, SUBANGULAR, SUBROUNDED TOP OF SPILT SPOON SAMPLE #2 (12 blows, 18")
10.5		3.0	10YR 4/3	GRAY BROWN SAND, POORLY SORTED, UNCONSOLIDATED, SUBROUNDED TO ROUNDED, COARSE TO VERY FINE. BOTTOM OF SPILT SPOON SAMPLE #2 (12 blows, 18")
				BROWN SAND/BLUE SAND CONTACT NOT REACHED

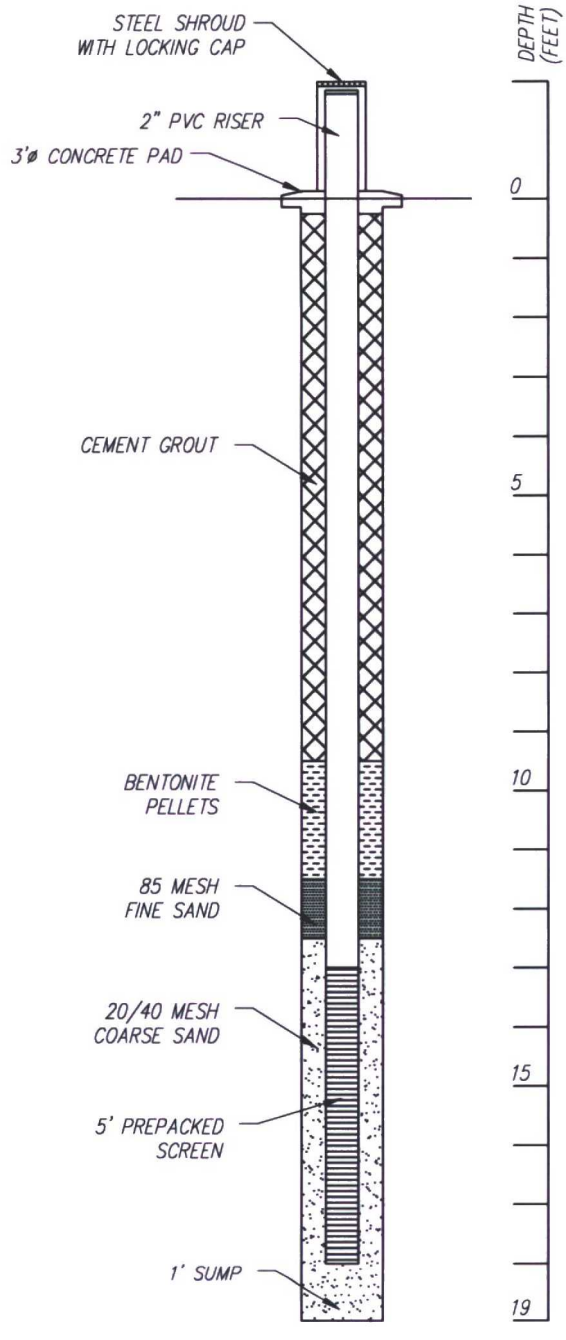
Date: September 2016
Scale: Horiz: NA Vert: NA
Project No: 5124371
Sheet: 7

SOIL TYPE	PID (PPM)	COLOR	SAMPLE DESCRIPTION
			BROWN UNCONSOLIDATED SAND NO SAMPLE COLLECTED, OBSERVED DRILLING RETURNS
	1.7	10YR 5/3	BROWN SAND, MODERATELY SORTED, MEDIUM TO FINE, UNCONSOLIDATED, SUBROUNDED, CLAY FILM. SPLIT SPOON SAMPLE #1 (15 blows, 18")
			NO SAMPLE

1.2	10YR 5/3	BROWN SAND. MODERATELY SORTED, MEDIUM TO FINE, UNCONSOLIDATED, CLAY MODULES. SPLIT SPOON SAMPLE #2 (11 blows, 18")
	2.6	10YR 5/3	GRAY BROWN SANDSTONE MODERATELY SORTED, MEDIUM TO FINE, SEMI CONSOLIDATED, CLAY FILM, MINOR MICA. SPLIT SPOON SAMPLE #3 (114 blows, 12")
			NO SAMPLE

10.3	GLEY2 5/5BG	CORE 1: MISSING 3.0' OF 4.0' CORE GRAY BROWN SANDSTONE, MODERATELY SORTED. MEDIUM TO FINE, SEMICONSOLIDATED, MINOR MICA
			NO SAMPLE
			NO SAMPLE
	53	GLEY 5/10B	CORE 2: MISSING 3.5' OF CORE DARK GRAY SANDSTONE, POORLY SORTED, COARSE TO MEDIUM, UNCONSOLIDATED, SOME VERY DARK GRAY SHALE
			BROWN SAND/BLUE SAND CONTACT = 11.5'

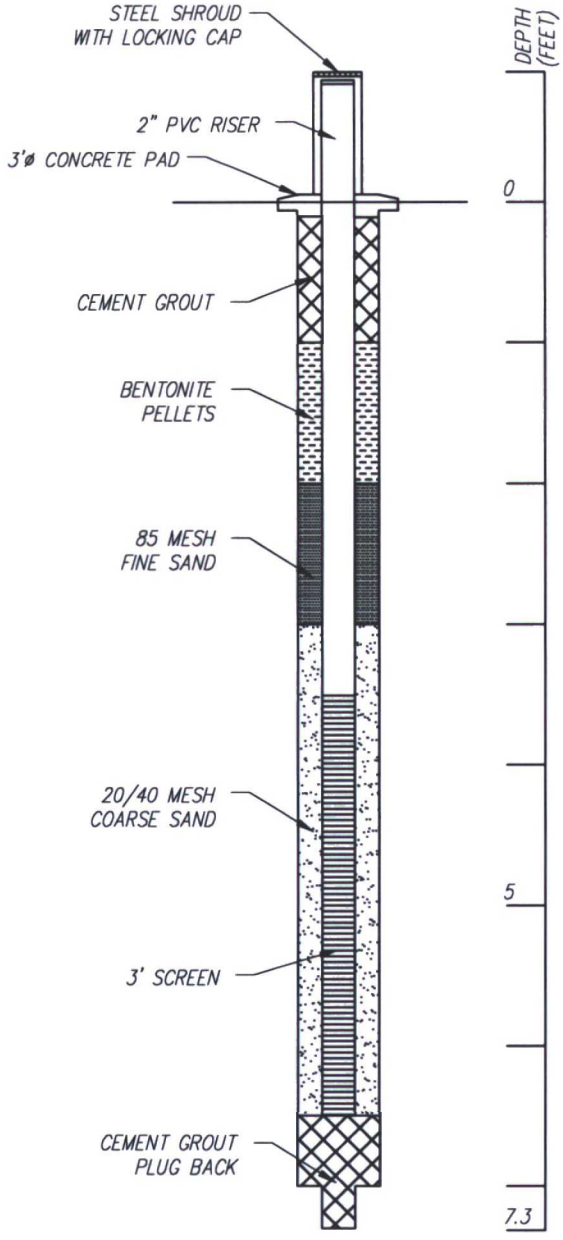
Date: September 2016
Scale: Horiz: NA Vert: NA
Project No: 5124371
Sheet: 8

SOIL TYPE	PID (PPM)	COLOR	SAMPLE DESCRIPTION
			BROWN UNCONSOLIDATED SAND BACKFILL NO SAMPLE COLLECTED, OBSERVED DRILLING RETURNS
	6.4	10YR 5/4	BROWN SAND, POORLY SORTED, FINE TO COARSE, UNCONSOLIDATED, ARKOSIC, CLAY FILMS, NON CALCAREOUS CEMENTATION. SPLIT SPOON SAMPLE #1 (28 blows, 18")
			NO SAMPLE COLLECTED
	1.3	2.5Y 6/2	BROWN/GRAY SAND, MODERATELY SORTED, FINE TO VERY FINE, SEMICONSOLIDATED, SUBROUNDED SOME MICA, NON CALCAREOUS CEMENTATION. TOP OF SPLIT SPOON SAMPLE #2 (20 blows, 6")
	1.3	2.5Y 5/2	BROWN/GRAY SAND, WELL SORTED, MEDIUM TO FINE, SEMICONSOLIDATED, SUBROUNDED TO SUBANGULAR, CLAYEY CEMENTATION. BOTTOM OF SPILT SPOON SAMPLE #2 (80 blows, 6")
			BROWN SAND/BLUE SAND CONTACT 6.8'

NOTE:
SAMPLE FROM 6.8' CONTACT JARRED FOR ADDITIONAL ANALYSIS

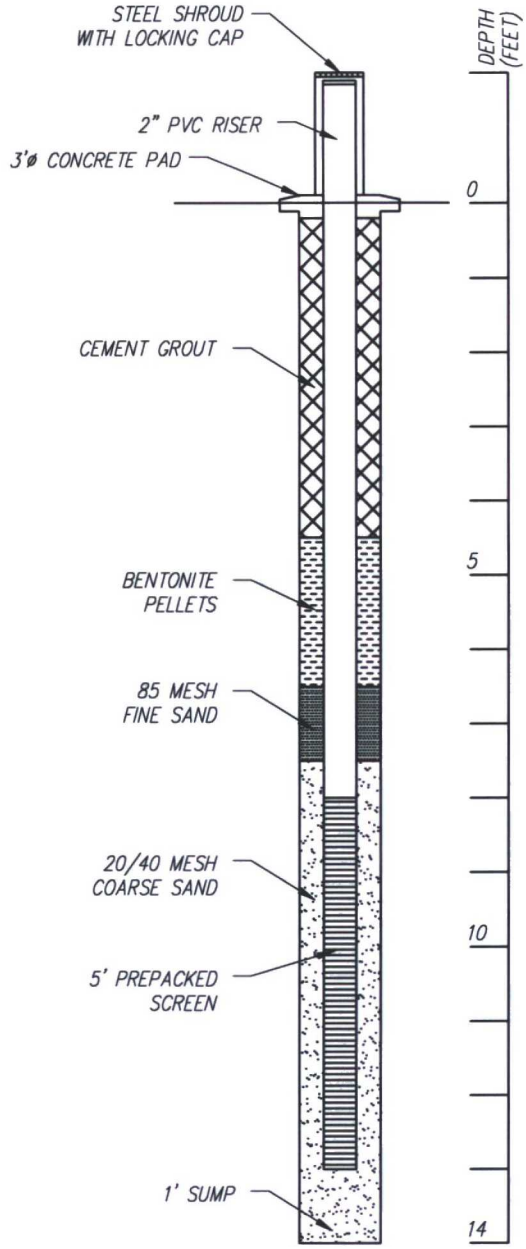
Date: September 2016
Scale: Horiz: NA Vert: NA
Project No: 5124371
Sheet: 9

SOIL TYPE	PID (PPM)	COLOR	SAMPLE DESCRIPTION
			BROWN UNCONSOLIDATED SAND BACKFILL NO SAMPLE COLLECTED, OBSERVED DRILLING RETURNS
			BROWN SAND, POORLY SORTED, VERY COARSE TO MEDIUM, UNCONSOLIDATED, MINOR GRAY CLAY INCLUSIONS, SUBANGULAR.

6.3	5YR 5/4	BROWN GRAY SAND, MODERATE TO WELL SORTED, FINE TO VERY FINE SEMICONSOLIDATED, ANGULAR TO SUBANGULAR, MINOR MICA, CLAYEY, NON CALCAREOUS CEMENT. SPLIT SPOON SAMPLE #1 (100 blows, 7")

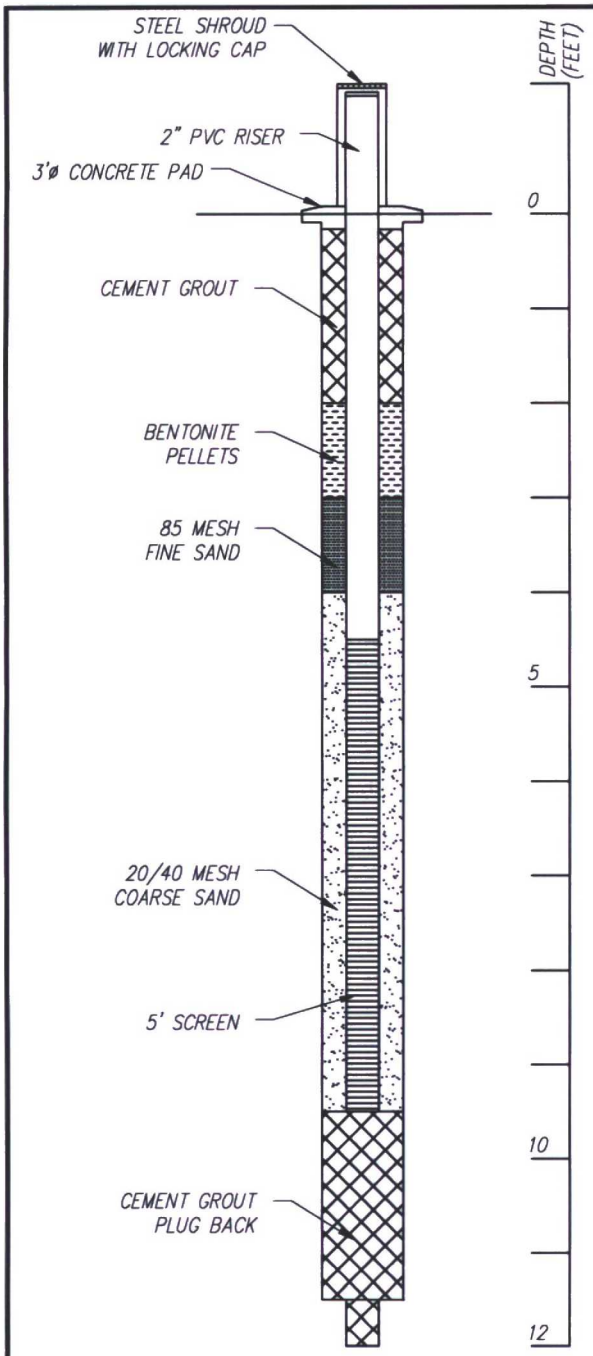
DEPTH (FEET)	SOIL TYPE	PID (PPM)	COLOR	SAMPLE DESCRIPTION
0				BROWN UNCONSOLIDATED SAND NO SAMPLES COLLECTED, OBSERVED DRILLING RETURNS
5		1.2	5YR 4/2	BROWN SAND, POOR SORTING, FINE TO COARSE, UNCONSOLIDATED, ANGULAR TO SUBANGULAR, MINOR PEBBLES, ARKOSIC, NO APPARENT CEMENTATION. 75–80% QUARTZ. SPLIT SPOON SAMPLE #1 (20 blows, 18")
				BROWN UNCONSOLIDATED SAND NO SAMPLES COLLECTED, OBSERVED DRILLING RETURNS
10		2.0	5YR 4/2	BROWN SAND, POOR SORTING, FINE TO COARSE, UNCONSOLIDATED, ANGULAR TO SUBANGULAR, SOME GRAY SAND, ARKOSIC WITH SOME PEBBLES, NO APPARENT CEMENTATION. 75–80% QUARTZ. SPLIT SPOON SAMPLE #2. CONTACT @ 10.0'

4.9	10YR 3/3	BROWN WITH BLUE/GRAY MOTTLED, MODERATE SORTING, MEDIUM TO FINE, ANGULAR TO SUBANGULAR, SOME PLASTICITY. SPLIT SPOON SAMPLE #2 Top (30 blows, 6") Bottom (70 blows, 6")
12		1.6	10YR 3/3	BROWN WITH BLUE/GRAY MOTTLED, MODERATE SORTING, MEDIUM TO FINE, ANGULAR TO SUBANGULAR, SOME PLASTICITY. SPLIT SPOON SAMPLE #3 (107 blows, 7")
				BROWN SAND/BLUE SANDSTONE CONTACT 10.0'

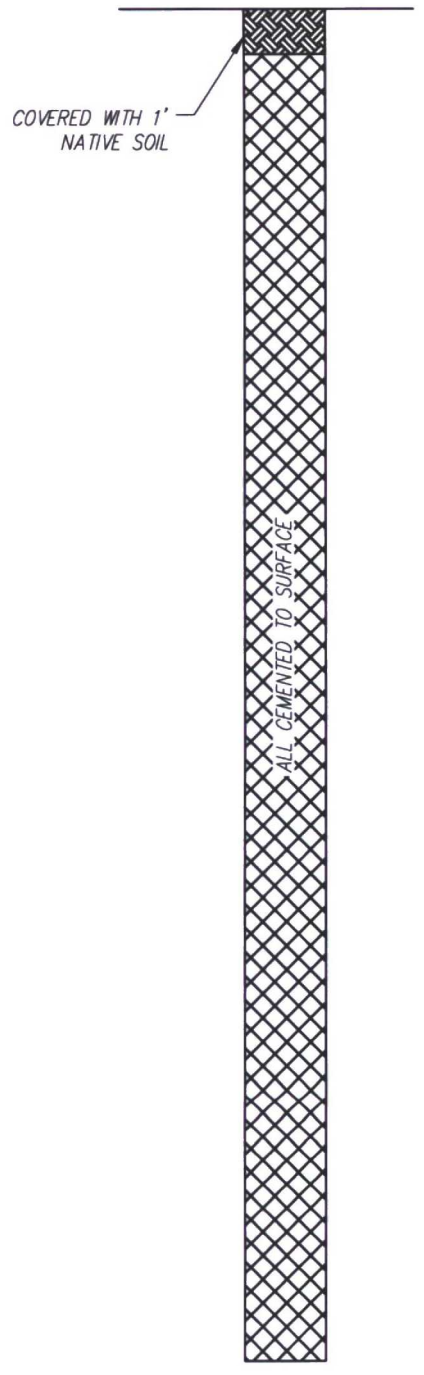
Date: September 2016
Scale: Horiz: NA Vert: NA
Project No: 5124371
Sheet: 12

NOTE: ARTESIAN WATER FLOW ENCOUNTERED IN THE DARK GRAY FRACTURED SHALE @ 29' TO 30'. VERBAL APPROVAL FROM NMOSE TO PLUG AND ABANDON THIS BOREHOLE WITH CEMENT GROUT.

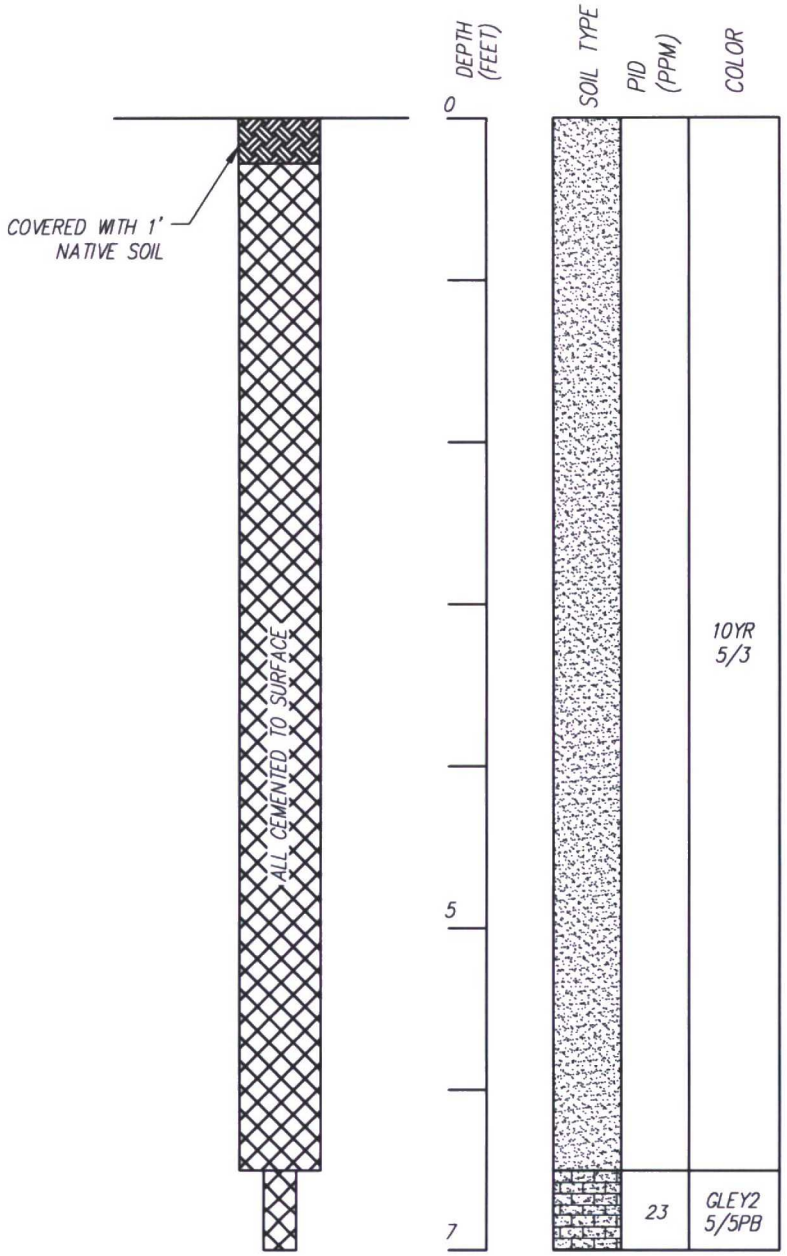
DEPTH (FEET)	SOIL TYPE	PID (PPM)	COLOR	SAMPLE DESCRIPTION
0				UNCONSOLIDATED BROWN SAND NO SAMPLES IN THIS BORING, OBSERVED DRILLING RETURNS
5				BROWN SAND/BLUE SAND CONTACT 10.5'
10		1.9	GLEY2 7/5B	SPLIT SPOON SAMPLE GRAY BLUE SAND, MODERATE SORTING, FINE TO VERY FINE, UNCONSOLIDATED, MINOR MICA, CLAY CEMENTATION, HIGH FELDSPAR
15		5.0	GLEY2 7/5B	CORE GRAY BLUE SANDSTONE, MODERATE SORTING, MEDIUM TO FINE, SEMICONSOLIDATED, SUBANGULAR, MINOR MICA
				NO CORE RECOVERY
20		6.5	GLEY2 7/10B	GRAY BLUE SANDSTONE, MODERATE TO WELL SORTED, FINE, SEMICONSOLIDATED, SUBROUNDED, MINOR MICA, CLAY CEMENTATION
				NO CORE RECOVERY
25		10.5	GLEY2 7/5PB	GRAY BLUE SANDSTONE, MODERATE SORTING, FINE, SEMICONSOLIDATED, SUBANGULAR TO SUBROUNDED, MINOR MICA, CLAY CEMENTATION
				NO CORE RECOVERY
30		7.9	5YR 5/1	DARK GRAY, SILTY CLAYEY SHALE, SEMI CONSOLIDATED FRACTURED

NOTE:
AFTER DISCUSSION WITH BP REPRESENTATIVE, DECISION MADE TO PLUG THIS SOIL BORING WITH CEMENT GROUT. ANOTHER SOIL BORING WILL BE DRILLED FOR THE #7 WELL.

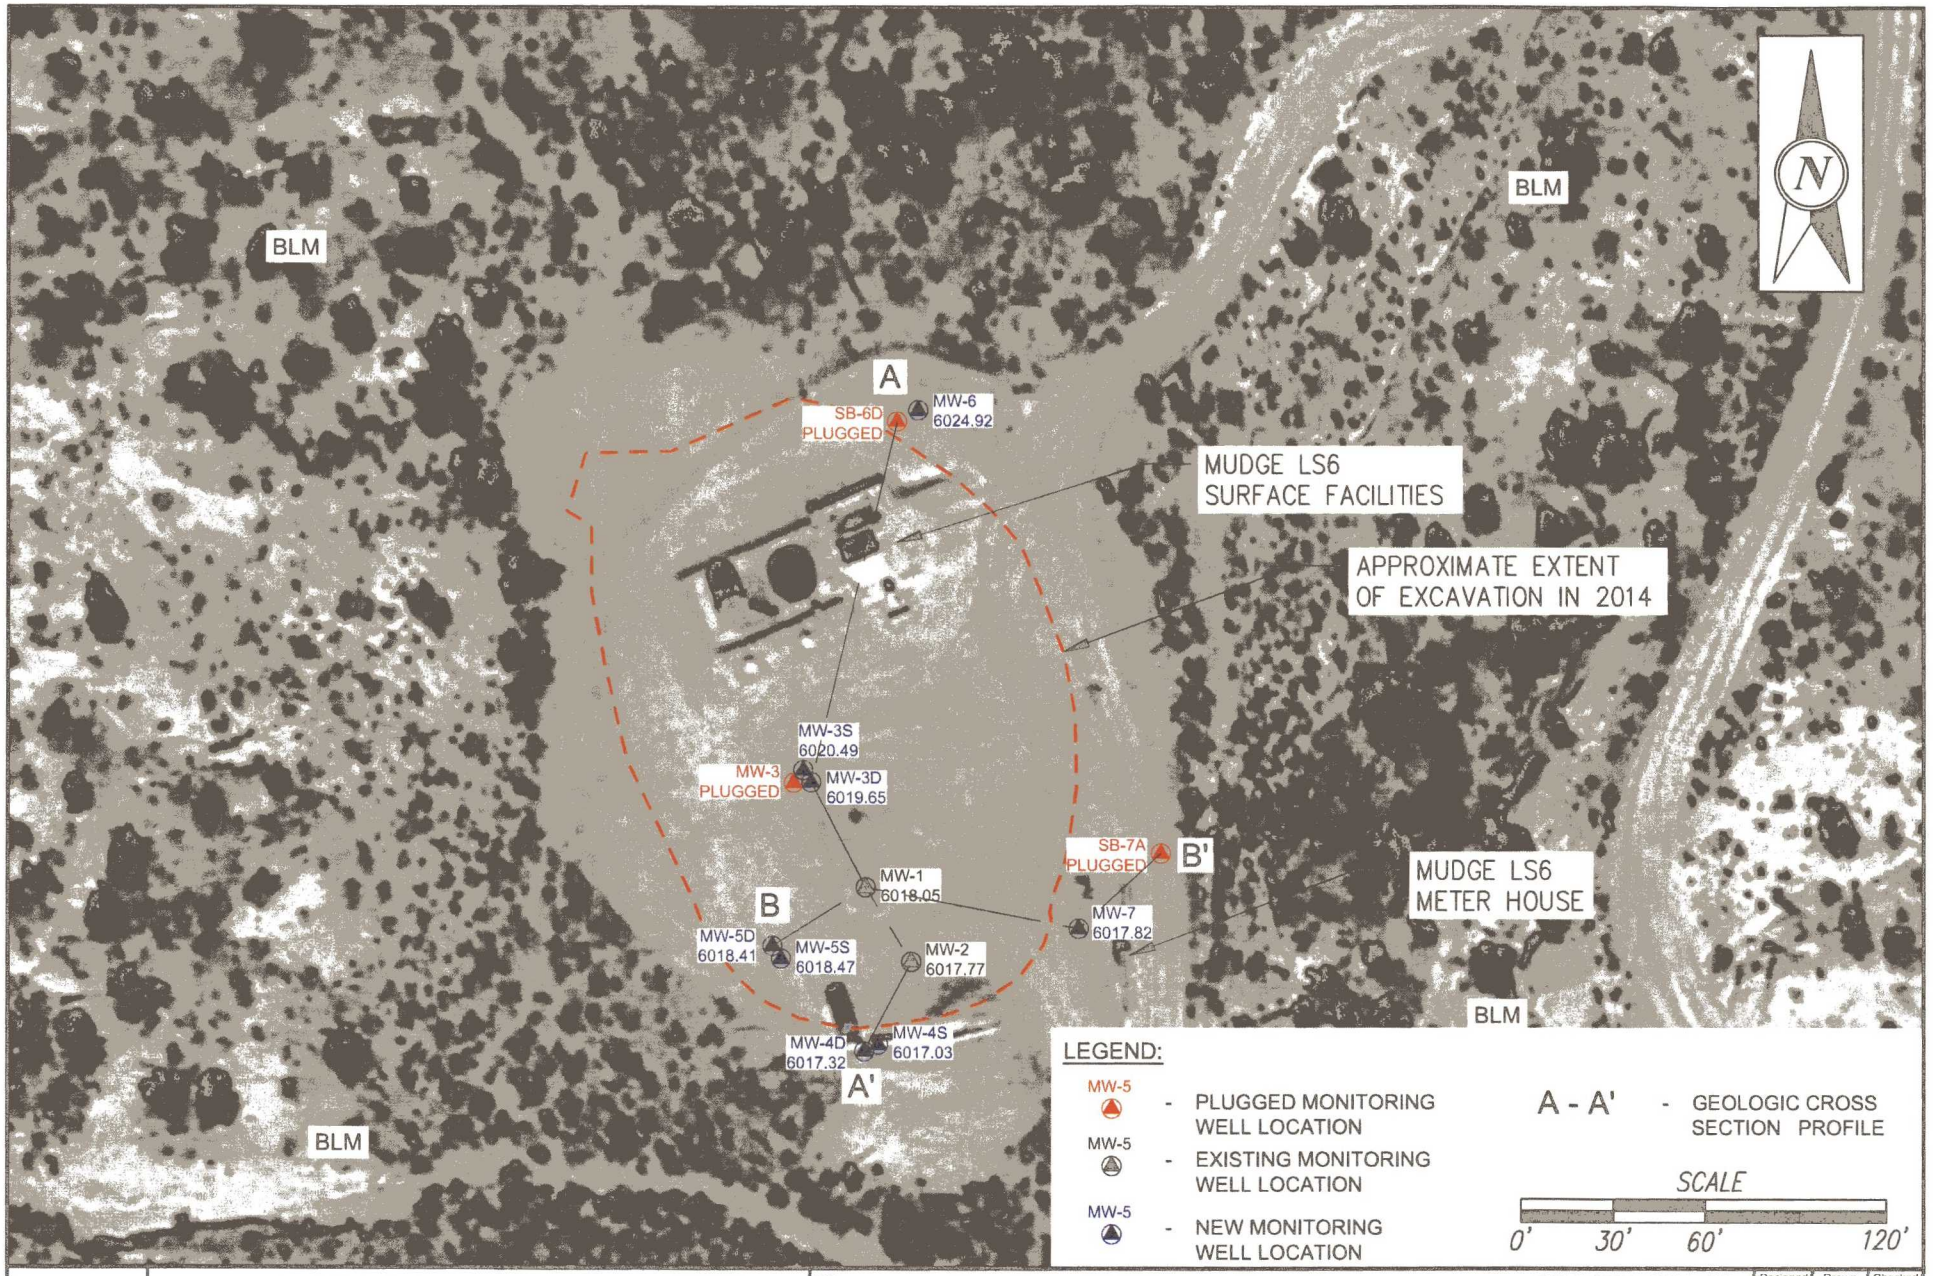
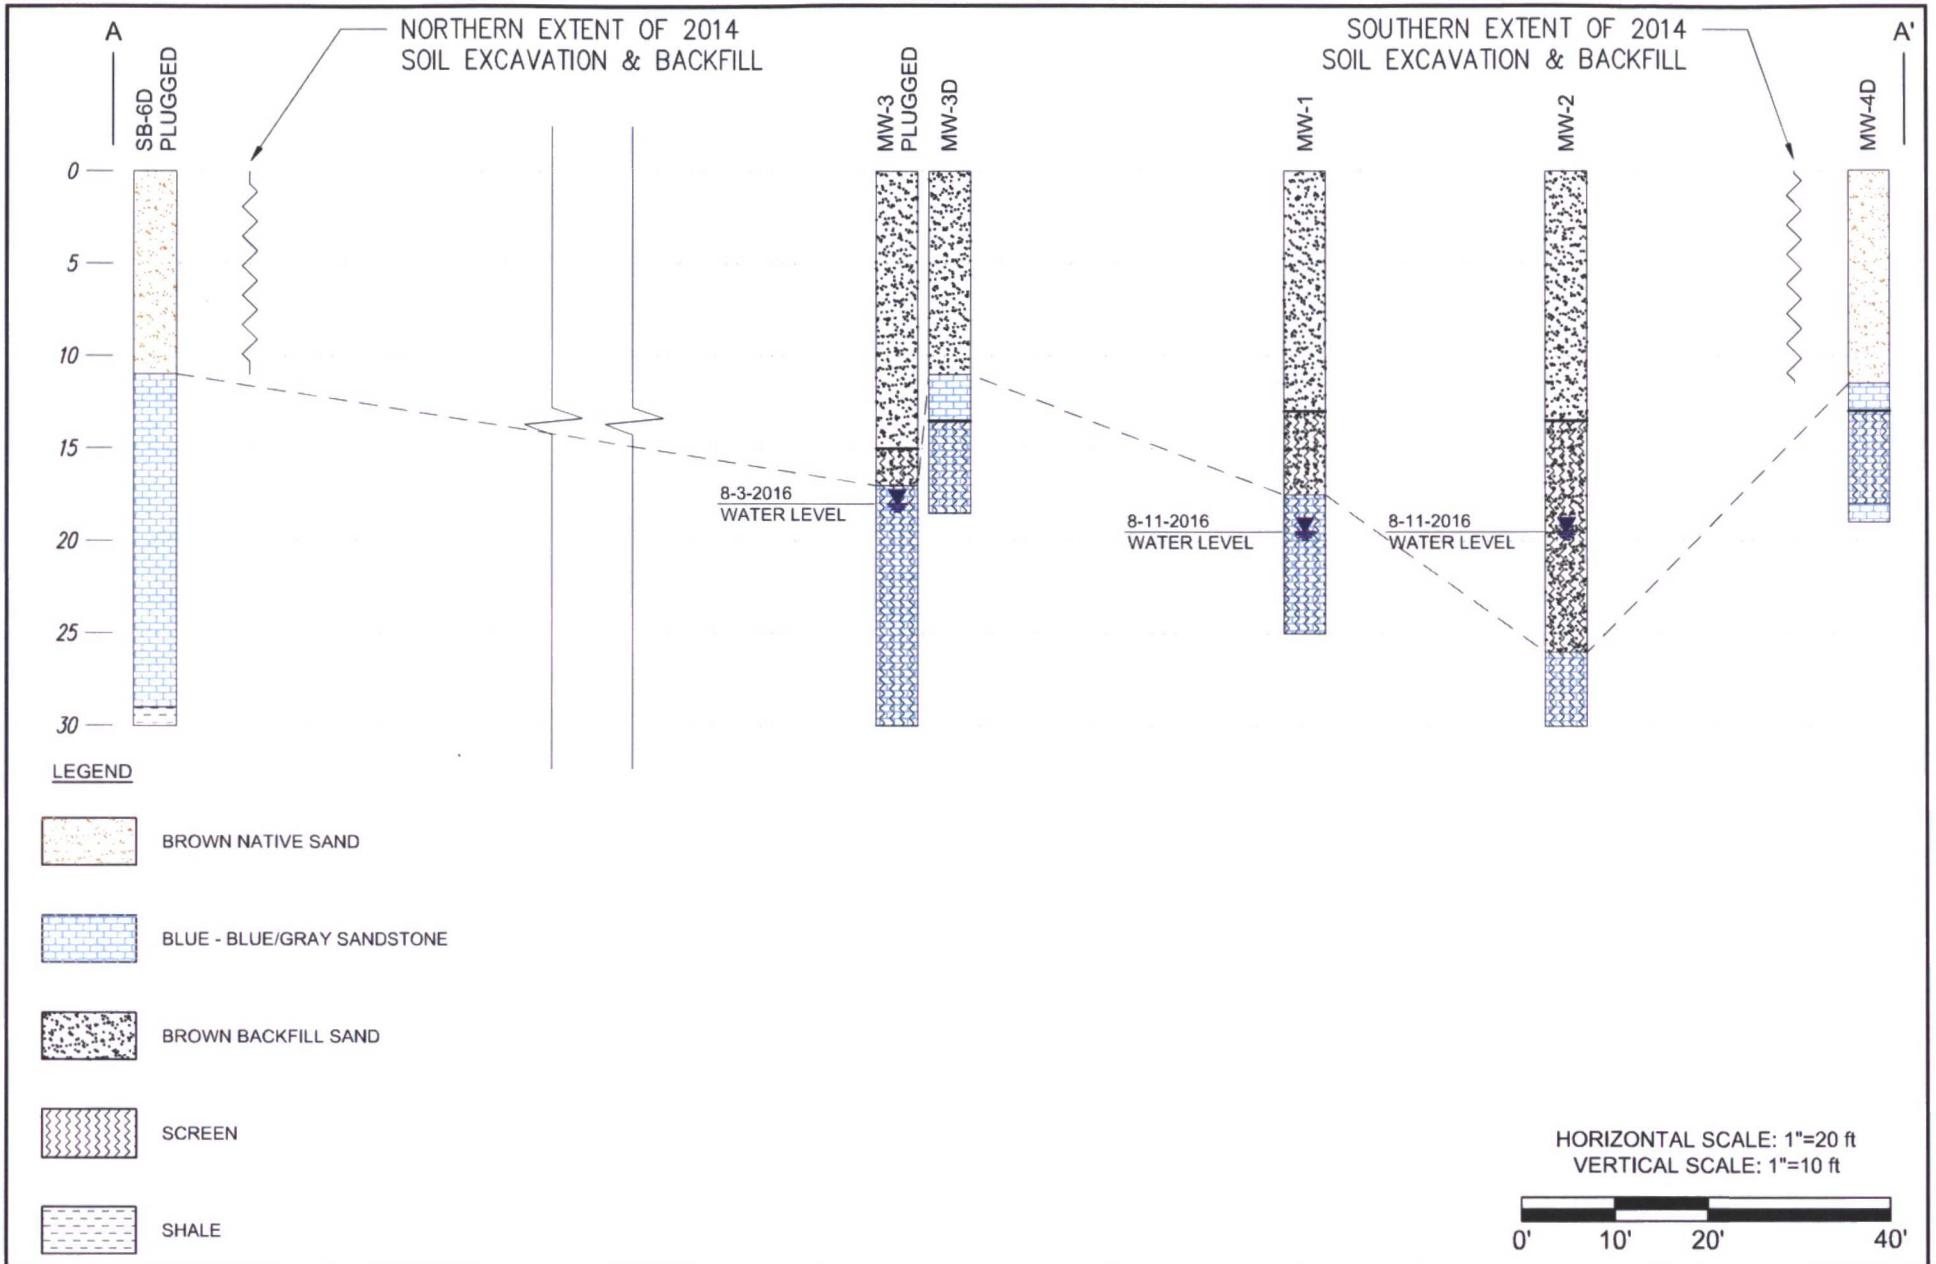
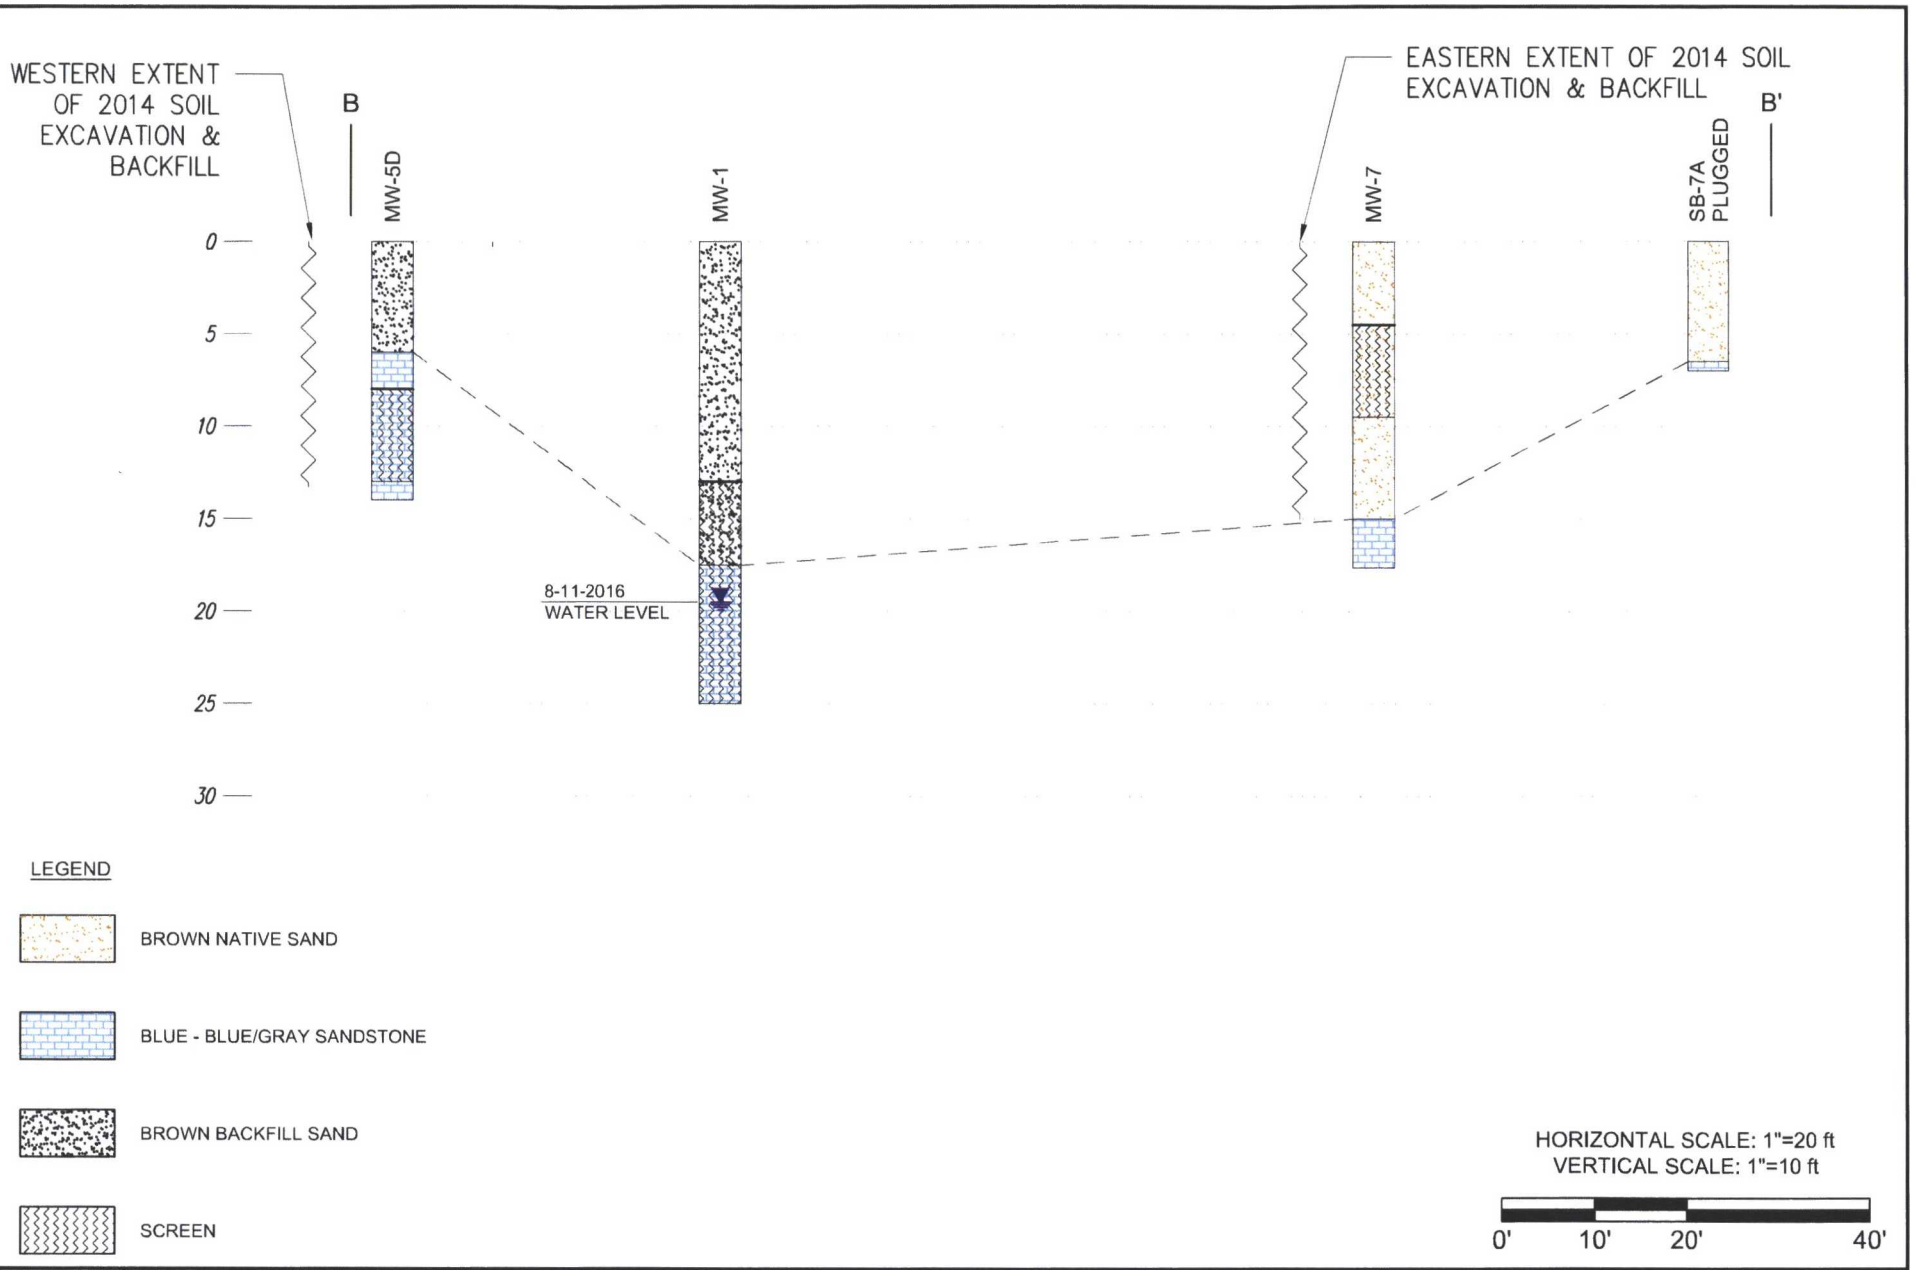
Geologic cross sections are found on Figures 17, 18 and 19.

A cross section constructed from all soil borings on the wellsite indicate that the brown sand/blue sandstone contact is bowl-shaped at the center of the wellsite. During the 2014 excavation it was noted that water was pooling at low points of the surface of the blue sandstone. This may be a part of an erosional feature following a north-south line that was filled with the native brown sand prior to the grading of the wellsite in 1953. The 2014 excavation and disturbance may have deepened what was already a low feature on the surface of the blue sandstone.
