Re: SiteClosure Report – Millensand Unit # 133 **OCD 1RP-1025**
Site Location: UL-G Sec 7 T 8 R35E
Report Received: November 6, 2006

Closure Report 10-11-06

Project:
Milnesand Unit # 133
U/L G Sec. ~~8 T 35 R 37~~ 7-8-35
Milnesand, Roosevelt County New Mexico

Job Summary Sheet

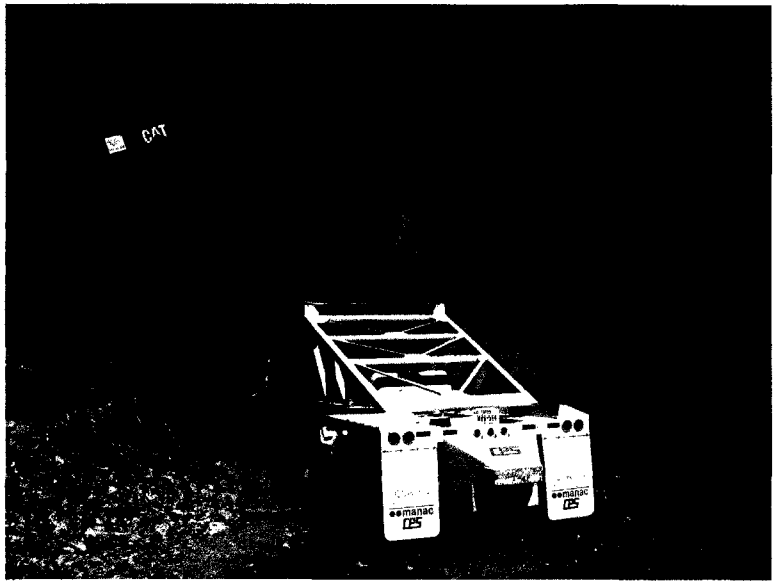
Loading Trucks

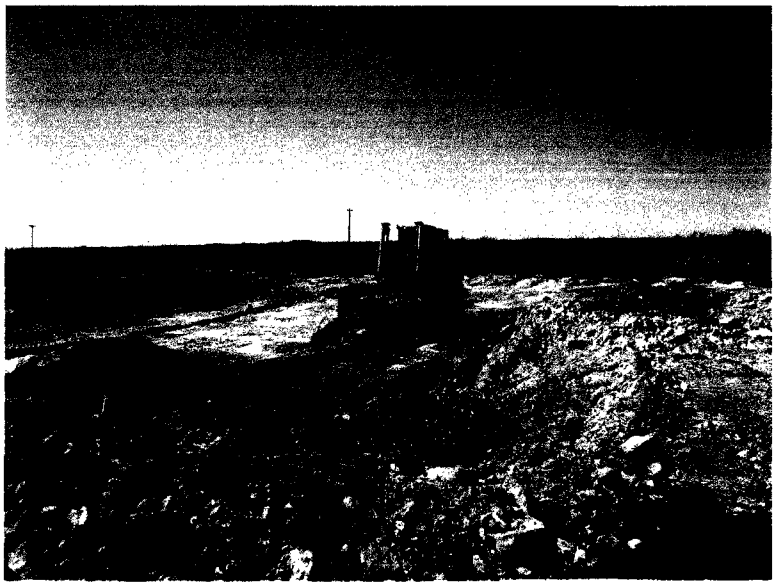
Pushing with Dozer

Loading Trucks with Contaminated Soil

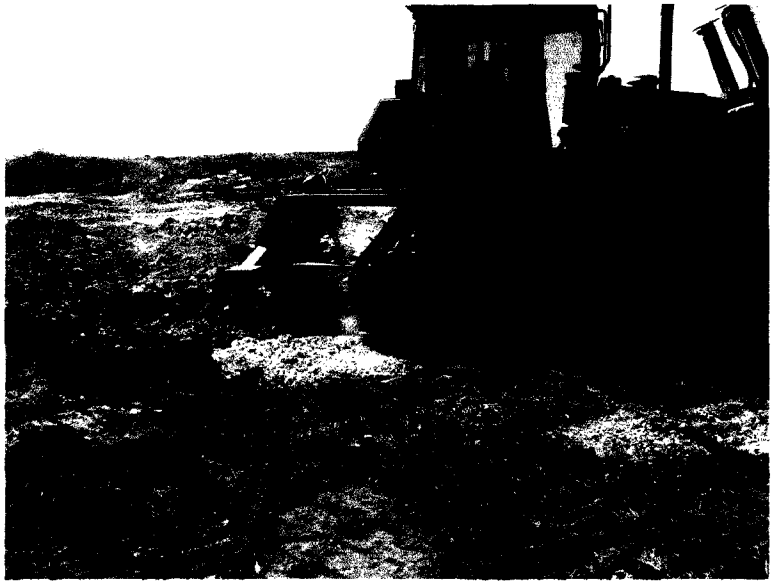
Ripping Rock with Dozer
