Subject:
Investigation and Characterization Plan
Blinebry Drinkard (BD) Jct. F-25-2
T21S, R37E, Section 25, Unit F, Eunice, Lea County, New Mexico

Date:
17 July 2007

RICE OPERATING COMPANY
JUNCTION BOX **DISCLOSURE*** REPORT

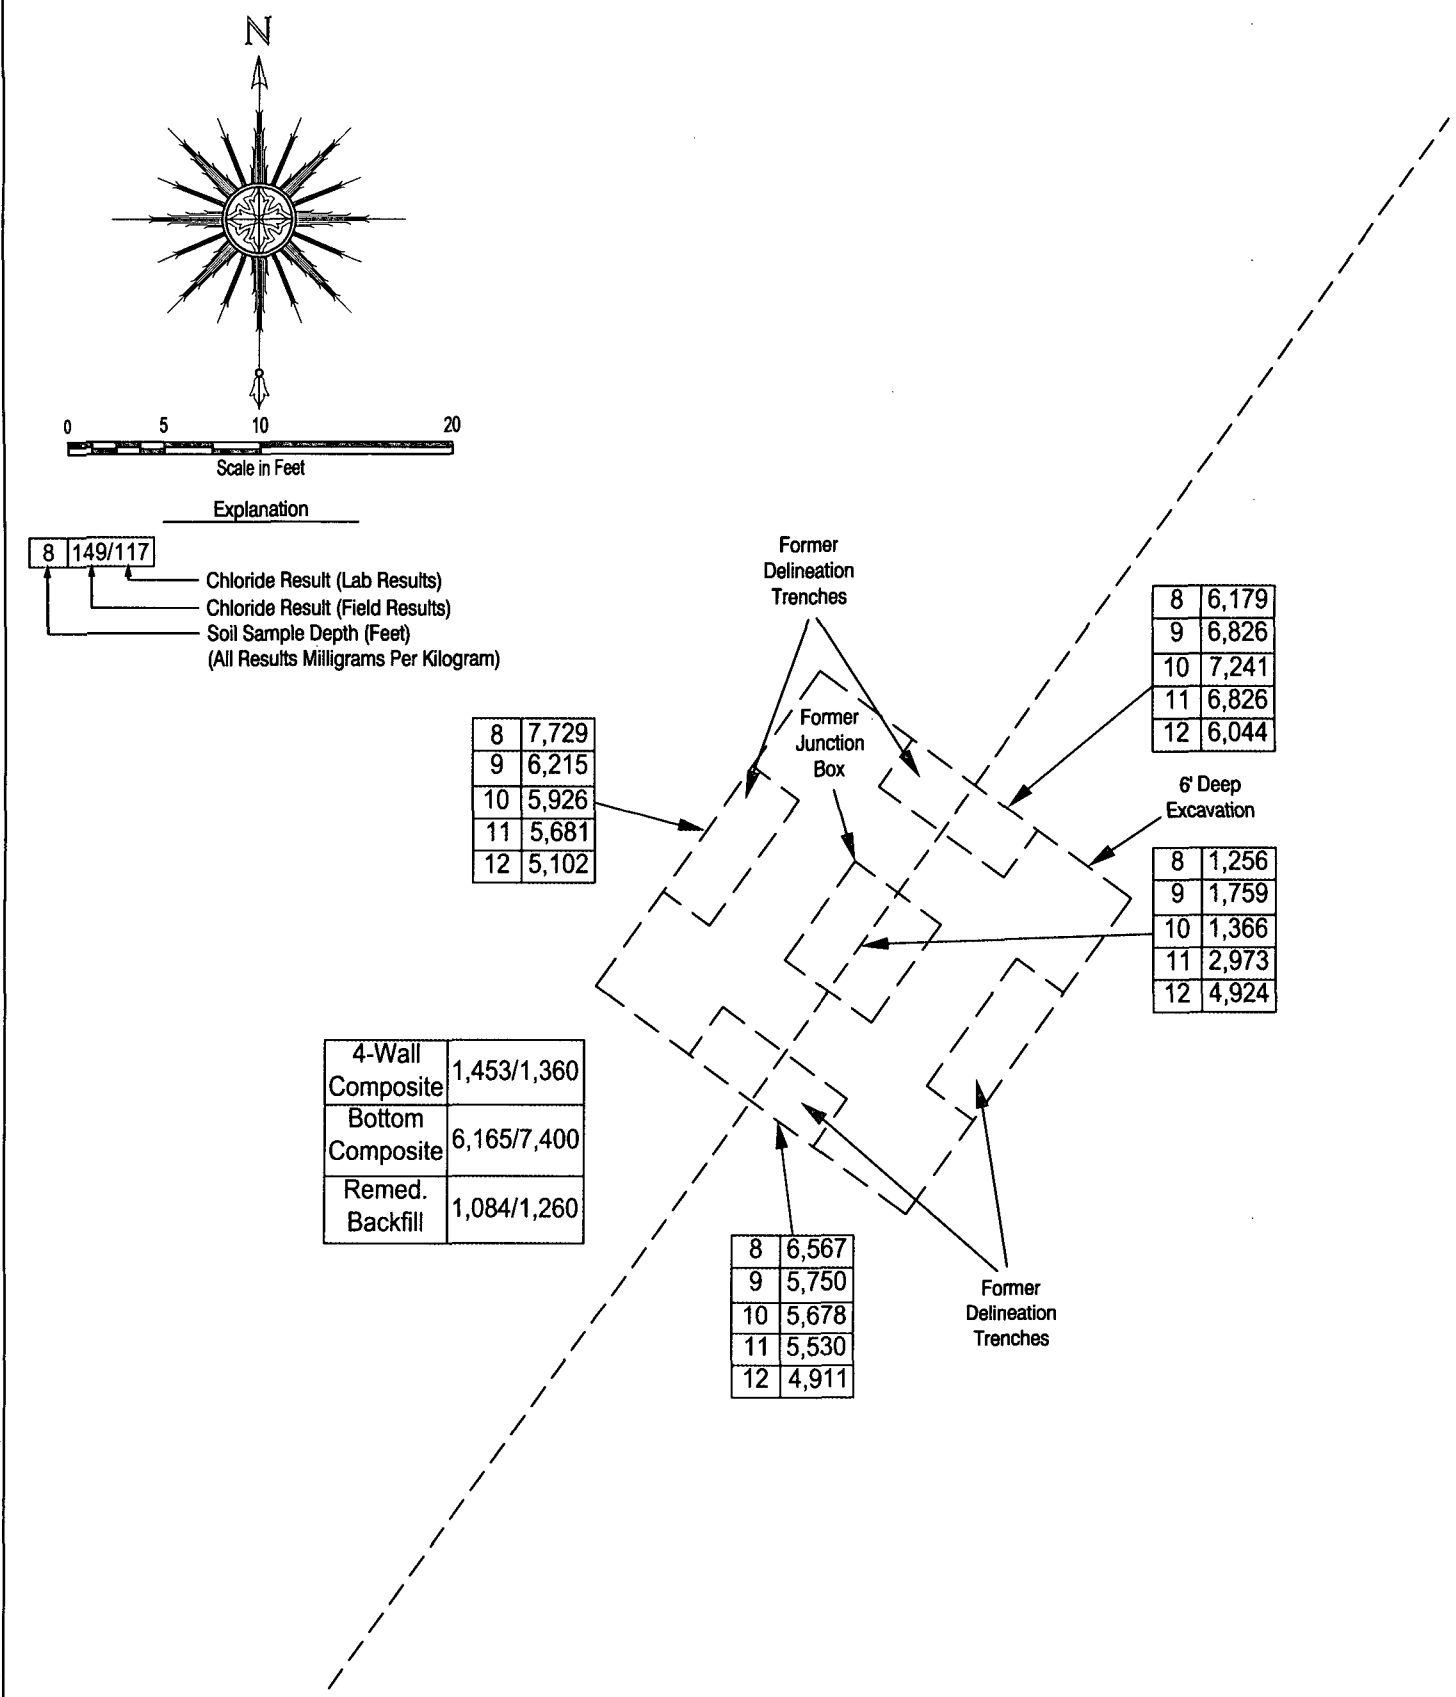
Project Number	MT000913.0001
Drawing Date	12 January 2007
Figure	2

Based on the results of the soil sampling analytical results, elevated chloride concentrations are present at the subject site as shown in Figure 2.

Soil Excavation and Sampling Results Chlorides (mg/Kg)
