AP - 076

Release Notification and Corrective Action

Name of Company – Pride Energy	Contact – Matt Pride
Address – P O Box 701950 Tulsa, OK 74170	Telephone No. – 918-524-9200
Facility Name – South Four Lakes #13	Facility Type – Drilling Pit

Pride Energy
South Four Lakes #13
UL 'L' Sec. 1 T12S R34E
Lea County, NM

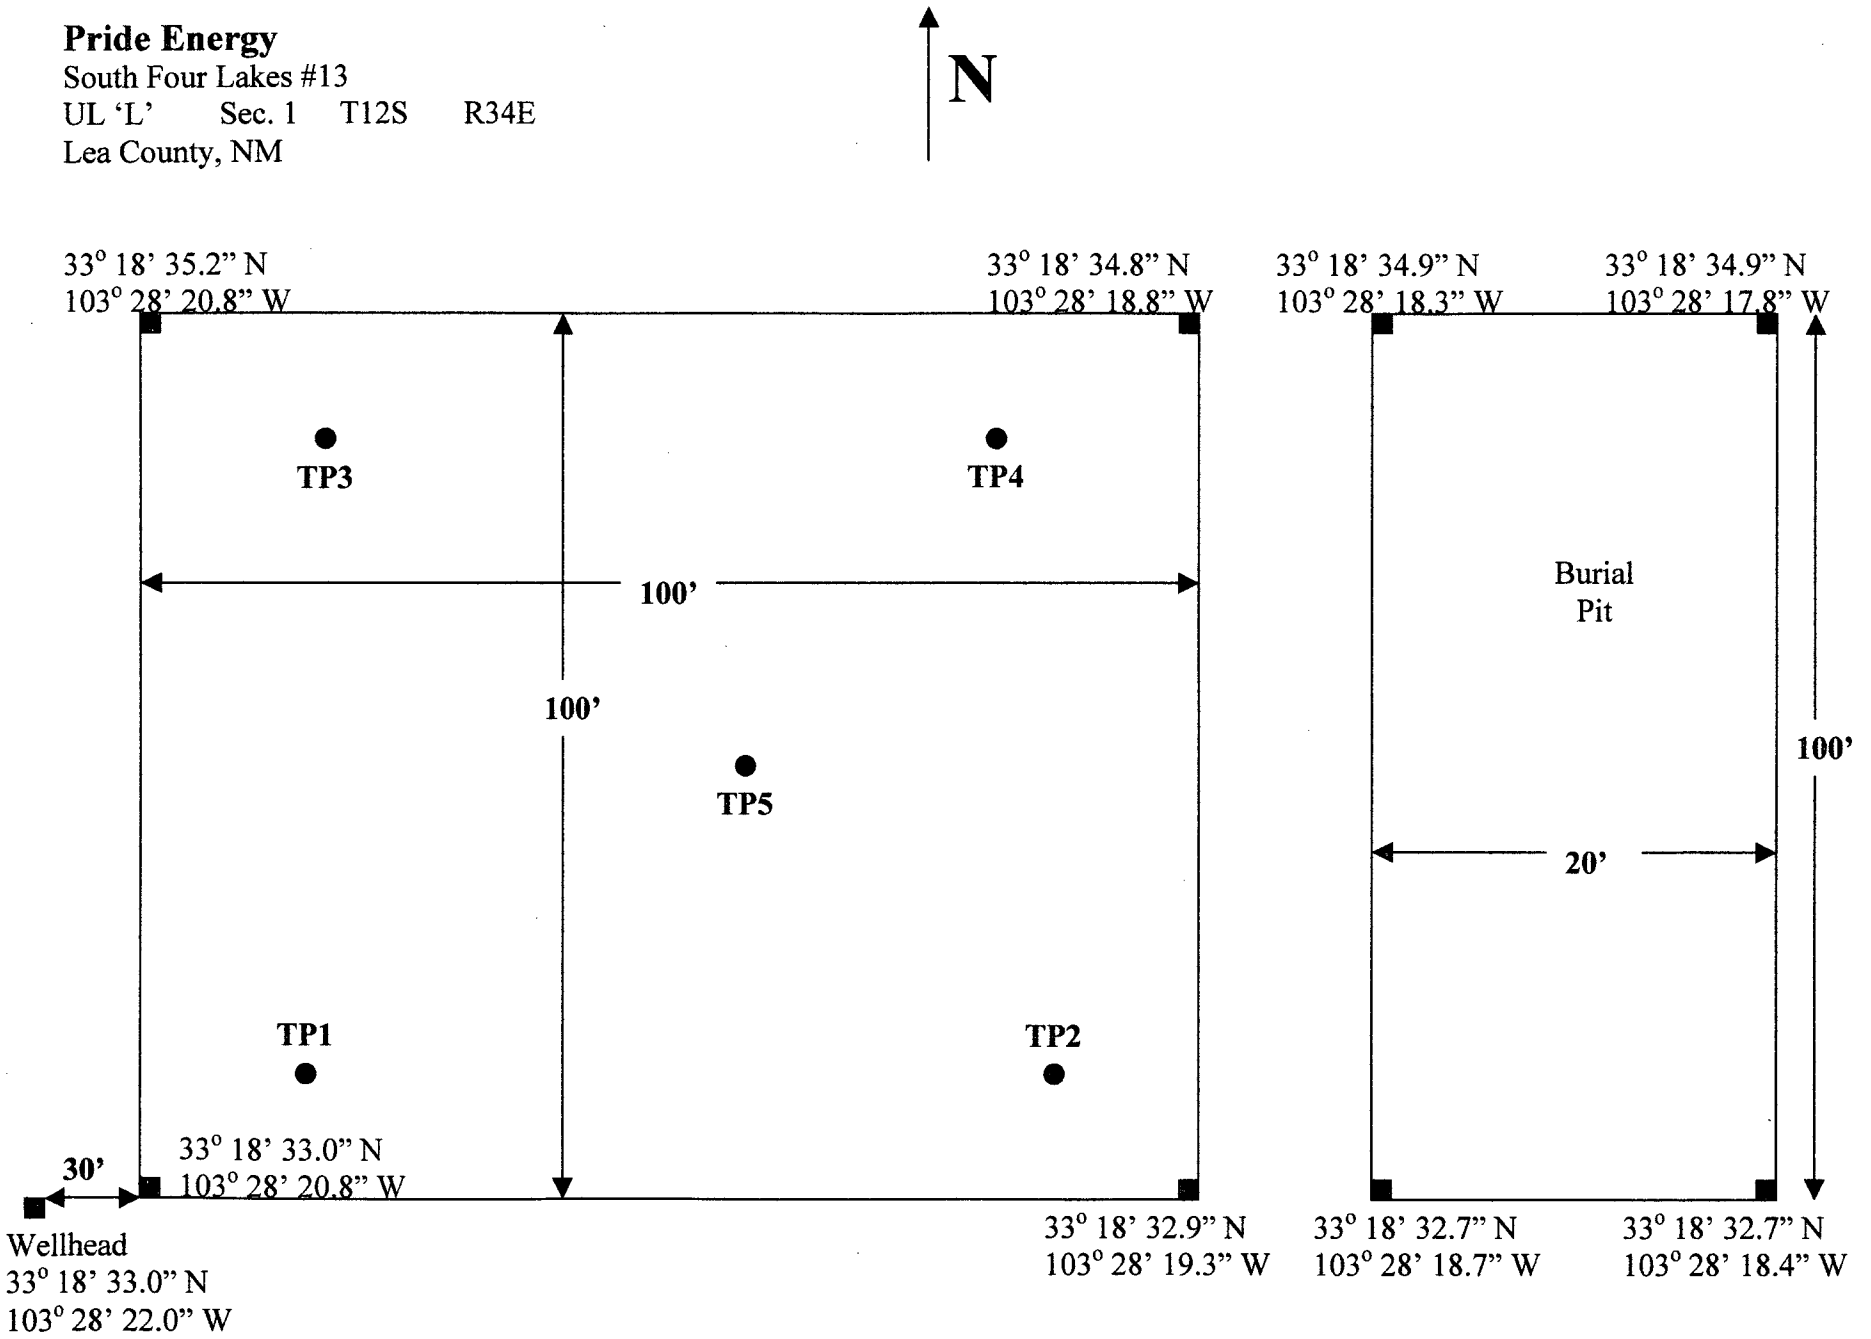
Describe Area Affected and Cleanup Action Taken. A plat map, field analytical and lab analysis are included with this C-141.
