CORRECTIVE ACTION PLAN
RICE Operating Company
BD A-27 Release Site
T22S-R37E-Section 27, Unit Letter A
Lea County, New Mexico

R. T. Hicks Consultants, Ltd.

RE: **CORRECTIVE ACTION PLAN**

BD A-27 RELEASE SITE
T22S-R37E-SECTION 27, UNIT LETTER A
LEA COUNTY, NEW MEXICO

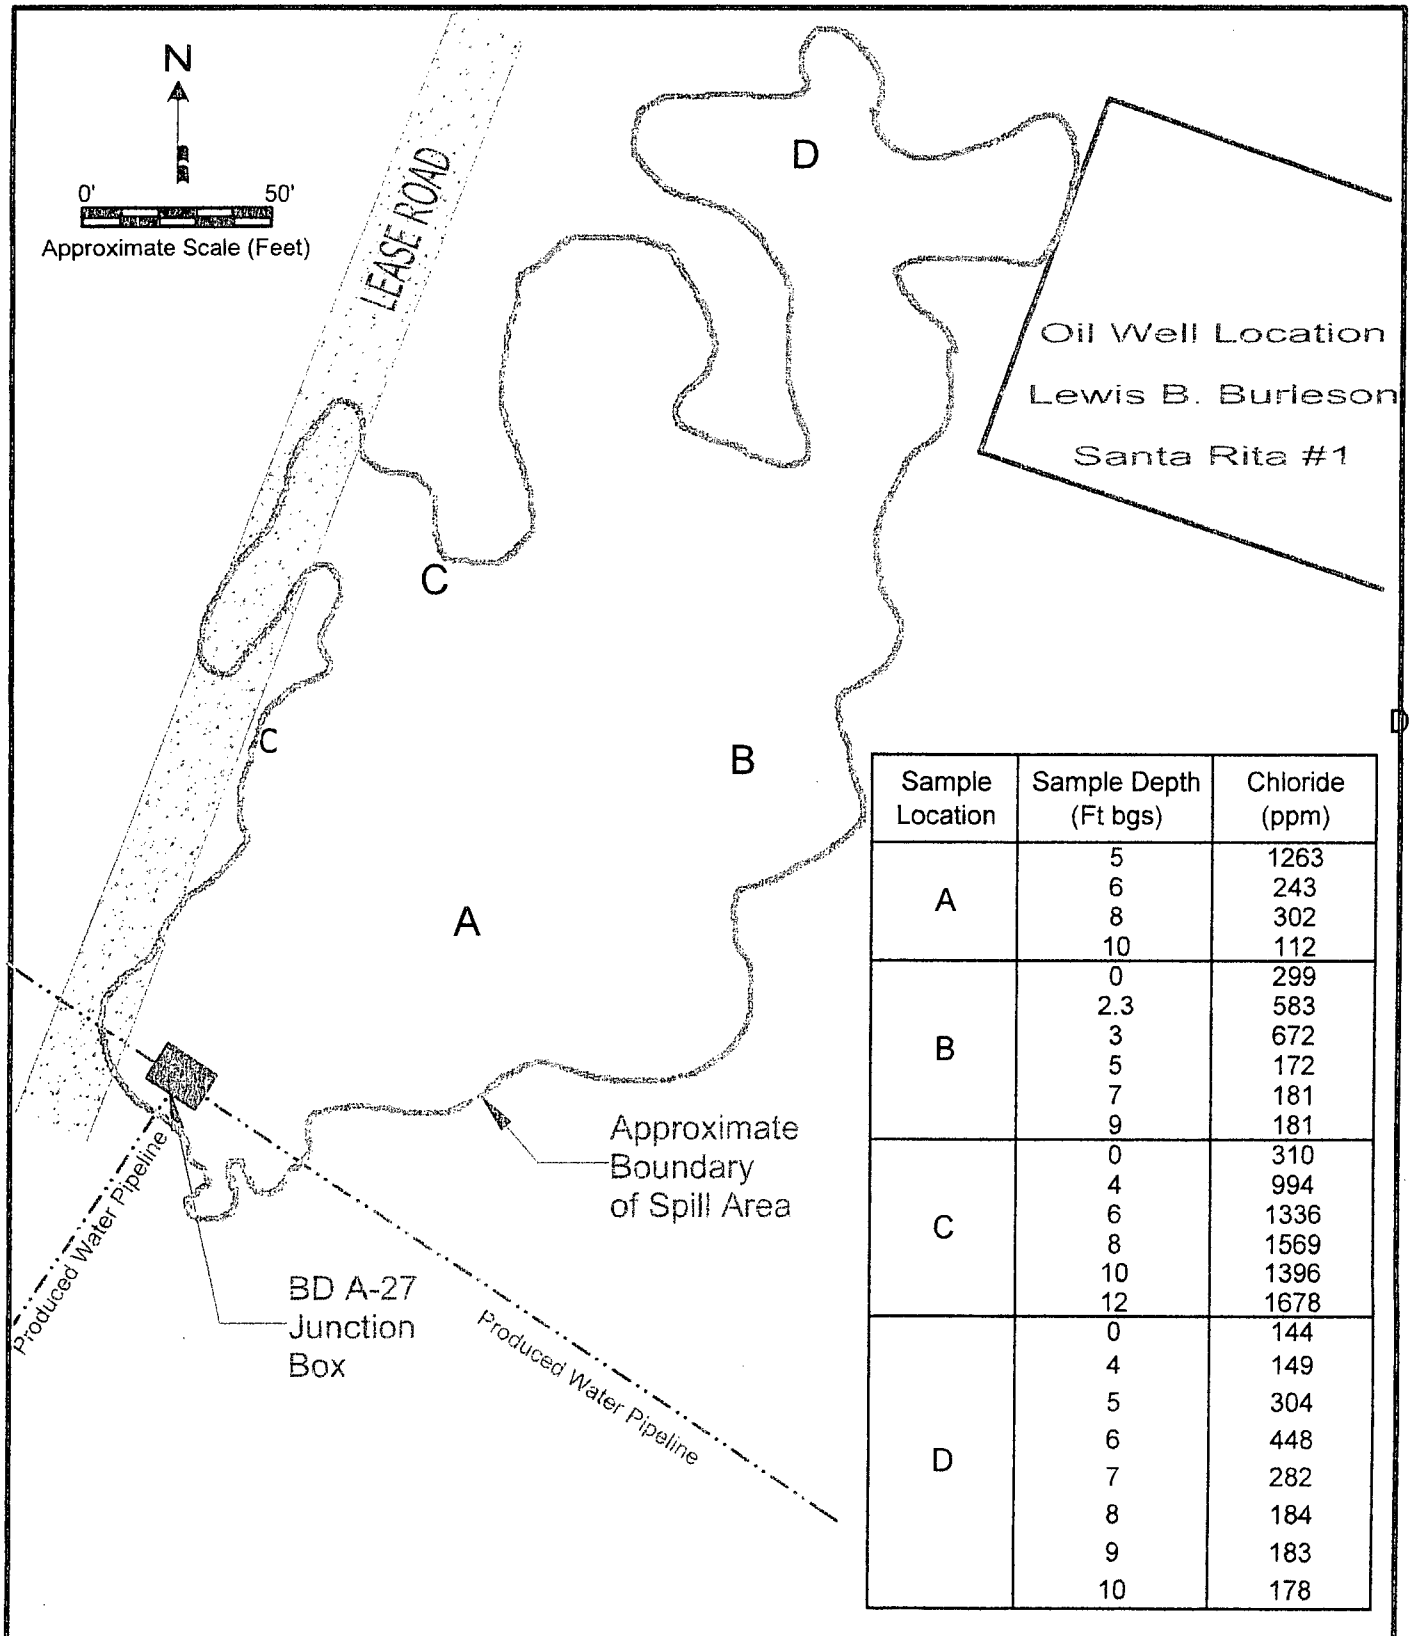
FIGURE 2
PRELIMINARY
SOIL SAMPLE
RESULTS

Results from previous investigations, as reported in the ICP, are depicted in Figures 2 through 5. On August 30-31, 2005, soil samples were collected using an air-rotary drilling rig for further delineation in accordance with the NMOCD-approved ICP. The soil sample locations, as shown on Figure 6, were chosen based on where the highest chloride concentrations were observed from previous investigations and in the lower-lying areas where pooling was evident. The samples were field-tested for chloride content using the titration method in accordance with procedures explained in QP-03 (ICP Appendices).

Sample Location	Sample Depth (Ft bgs)	Chloride (ppm)
A	5	1263
	6	243
	8	302
	10	112
B	0	299
	2.3	583
	3	672
	5	172
	7	181
	9	181
C	0	310
	4	994
	6	1336
	8	1569
	10	1396
	12	1678
D	0	144
	4	149
	5	304
	6	448
	7	282
	8	184
	9	183
	10	178

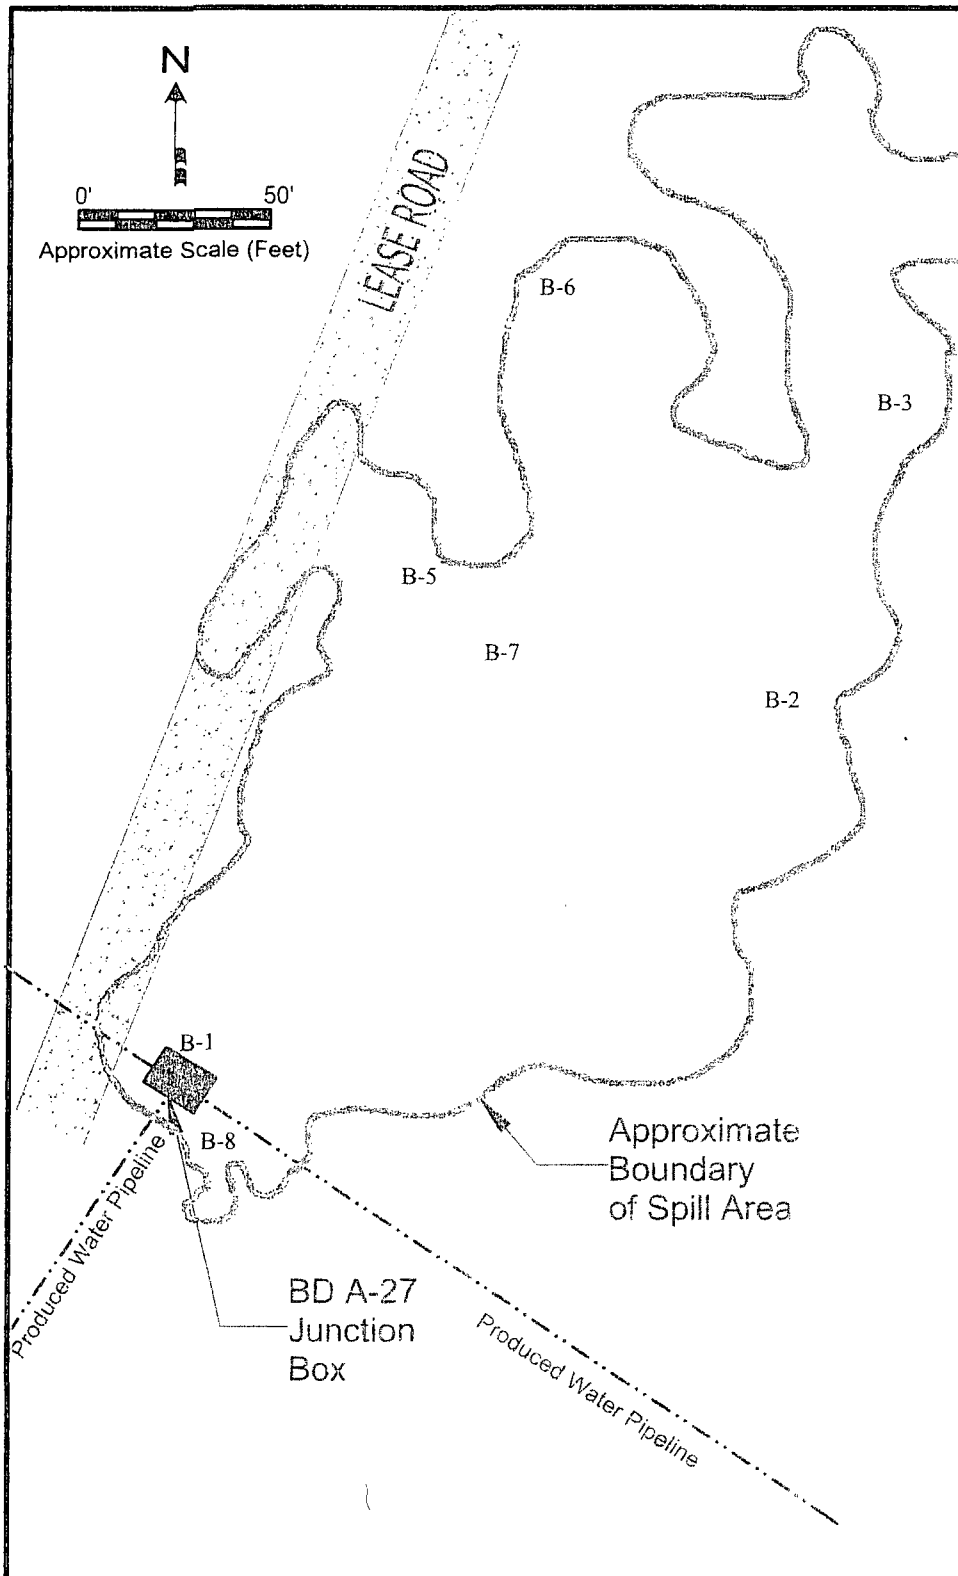
FIGURE 6
Soil Boring
Chloride Concentration
Map

The results of the soil sampling are summarized in Figure 6. In four borings (B-3, B-4, B-6, and B-8) chloride concentrations in soil were less than 250 mg/kg. Eleven of 41 samples showed chloride concentrations in excess of 250 mg/kg with the maximum field chloride concentration of 906 mg/kg (1490 mg/kg laboratory) from B-5 at a depth of 10-12 feet below ground surface (bgs). The deepest samples showing chloride concentrations greater than 250 mg/kg were obtained at 20 feet from B-1 (344 mg/kg) and B-7 (659 mg/kg). The higher chloride concentrations shown in Figure 6 appear to correspond to the higher gravimetric moisture contents, which is not surprising. The highest gravimetric moisture content of 18.4% occurs in B-7 at 15-17 feet bgs, a soft caliche and fine-grained sand interval. At 30 feet bgs in this same boring, gravimetric moisture declines to 4.8% in a sample of similar lithology.

Sample Location	Sample Depth (Ft bgs)	Chloride (ppm)	Moisture (percent)
B-1	0-2	120	---
	5-7	846 (796)	15.3
	10-12	637	---
	15-17	246	---
	20	344	---
	25-27	230 (178)	8.3
B-2	0-2	179	---
	5-10	175	---
	10-15	259	---
	15-20	239	---
	20-25	142	---
	25-27	230	---
B-3	0-2	218	---
	5-10	121	---
	10-15	93	---
	15-20	168	---
B-4	0-2	224	---
	5-7	219	---
	10-12	198	---
	15-17	79	---
B-5	0-2	208	---
	5-7	814	---
	10-12	906 (1490)	13.6
	15-17	441	---
	20	146	---
	25-27	4.6 (14.7)	3.8
B-6	0-2	102	---
	5-7	80	---
	10-12	123	---
	15-17	115	---
B-7	0-2	151	---
	5-7	759	---
	10-12	591	---
	15-17	864 (1200)	18.4
	20	659	---
	25-27	69	---
	30-32	110 (18.9)	4.8
B-8	0-2	209	---
	5-7	201	---
	10-12	116	---
	15-17	93	---

Values in parentheses indicate lab determined chloride concentrations.

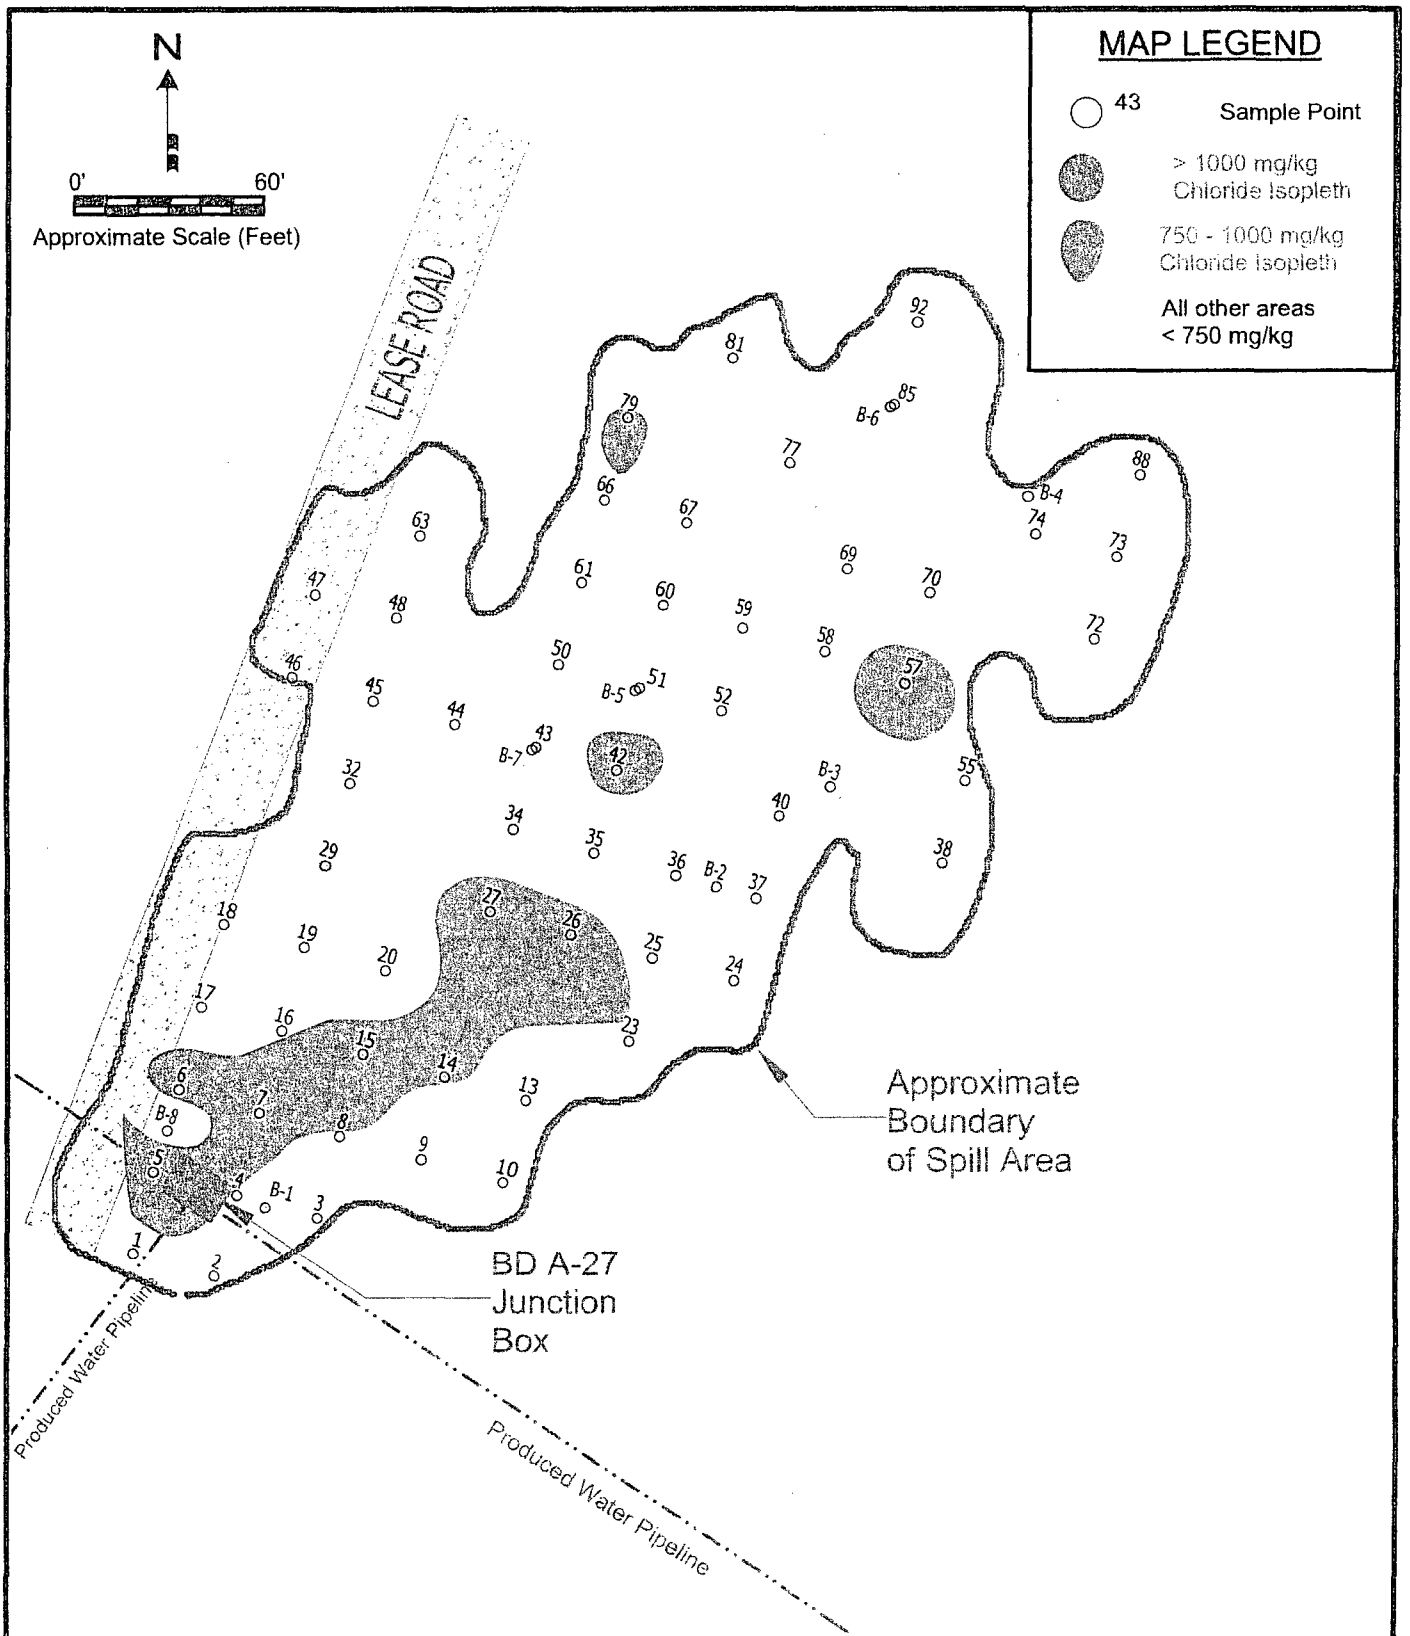
R. T. HICKS CONSULTANTS, LTD. P. O. Box 7624, Midland, Texas 79708	Site: BD A-27 Release Site Date: August 31, 2005 Author: G. Van Deventer Approximate Scale: 1 inch = 60 feet	FIGURE 7 Average Chloride Concentrations in 5-foot Root Zone

Chloride concentrations within the topsoil are very low throughout the area of the release and therefore conducive to natural restoration of the vegetation. In figure 7, areas of the site that have average chloride concentrations within the root zone (0 to 5 feet below ground surface) that are above 750 ppm and 1000 ppm are depicted. We will monitor the site and, as required, conduct efforts to encourage natural re-vegetation of the site. ROC will request closure for this site after the spill area is re-vegetated to approximately 70% of the ground cover observed in adjacent areas not affected by the release. We anticipate that the closure request will be made during or after next year's growing season (August 2007).

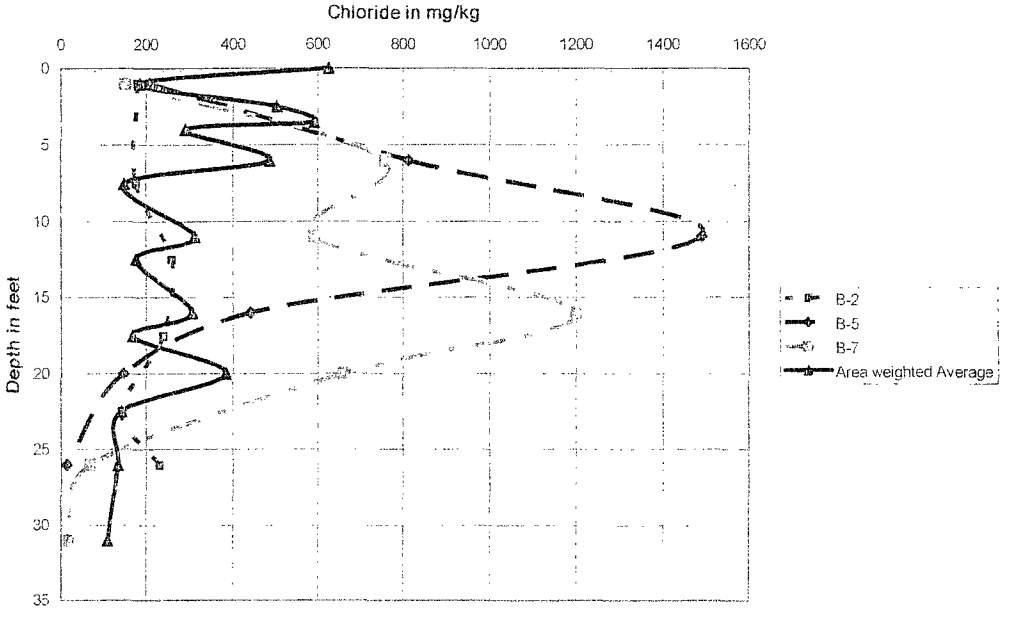
Figure 1
Field Chloride Profiles with Depth, A-27 Site

Initial Chloride Profile – Field chloride concentrations were obtained at multiple depths from the 8 borings drilled to depths up to 32 feet bgs and the 60 trenches dug to depths up to 4 feet bgs at the A-27 release site. This data was averaged with area weighting to calculate a representative chloride concentration profile for the site (Figure 1). Plotted with the area weighted chloride profile used for the HYDRUS modeling are the chloride profiles from B-5 and B-7 featuring the highest chloride masses. Also included is the chloride profile from B-2 ,which we consider typical of 5 of the 8 boreholes. From the field data, the chloride mass at the site is between 0 and 25 feet bgs. The area-weighted average was installed in the HYDRUS-1D model.

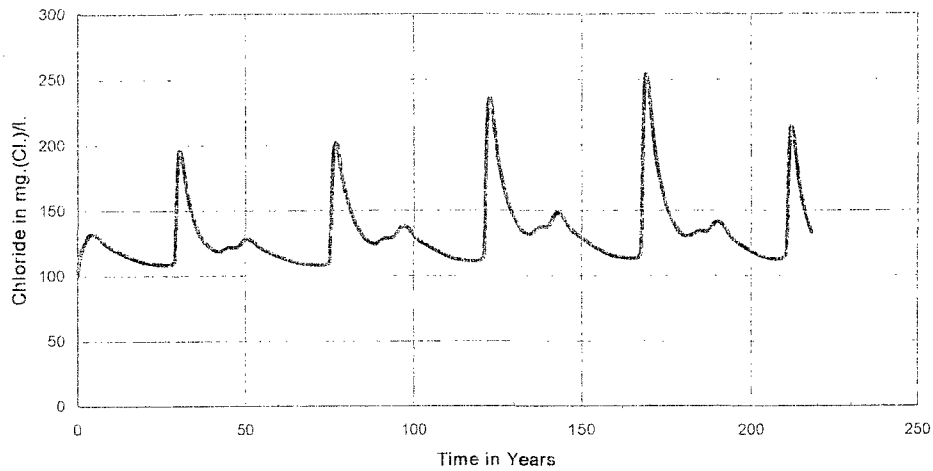
Figure 2
Chloride Concentration in the 10 foot Thick Aquifer at the A-27 Release Site, no Vegetation

With no vegetation allowed at the site, Figure 2 shows chloride concentration in a 10-foot thick aquifer immediately down gradient of the release site. Peak chloride concentration in the aquifer is 251 mg/L approximately 169 years from now. Of note is that inspection of the HYDRUS-1D output files reveals that peak chloride concentration entering ground water from the vadose zone occurs between years 154 and 167 years from now, earlier than peak chloride concentration in ground water. The peak chloride concentration in ground water is a result of a high vadose zone flux to the aquifer produced by earlier intense rainfall events. Four earlier peak chloride concentrations are results of the repeated weather data.

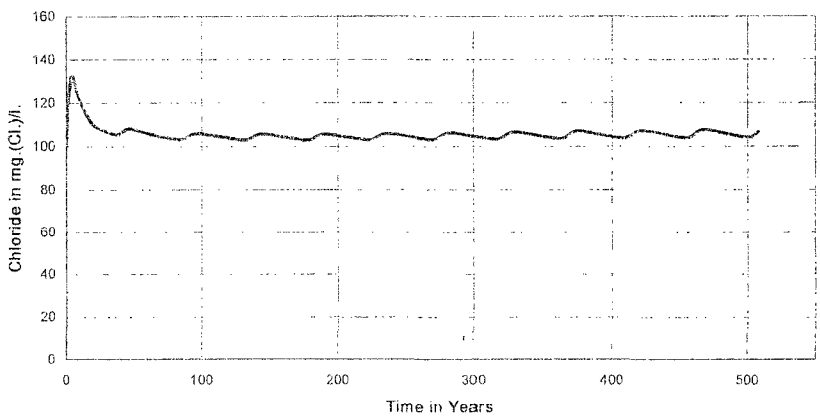
Figure 3
Chloride Concentration in the 10 Foot Thick Aquifer at the A-27 Release Site with Vegetation

With vegetation allowed to root in the upper 3 feet of the vadose zone, recharge to ground water is reduced due to evapotranspiration. The resultant chloride concentration in a 10-foot thick aquifer immediately down gradient of the release site is shown in Figure 3. Initially, the model predicts an increase in ground water chloride concentration. This is due to drainage "wet" initial condition established by the 138-year simulation described earlier. After about 20 years, the moisture and the attendant chloride in the lower vadose zone have drained and the vegetation establishes a new "steady state" with a material lower recharge rate. In the simulation, transpiration from vegetation reduces recharge, the soil profile becomes drier with resultant decreases in hydraulic conductivity and solute flux to ground water.

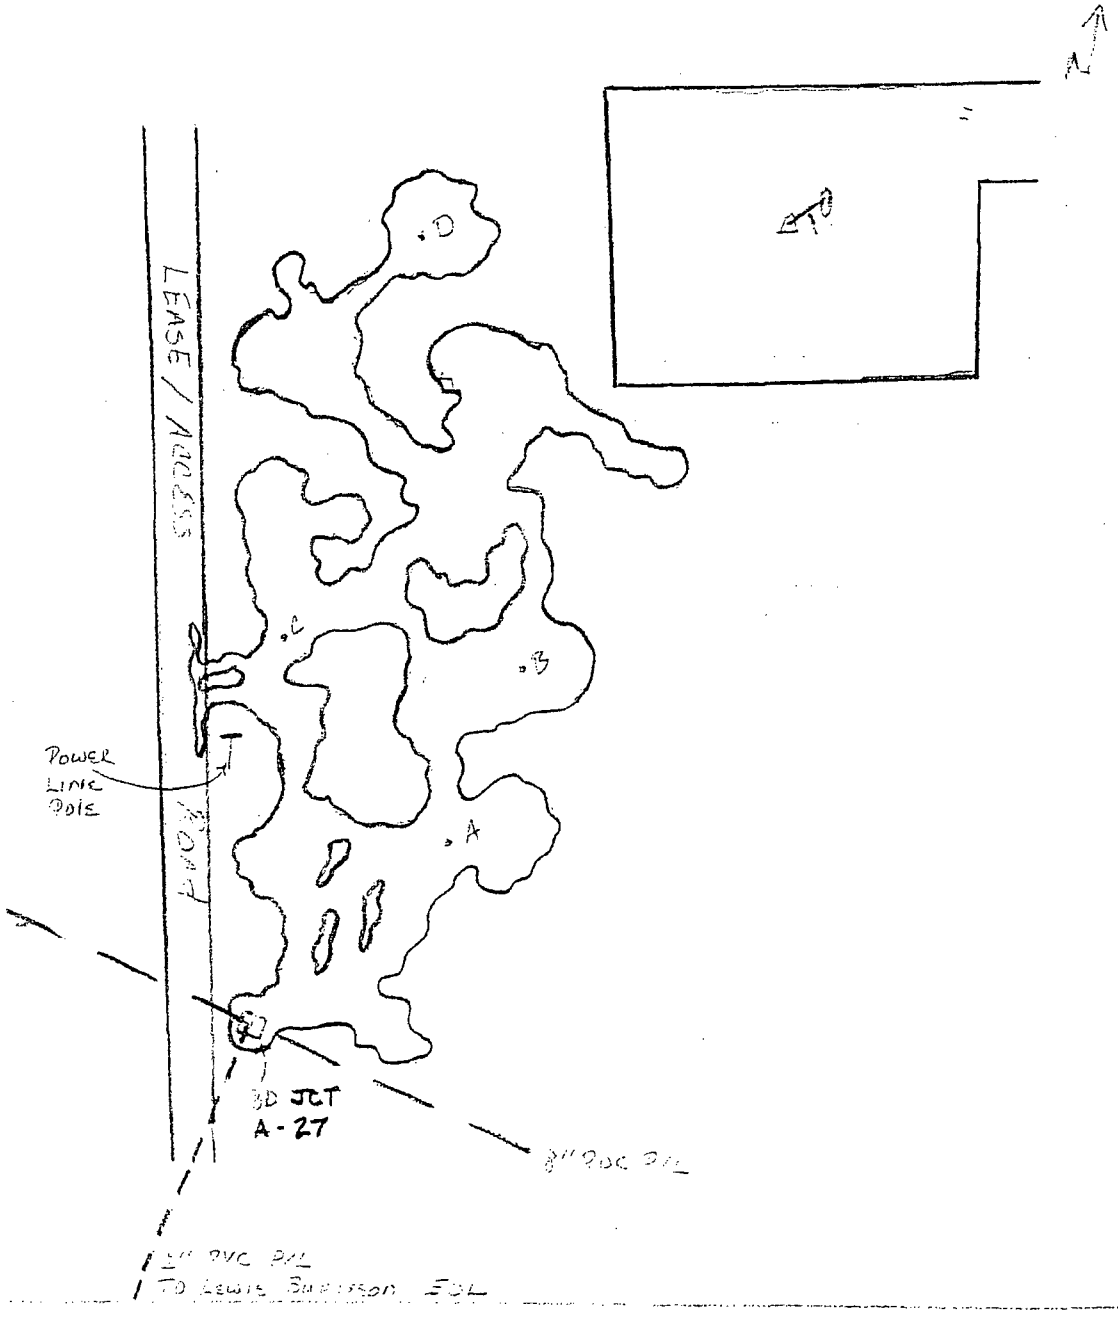
CAUSE OF LEAK

Discribe cause of problem & how it was repaired. Operator Running Heater treater @ to High temp, swelled PVC & Pushed Couplers out, old PVC Removed & Replaced w/ Sch 40 PVC Pipe & Coupler
