Reference: Poker Lake Unit #276 30-015-35137
G-13-24S-29E Eddy County, New Mexico
2RP-178

Re: Remediation Work Plan
BEPCO, L.P.
Poker Lake Unit #276
Section 13, T-24-S, R-29-E
Eddy County, New Mexico

IDENTIFICATION OF CHLORIDE-IMPACTED SOILS

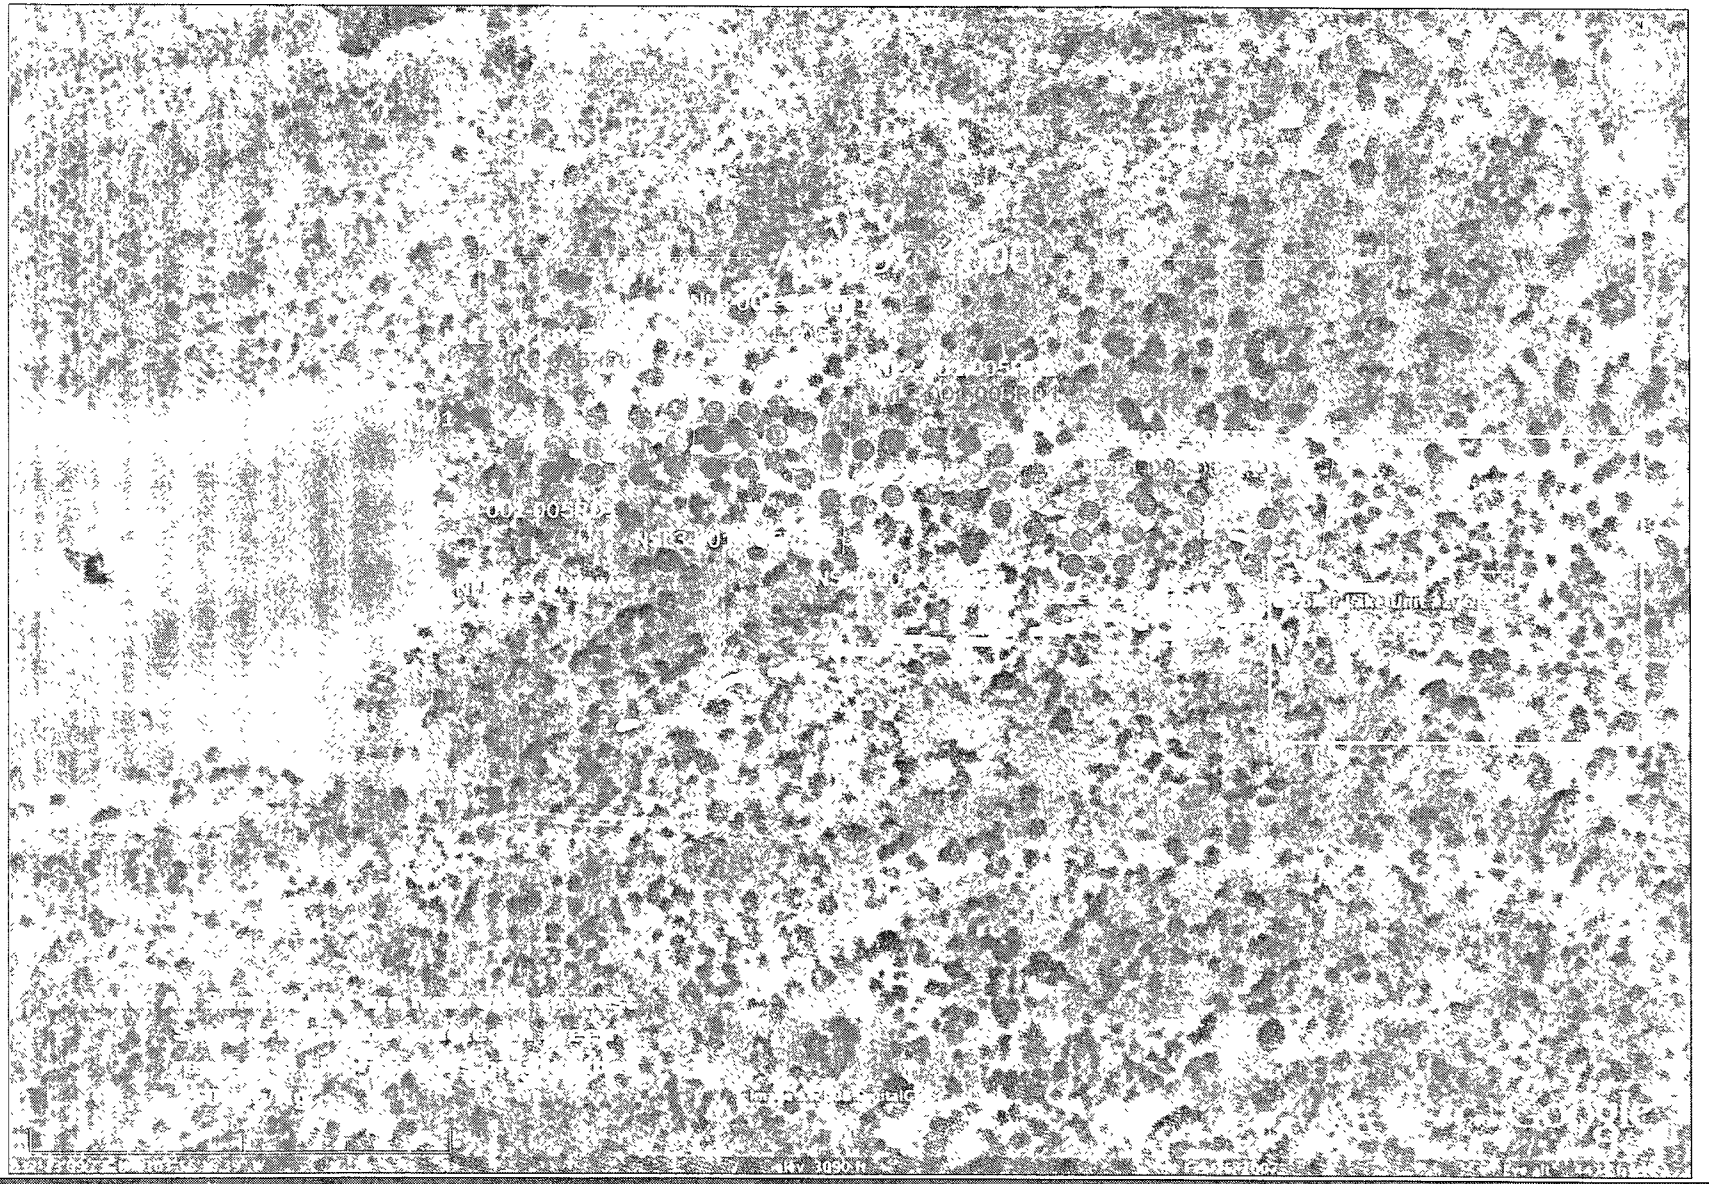
North Line

As evidenced by the analytical results previously submitted and duplicated on the attached Sample Data Summary, the contaminant of concern is chlorides. Chloride contaminated soils exceeding 250 mg/kg will be excavated from the ground until a representative sample from the walls and bottom of the excavation proves to be below this level. The chloride impacted soils will be removed and hauled to Controlled Recovery, Inc. (Permit No. R-9166). Further delineation and confirmation sampling will be conducted. Upon receipt of analytical verification of acceptable chloride concentration, a Final Report C-141 will be submitted.
