ANNUAL MONITORING REPORT

Re: BP America Production Company
Groundwater Monitoring Report
GCU # 170, Unit K, Sec. 35, T29N, R12W, NMPM
San Juan County, New Mexico

GROUNDWATER REMEDIATION REPORT

GCU #170
(K) SECTION 35, T29N, R12W, NMPM
SAN JUAN COUNTY, NEW MEXICO

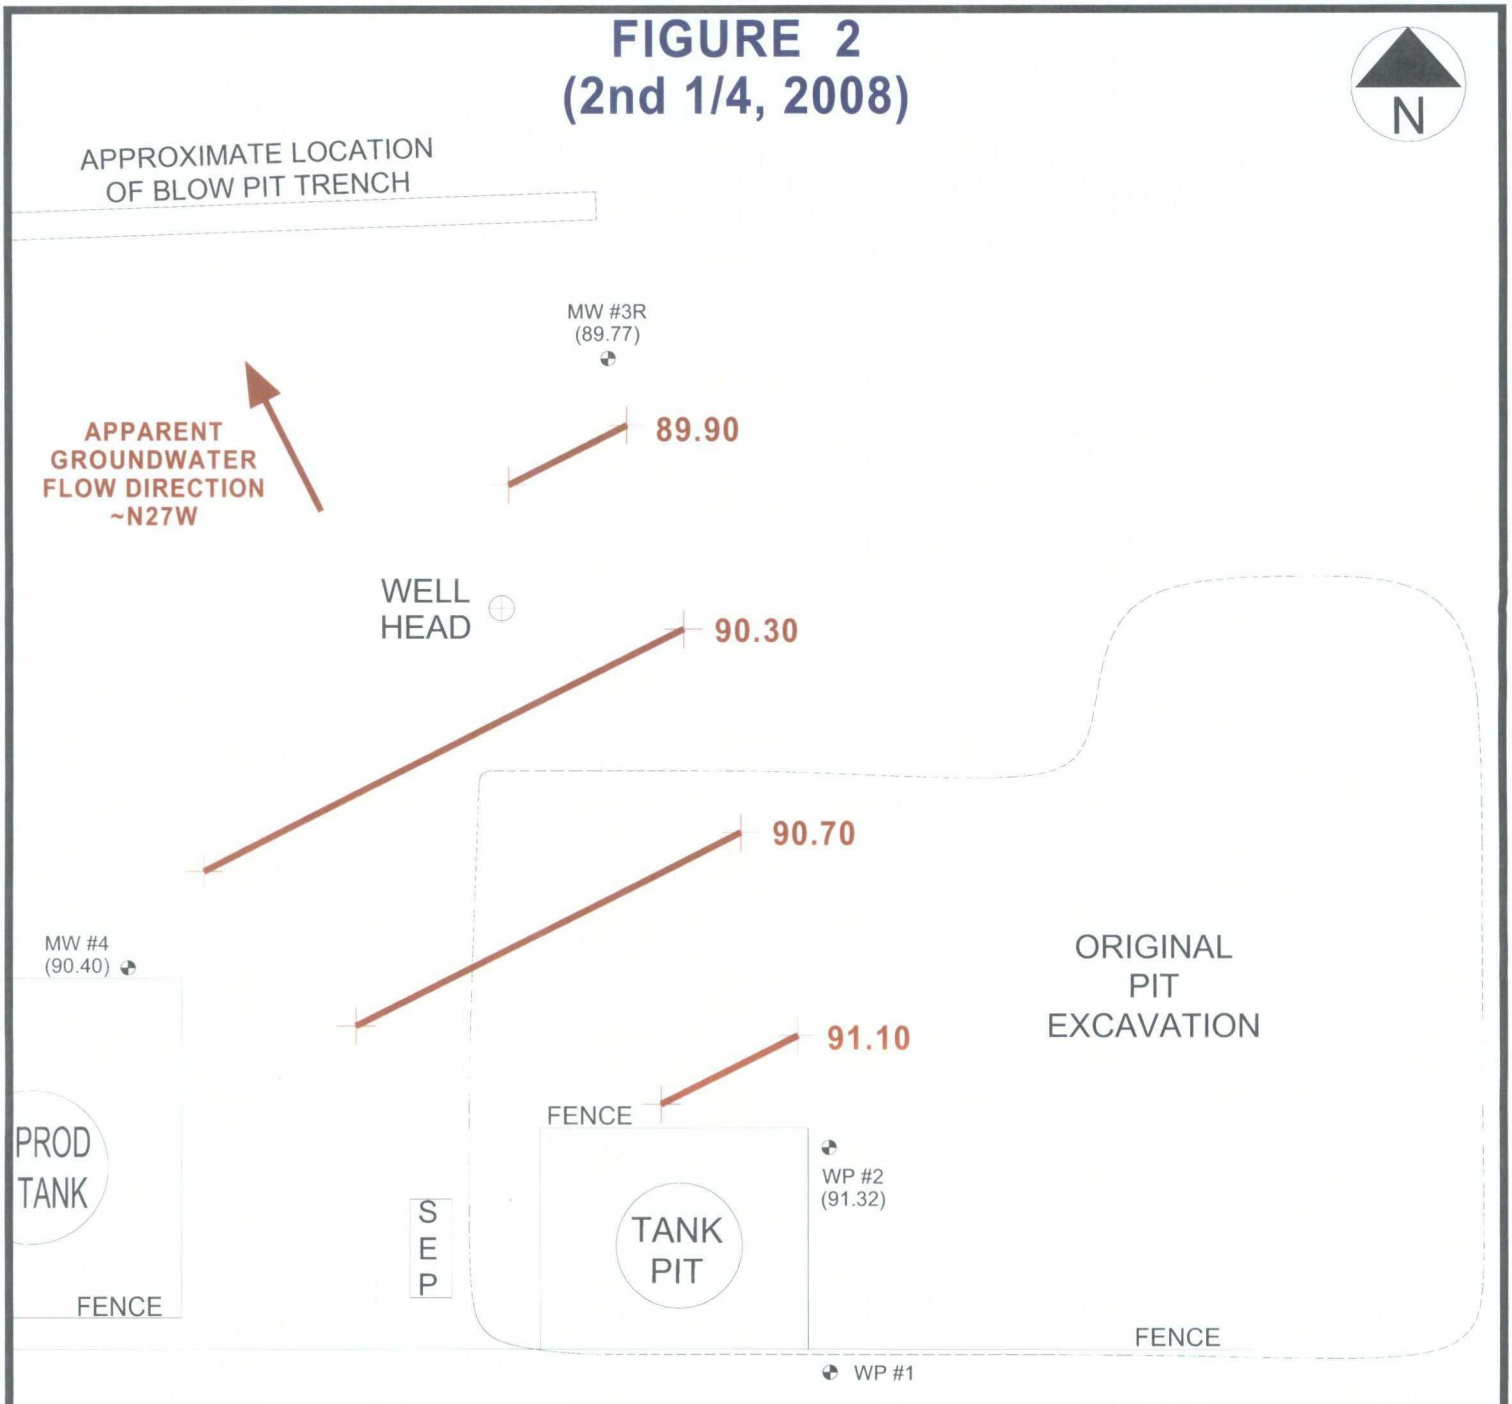
FIGURE 2
(2nd 1/4, 2008)

Groundwater has consistently been measured with a gradient towards the northwest direction (Figures 2 and 3).

Top of Well Elevation
WP #2	(100.80)
MW #3R	(99.59)
MW #4	(101.14)
MW #4 (90.40)	Groundwater Elevation as of 6/9/08.

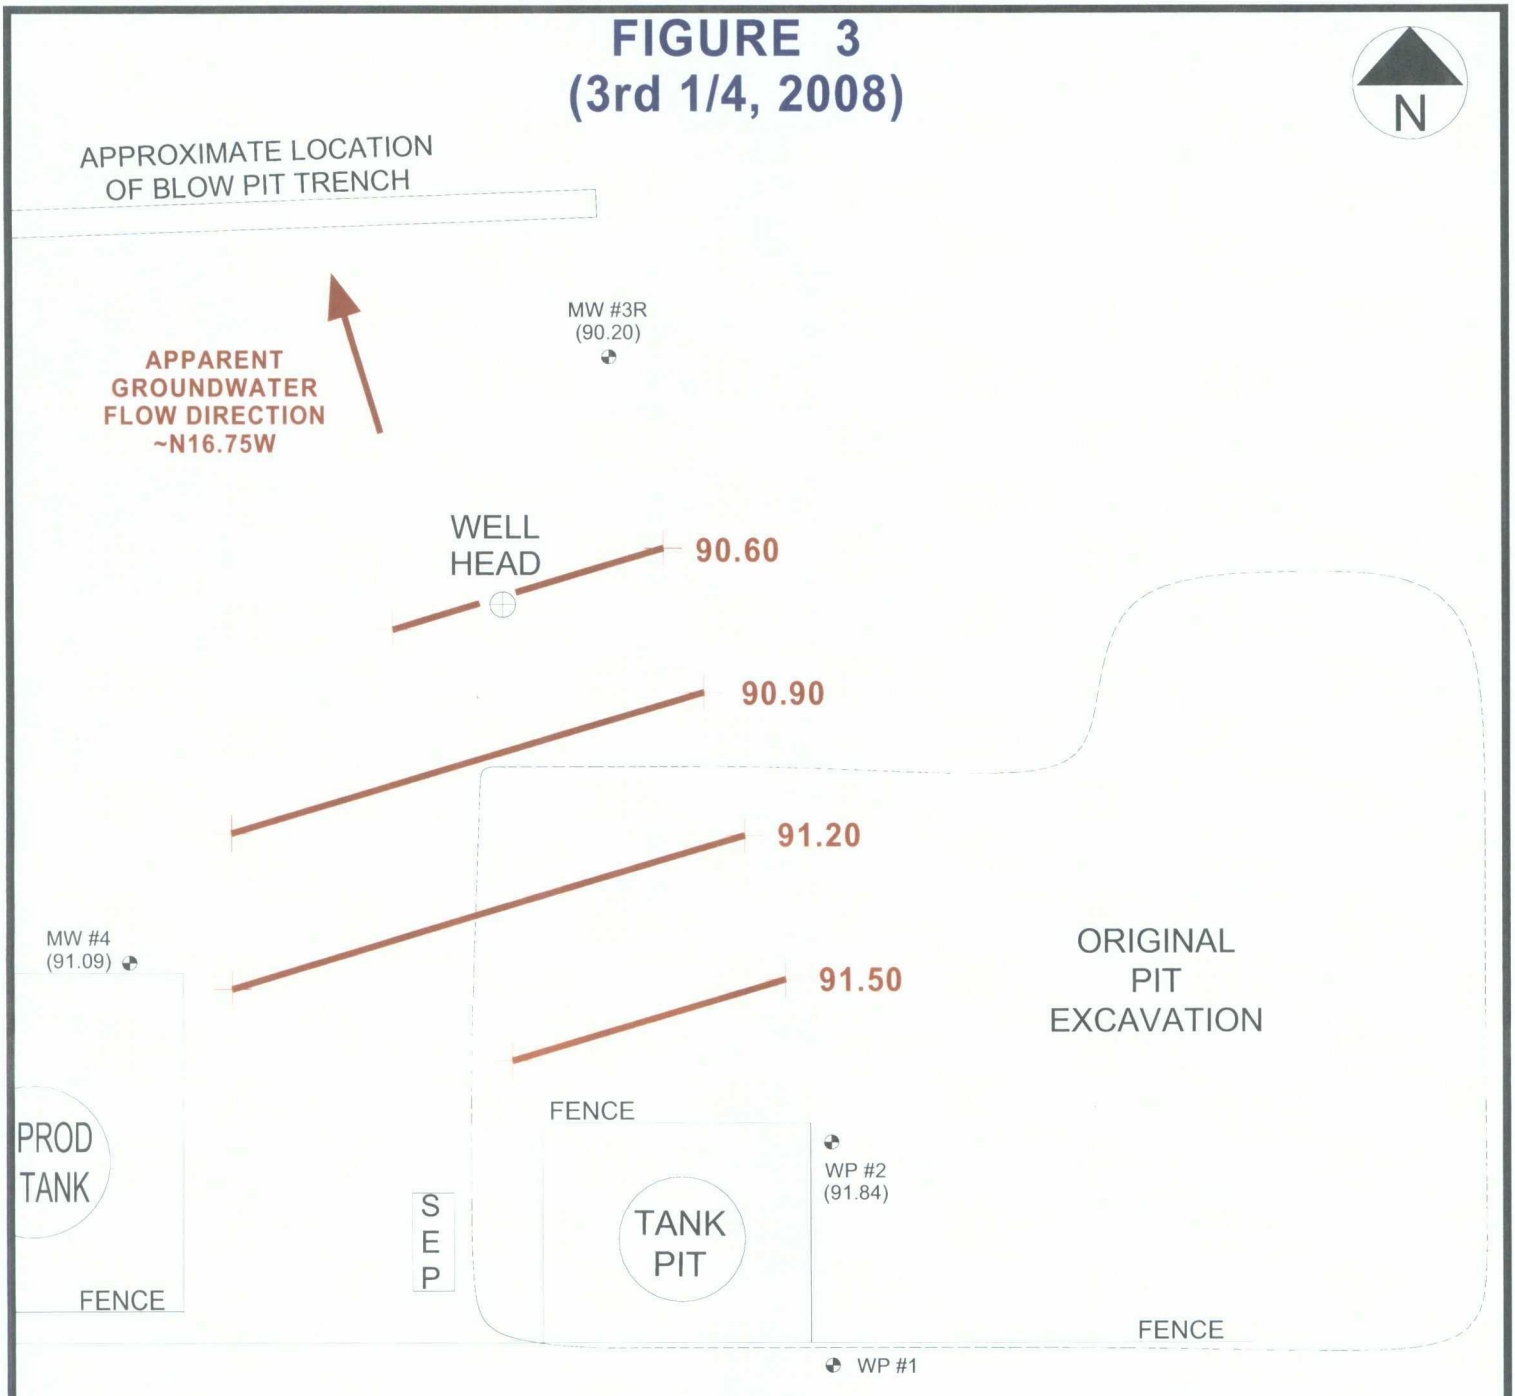
FIGURE 3
(3rd 1/4, 2008)

Top of Well Elevation
WP #2	(100.80)
MW #3R	(99.59)
MW #4	(101.14)
MW #4 (91.09)	Groundwater Elevation as of 8/27/08.
