WORKPLANS

October 5th, 2009

RE: **Investigation and Characterization Plan**
Rice Operating Company – BD SWD System
BD O-23-1 Vent UL O, Sect 23, Township 21S, Range 37E

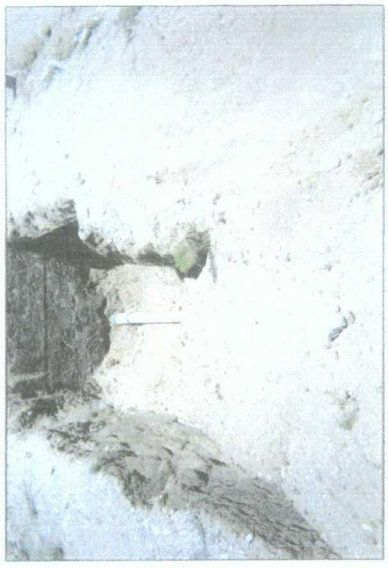
BD O-23-1 vent

After plumbing; box removed 7/16/2003

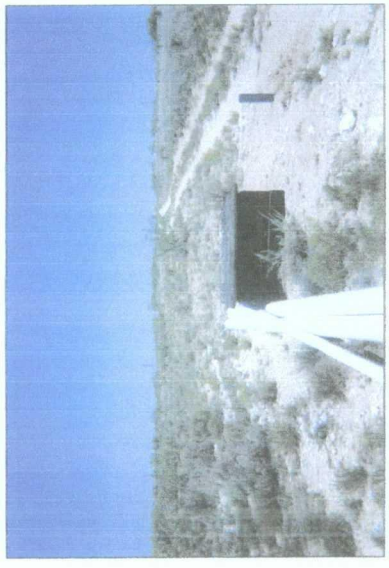
Before Excavation 7/14/2003

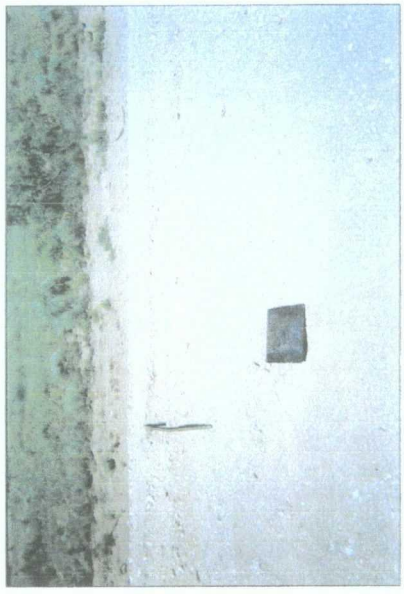
Backfilled with identification plate 5/11/2004
