WORKPLANS

October 5, 2009

RE: **Investigation and Characterization Plan**
Rice Operating Company – Vacuum SWD System
Vacuum L-34 Vent UL L, Sect 34, Township 17S, Range 35E

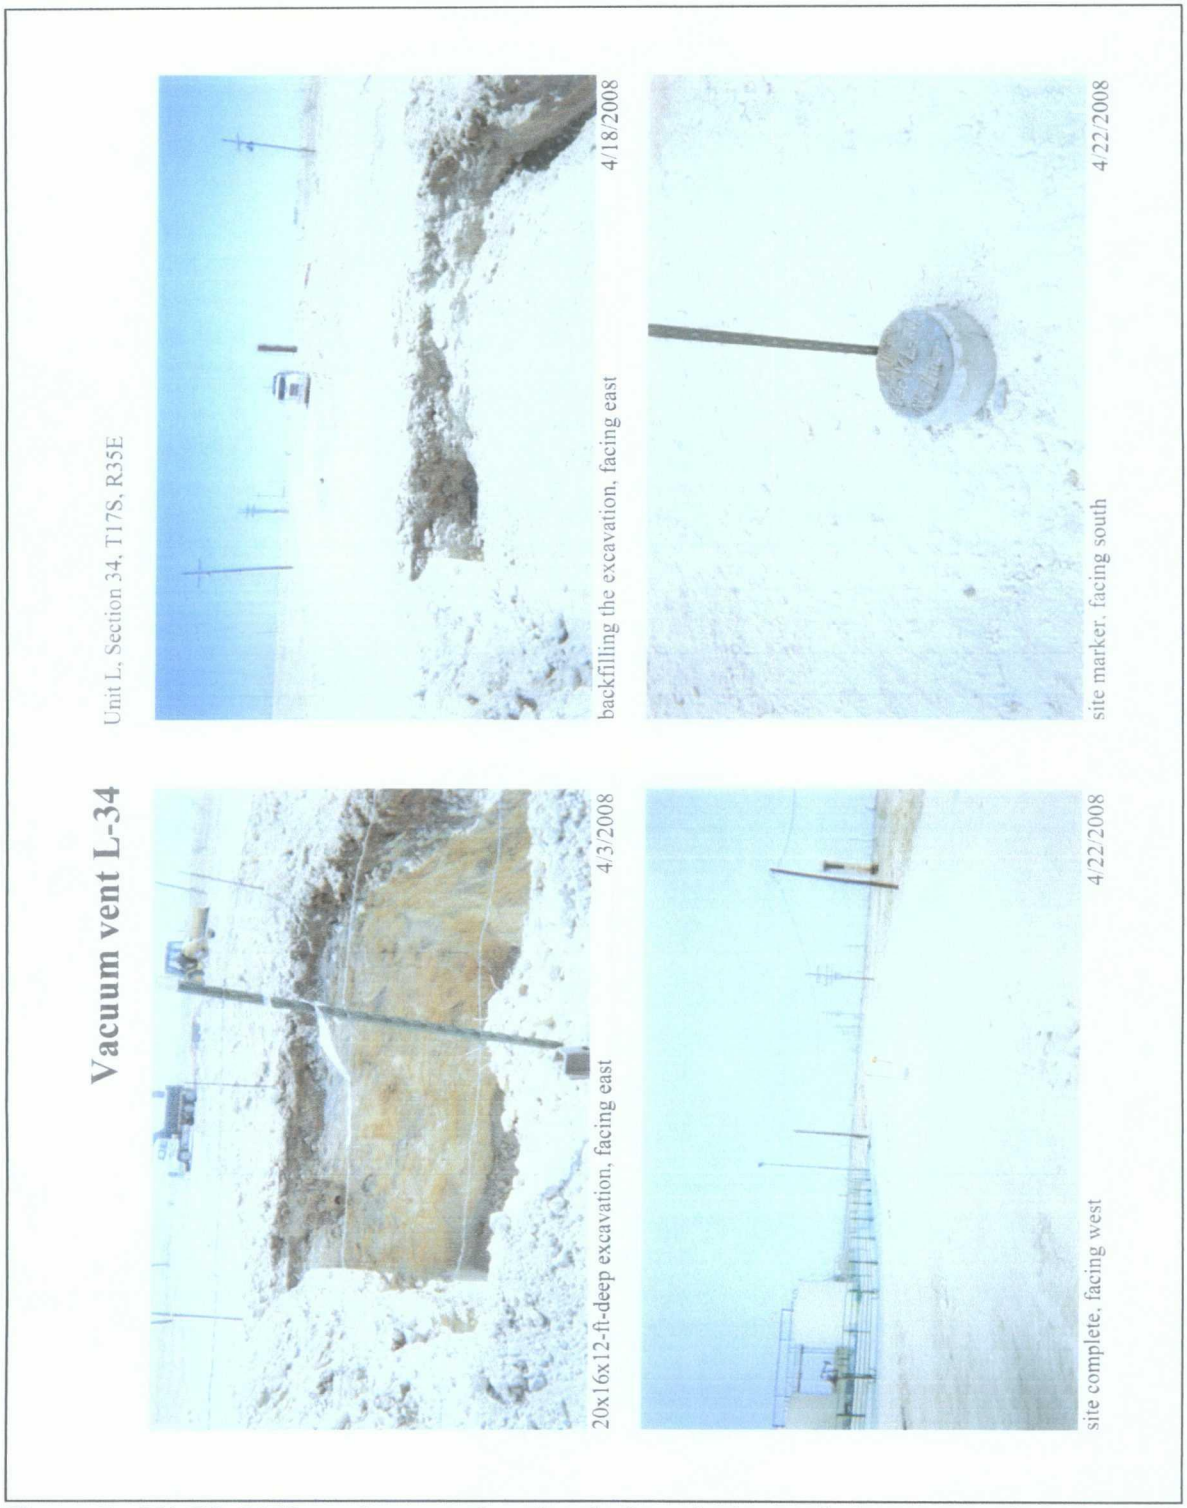
The excavated soil was blended on site, backfilled into the excavation and then contoured to the surrounding terrain (Figure 3). An identification plate was placed on the surface to mark this location for future environmental considerations.

Figure 3 – VAC L-34 Vent photographs taken before, during and after junction box removal.
