CQA / CQC REPORT

New Evaporation Pond

Date: _July 2009__

NMOCD PERMIT No. NM-01-0019
EVAPORATION POND AS BUILT

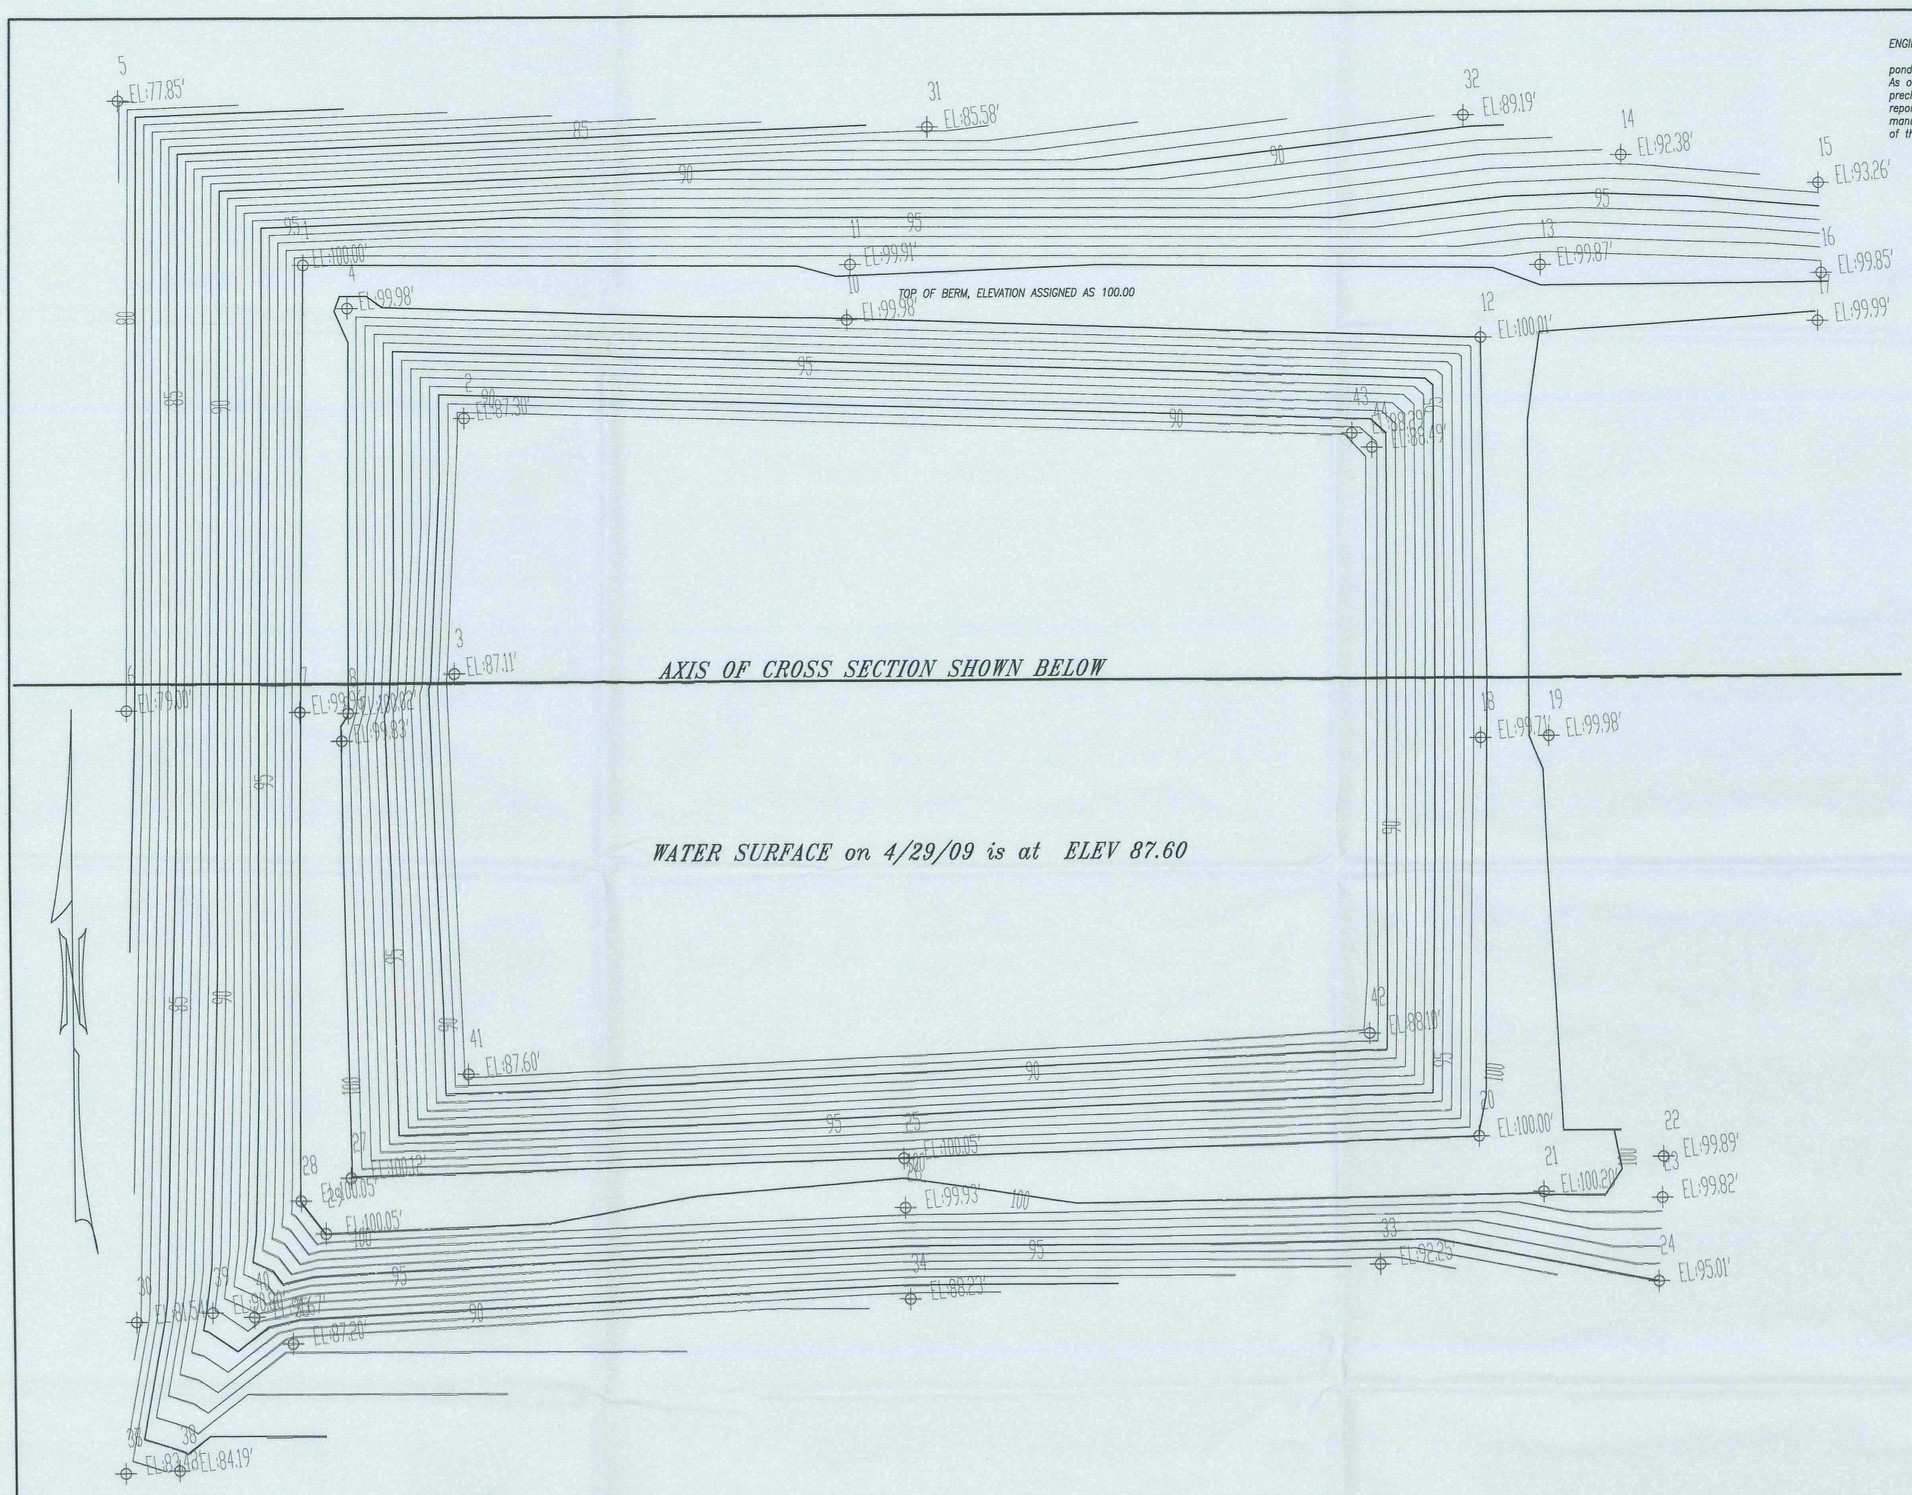
PLAN VIEW OF NEW EVAPORATION/IMPOUND POND SCALE 1"=30' CONTOUR INTERVAL 1 FT

Presented hereon is the result of a survey to define the as built configuration of an evaporation pond constructed in the NW/4 of Section 9, T11S, R31E, NMPM, Chaves Co. NM, under Peermit NM-01-0020. As of the date of Survey, there was water in the bottom of the pond which had been introduced to preclude wind from lifting the liner system. We were unable to establish a bottom of the pond for this report. The pond is lined on the inside of the berm, We are unable to affirm or refute the liner thickness, manufacturer, or any of the seaming details or testing without destructive testing, which is beyond the scope of this engagement. Soil engineering data and compaction testing results were not made available to us..

maximum water elevation at spill point 100.00
maximum wind generated wave height
from 90mph wind ..... 0.44 ft
100 yr/60day precipitation event
generates a change in pond depth of ...1.55 ft

Maximum allowable water level is 98.00

Surface area of 98 ft contour is ...125038 sqft
Surface area of 88 ft contour is ....81847 sqft
Volume capacity between 88 abd 98 ft countours is 23.57 acre feet
