RE: **INVESTIGATION & CHARACTERIZATION PLAN (ICP)**
Rice Operating Company – Vacuum SWD System
Vacuum Jct N-28-1: UL/N, Sec. 28, T17S, R35E (formerly Vacuum Jct K-28-1)
NMOCD Case Number: 1R425-87

RICE OPERATING COMPANY
JUNCTION BOX DISCLOSURE* REPORT

Vacuum Jct. K-28-1

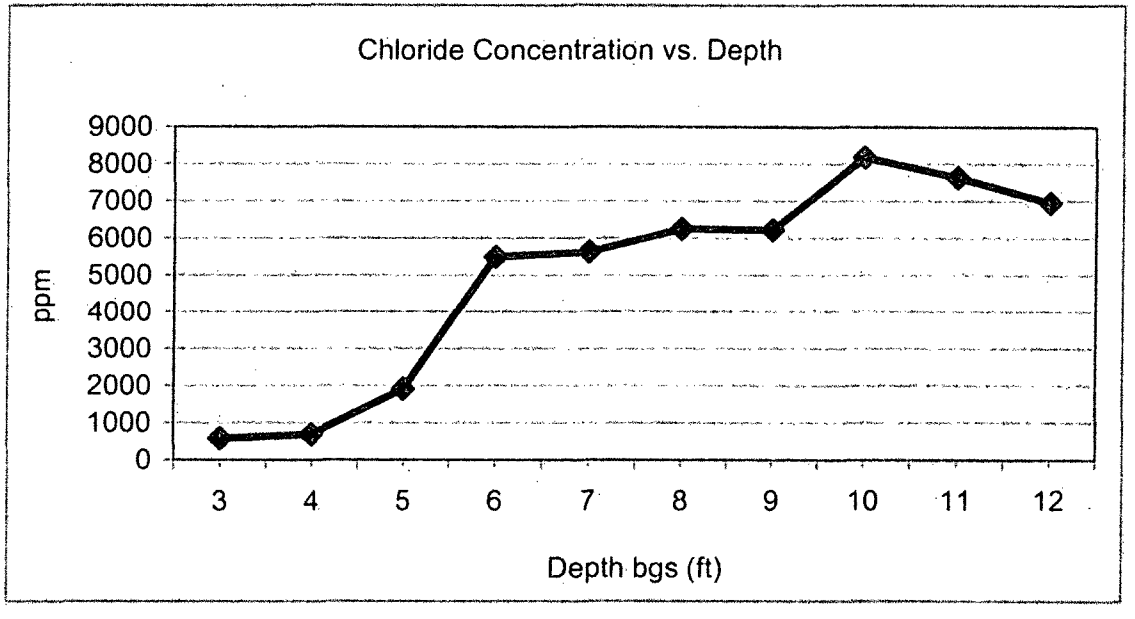
CHLORIDE CONCENTRATION CURVE

Soil Boring samples at the junction (source)

Depth bgs (ft)	[Cl] ppm
3	581
4	688
5	1906
6	5498
7	5628
8	6249
9	6224
10	8182
11	7635
12	6958

Groundwater = 68 ft
