Re: BP America Production Company
Groundwater Monitoring Report
GCU # 107, Unit D, Sec. 19, T29N, R12W, NMPM
San Juan County, New Mexico

GROUNDWATER REMEDIATION REPORT

GCU # 107
(D) SECTION 19, T29N, R12W, NMPM
SAN JUAN COUNTY, NEW MEXICO

DECEMBER 2010

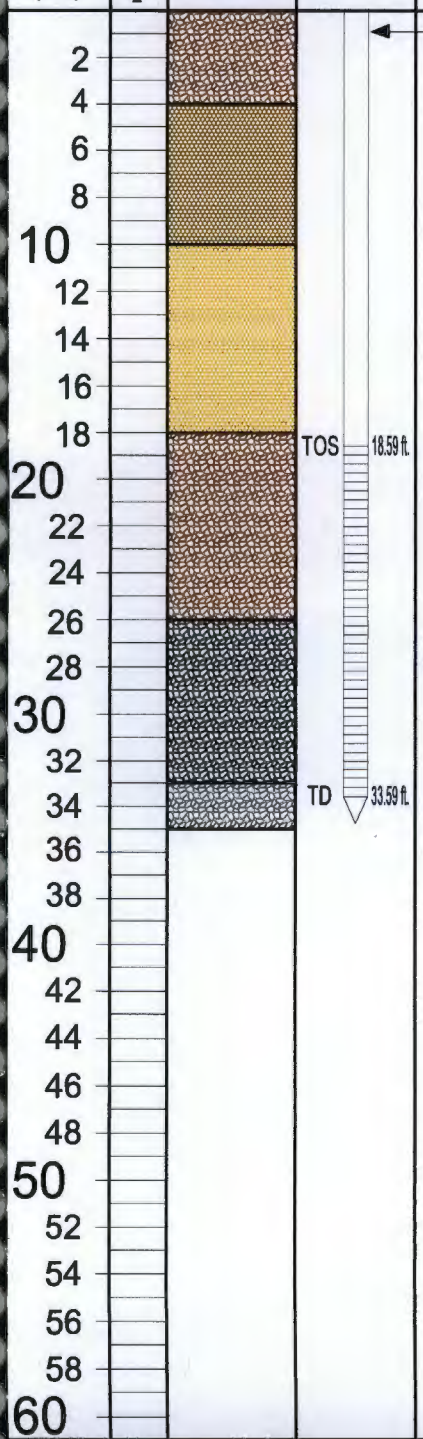
BORING #.....	BH - 3
MW #.....	2
PAGE #.....	3
DATE STARTED	10/28/09
DATE FINISHED	10/28/09
OPERATOR.....	KP
PREPARED BY	NJV

BLACK SAND & GRAVEL, NON COHESIVE, MOIST TO WET, FIRM, APPARENT HYDROCARBON ODOR DETECTED PHYSICALLY WITHIN CUTTINGS (26.0 - 33.0 FT. BELOW GRADE).

DARK GRAY SAND & GRAVEL, NON COHESIVE, MOIST TO WET, FIRM, NO TO SLIGHT APPARENT HYDROCARBON ODOR DETECTED PHYSICALLY WITHIN CUTTINGS (33.0 - 35.0 FT. BELOW GRADE).
