Release Notification 9PH1J-191008-C-1410

Site Name Muy Wayno Frac Pond	Site Type Water Transfer Header
Date Release Discovered 09/25/2019	API# *(if applicable)* 30-015-41037 (Poker Lake Unit #380H)

December 20, 2019

RE: Closure Request
Muy Wayno Frac Pond
Remediation Permit Number 2RP-5674
Eddy County, New Mexico

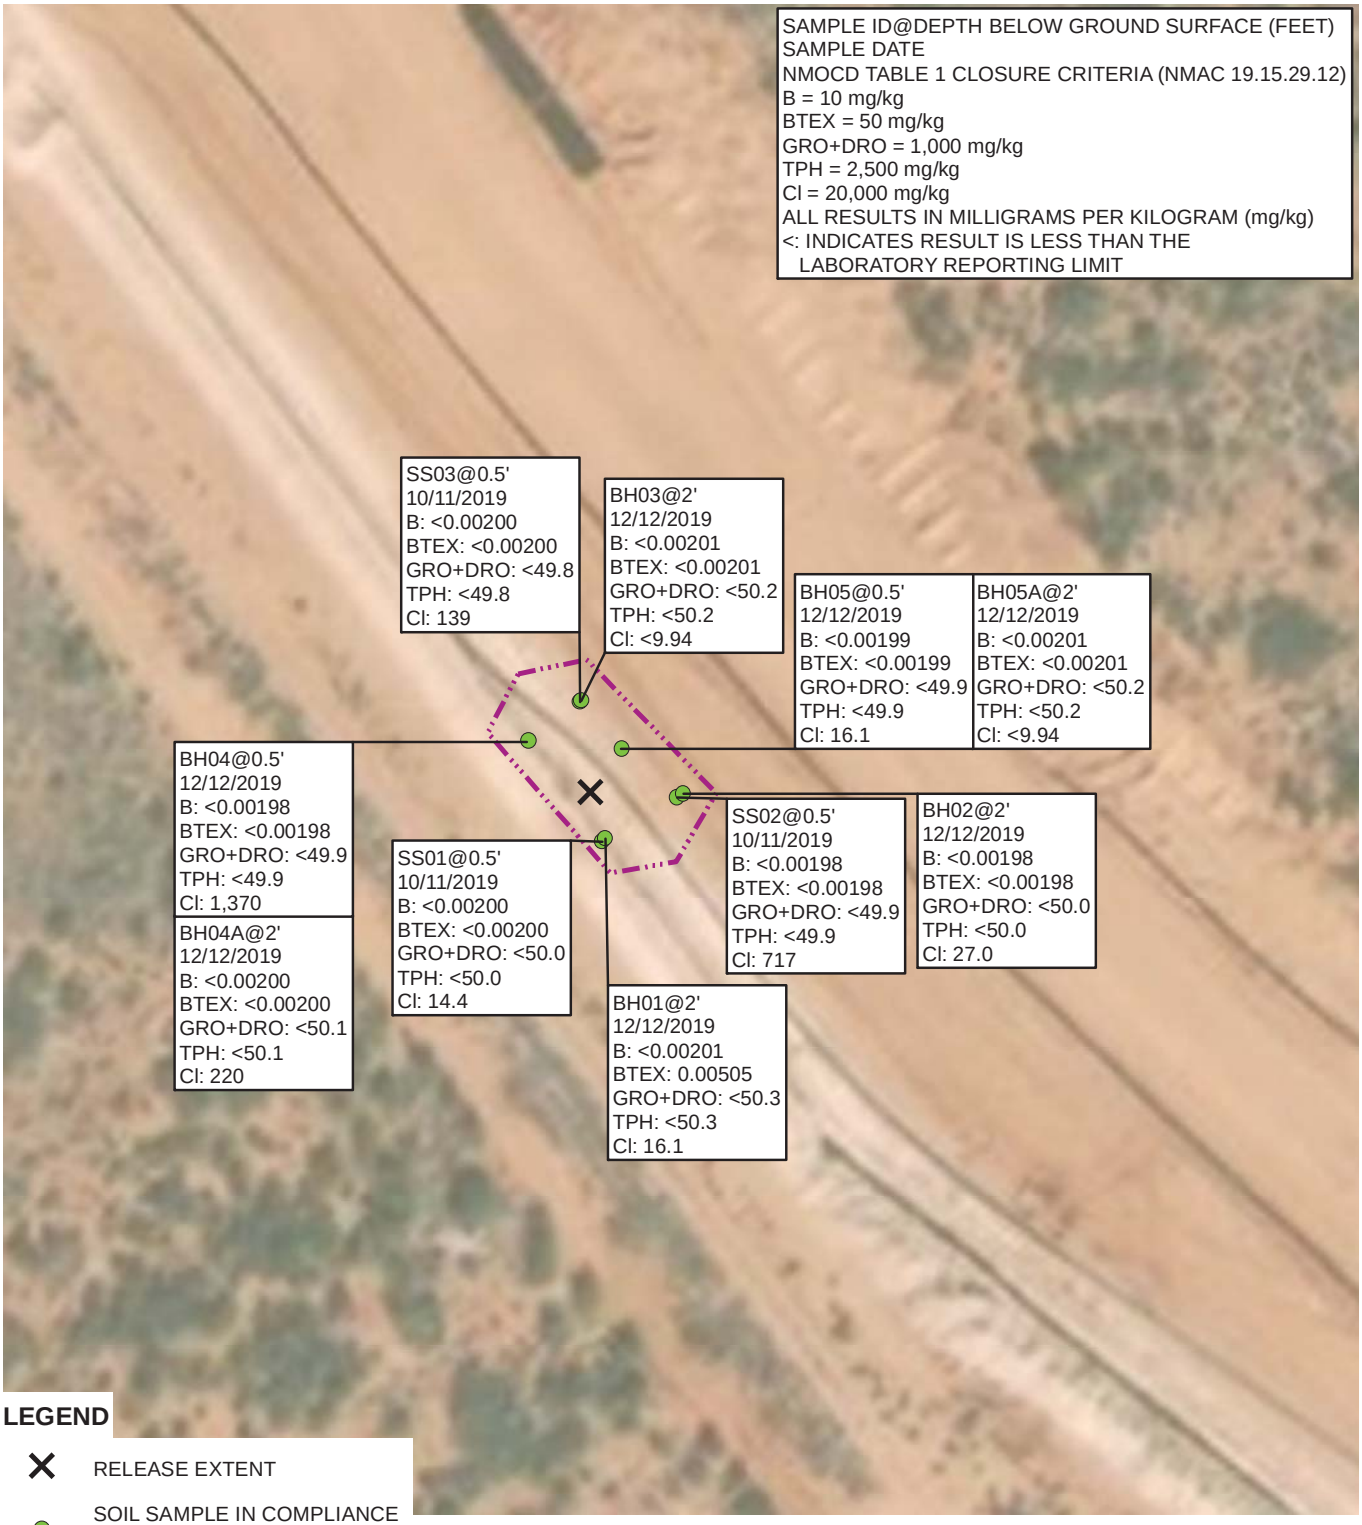
FIGURE 2
SOIL SAMPLE LOCATIONS
MUY WAYNO FRAC POND
UNIT H SEC 9 T25S R30E
EDDY COUNTY, NEW MEXICO
XTO ENERGY, INC.

On October 11, 2019, LTE personnel evaluated the release extent based on information provided on the Form C-141 and visual observations. LTE personnel collected three preliminary soil samples (SS01 through SS03) within the release extent from a depth of approximately 0.5 feet bgs to assess for the presence or absence of soil impacts at the ground surface. Soil was field screened for volatile aromatic hydrocarbons and chloride utilizing a calibrated photo-ionization detector (PID) and Hach® chloride QuanTab® test strips, respectively. The release extent and preliminary soil sample locations were mapped utilizing a handheld Global Positioning System (GPS) unit and are depicted on Figure 2.

Soil from the boreholes was field screened for volatile aromatic hydrocarbons and chloride utilizing a calibrated PID and Hach® chloride QuanTab® test strips, respectively. Field screening results and observations for each borehole were documented on a lithologic/soil sampling log and are included as Attachment 3. The delineation soil samples were collected, handled, and analyzed as described above at Xenco in Carlsbad, New Mexico. All boreholes were backfilled with the same soil removed. The borehole locations are depicted on Figure 2.

Preliminary soil samples SS01 through SS03 and delineation soil samples BH01, BH02, BH03, BH04/BH04A, and BH05/BH05A were collected within the release extent from depths ranging from 0.5 feet to two feet bgs to assess for the presence or absence of soil impacts as a result of the September 25, 2019, recycled water release. Laboratory analytical results for all soil samples indicated benzene, BTEX, TPH-GRO, TPH-DRO, TPH, and chloride concentrations were compliant with the Closure Criteria. Additionally, field screening of soil indicated volatile aromatic hydrocarbons and chloride concentrations were not elevated and soil staining and petroleum hydrocarbon odors were not identified within the release extent.

Based on initial response efforts, absence of elevated field screening results, and soil sample laboratory analytical results compliant with the Closure Criteria, no impacted soil was identified and no soil excavation was required as a result of the recycled water release. XTO requests NFA for RP Number 2RP-5674. An updated C-141 is included as Attachment 1.
