July 2, 2020

Re: Site Assessment Summary and Remediation Plan
Natural Gas Gathering Line #11117 Leak Location 1
GPS: Latitude 32.298043 Longitude -104.256508
UL "P", Sec. 14, T23S, R26E
Eddy County, NM
NMOCD Ref. No. NRM2016953070

Tasman Geosciences, Inc. (Tasman), on behalf of DCP Operating Company, LP (DCP), has prepared this Site Assessment Summary and Remediation Plan for the condensate and natural gas Release Site known as the Natural Gas Gathering Line #11117 Leak Location 1. Details of the release are summarized below:

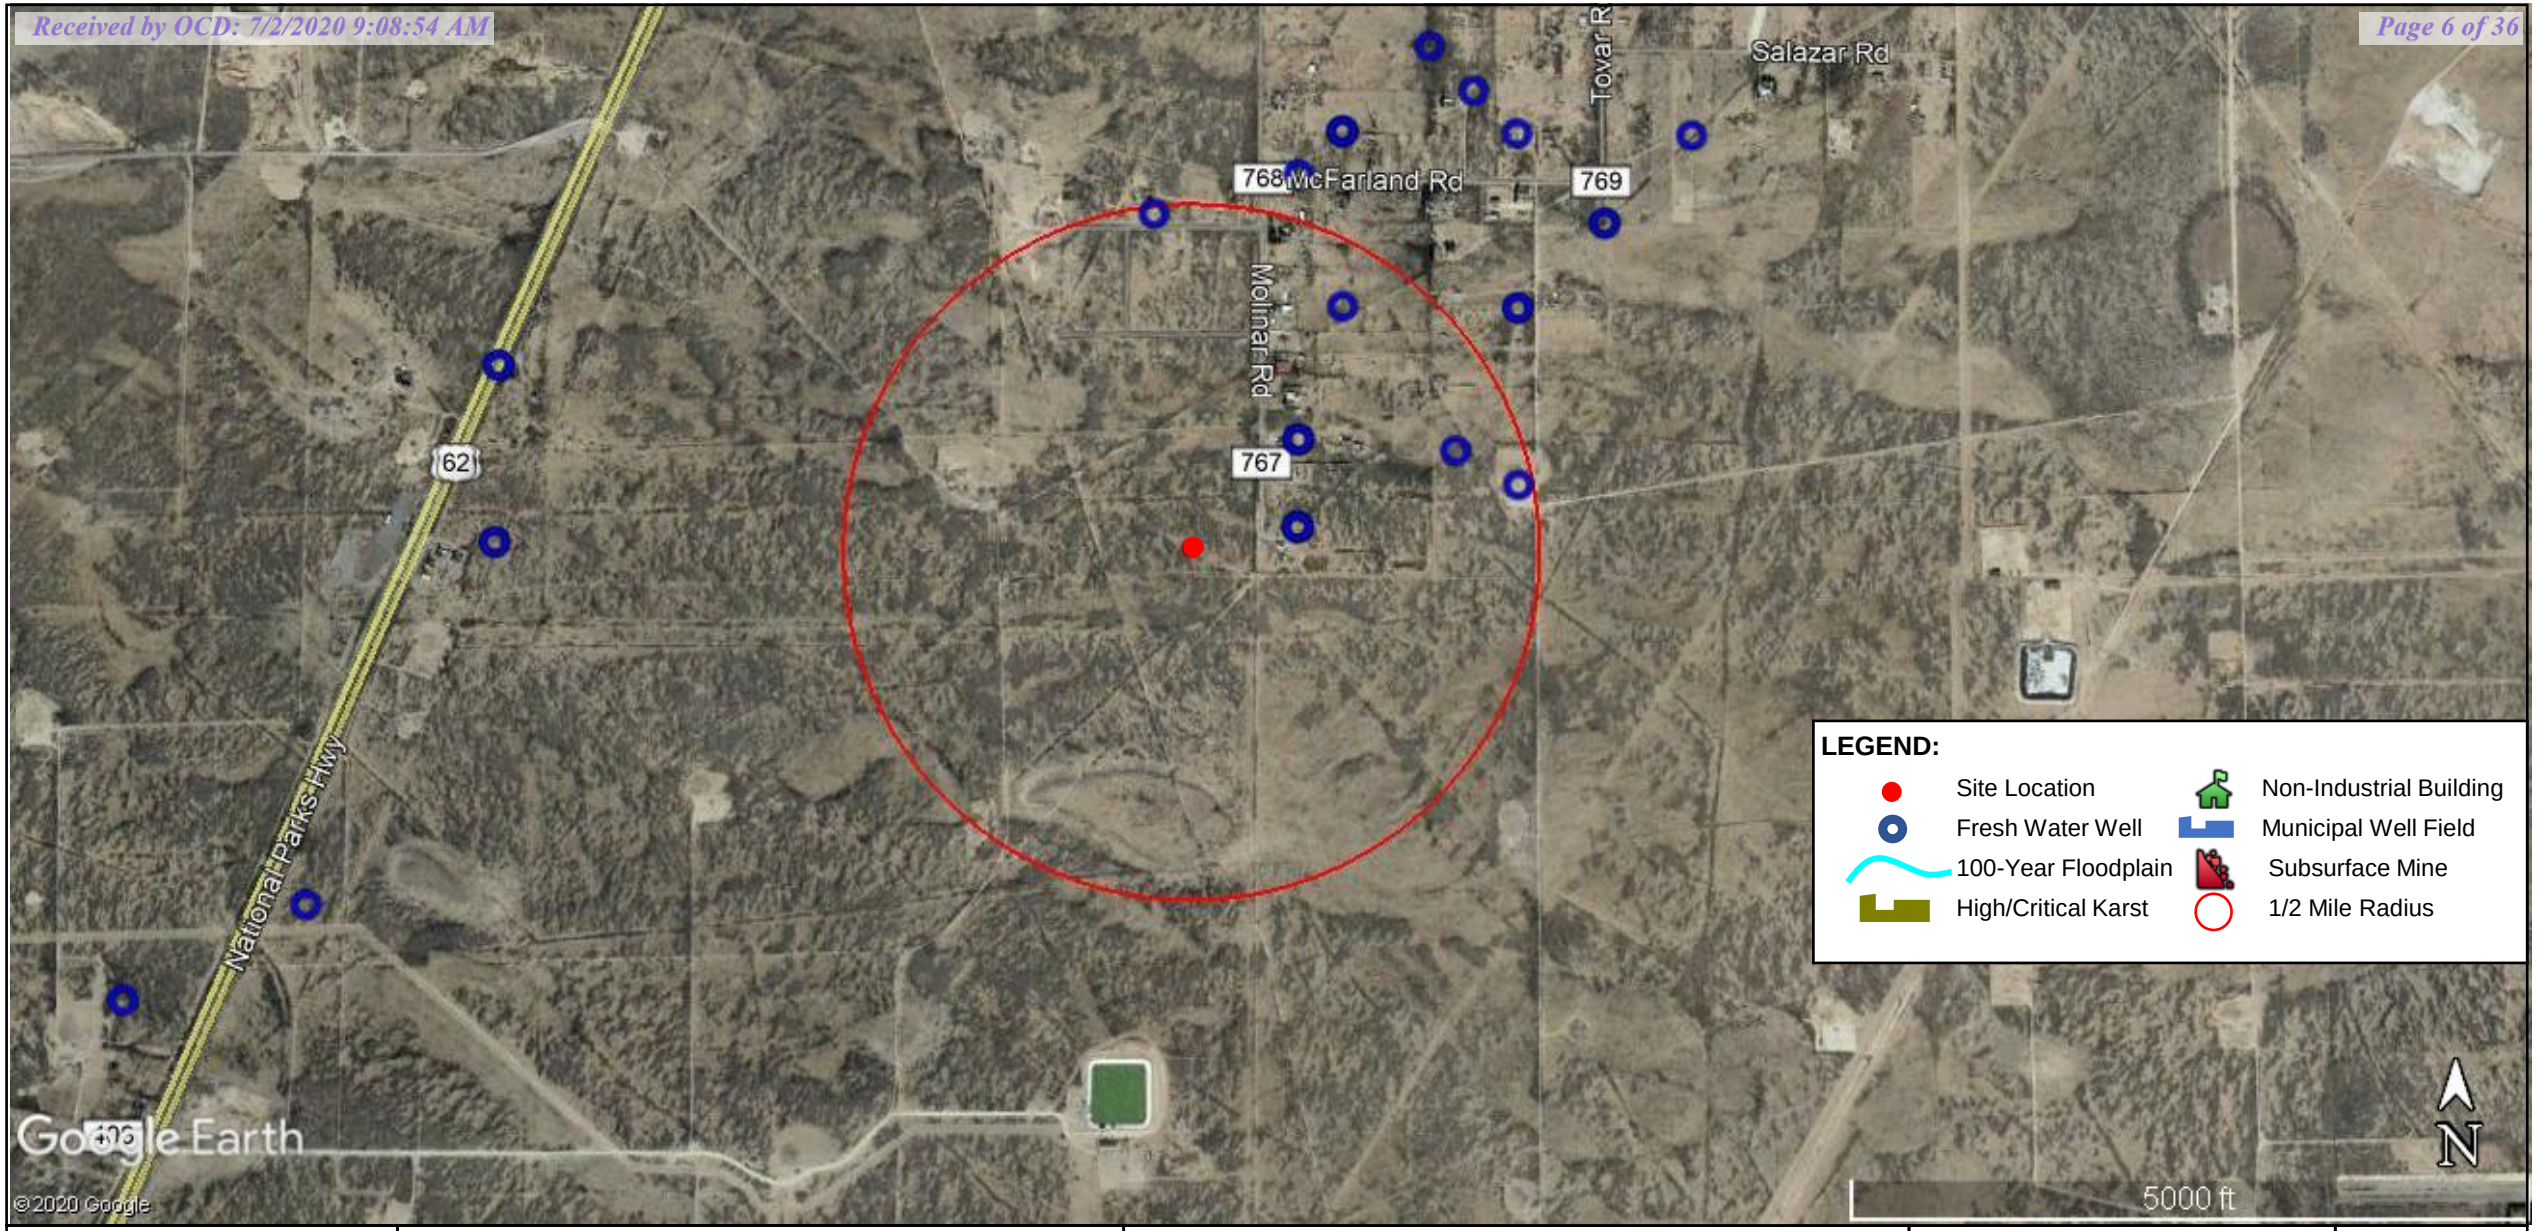
Site Characteristics Map is provided as Attachment #1. General Site Photographs are provided as Attachment #6. A Copy of the Initial Release Notification and Corrective Action (NMOCD Form C-141) is provided as Attachment #8.

Site Characteristics	
Approximate Depth to Groundwater	**~193 Ft.**
Within 300 ft. of any continuously flowing or significant watercourse?	☐ Yes ☑ No
Within 200 ft. of any lakebed, sinkhole, or playa lake?	☐ Yes ☑ No
Within 300 ft. of an occupied permanent residence, school, hospital, or institution?	☐ Yes ☑ No
Within 500 ft. of a spring or private, domestic fresh water well?	☐ Yes ☑ No
Within 1,000 ft. of any fresh water well?	☑ Yes ☐ No
Within the incorporated municipal boundaries or within a municipal well field?	☐ Yes ☑ No
Within 300 ft. of a wetland?	☐ Yes ☑ No
Within the area overlying a subsurface mine?	☐ Yes ☑ No
Within an unstable area?	☐ Yes ☑ No
Within a 100-year floodplain?	☐ Yes ☑ No

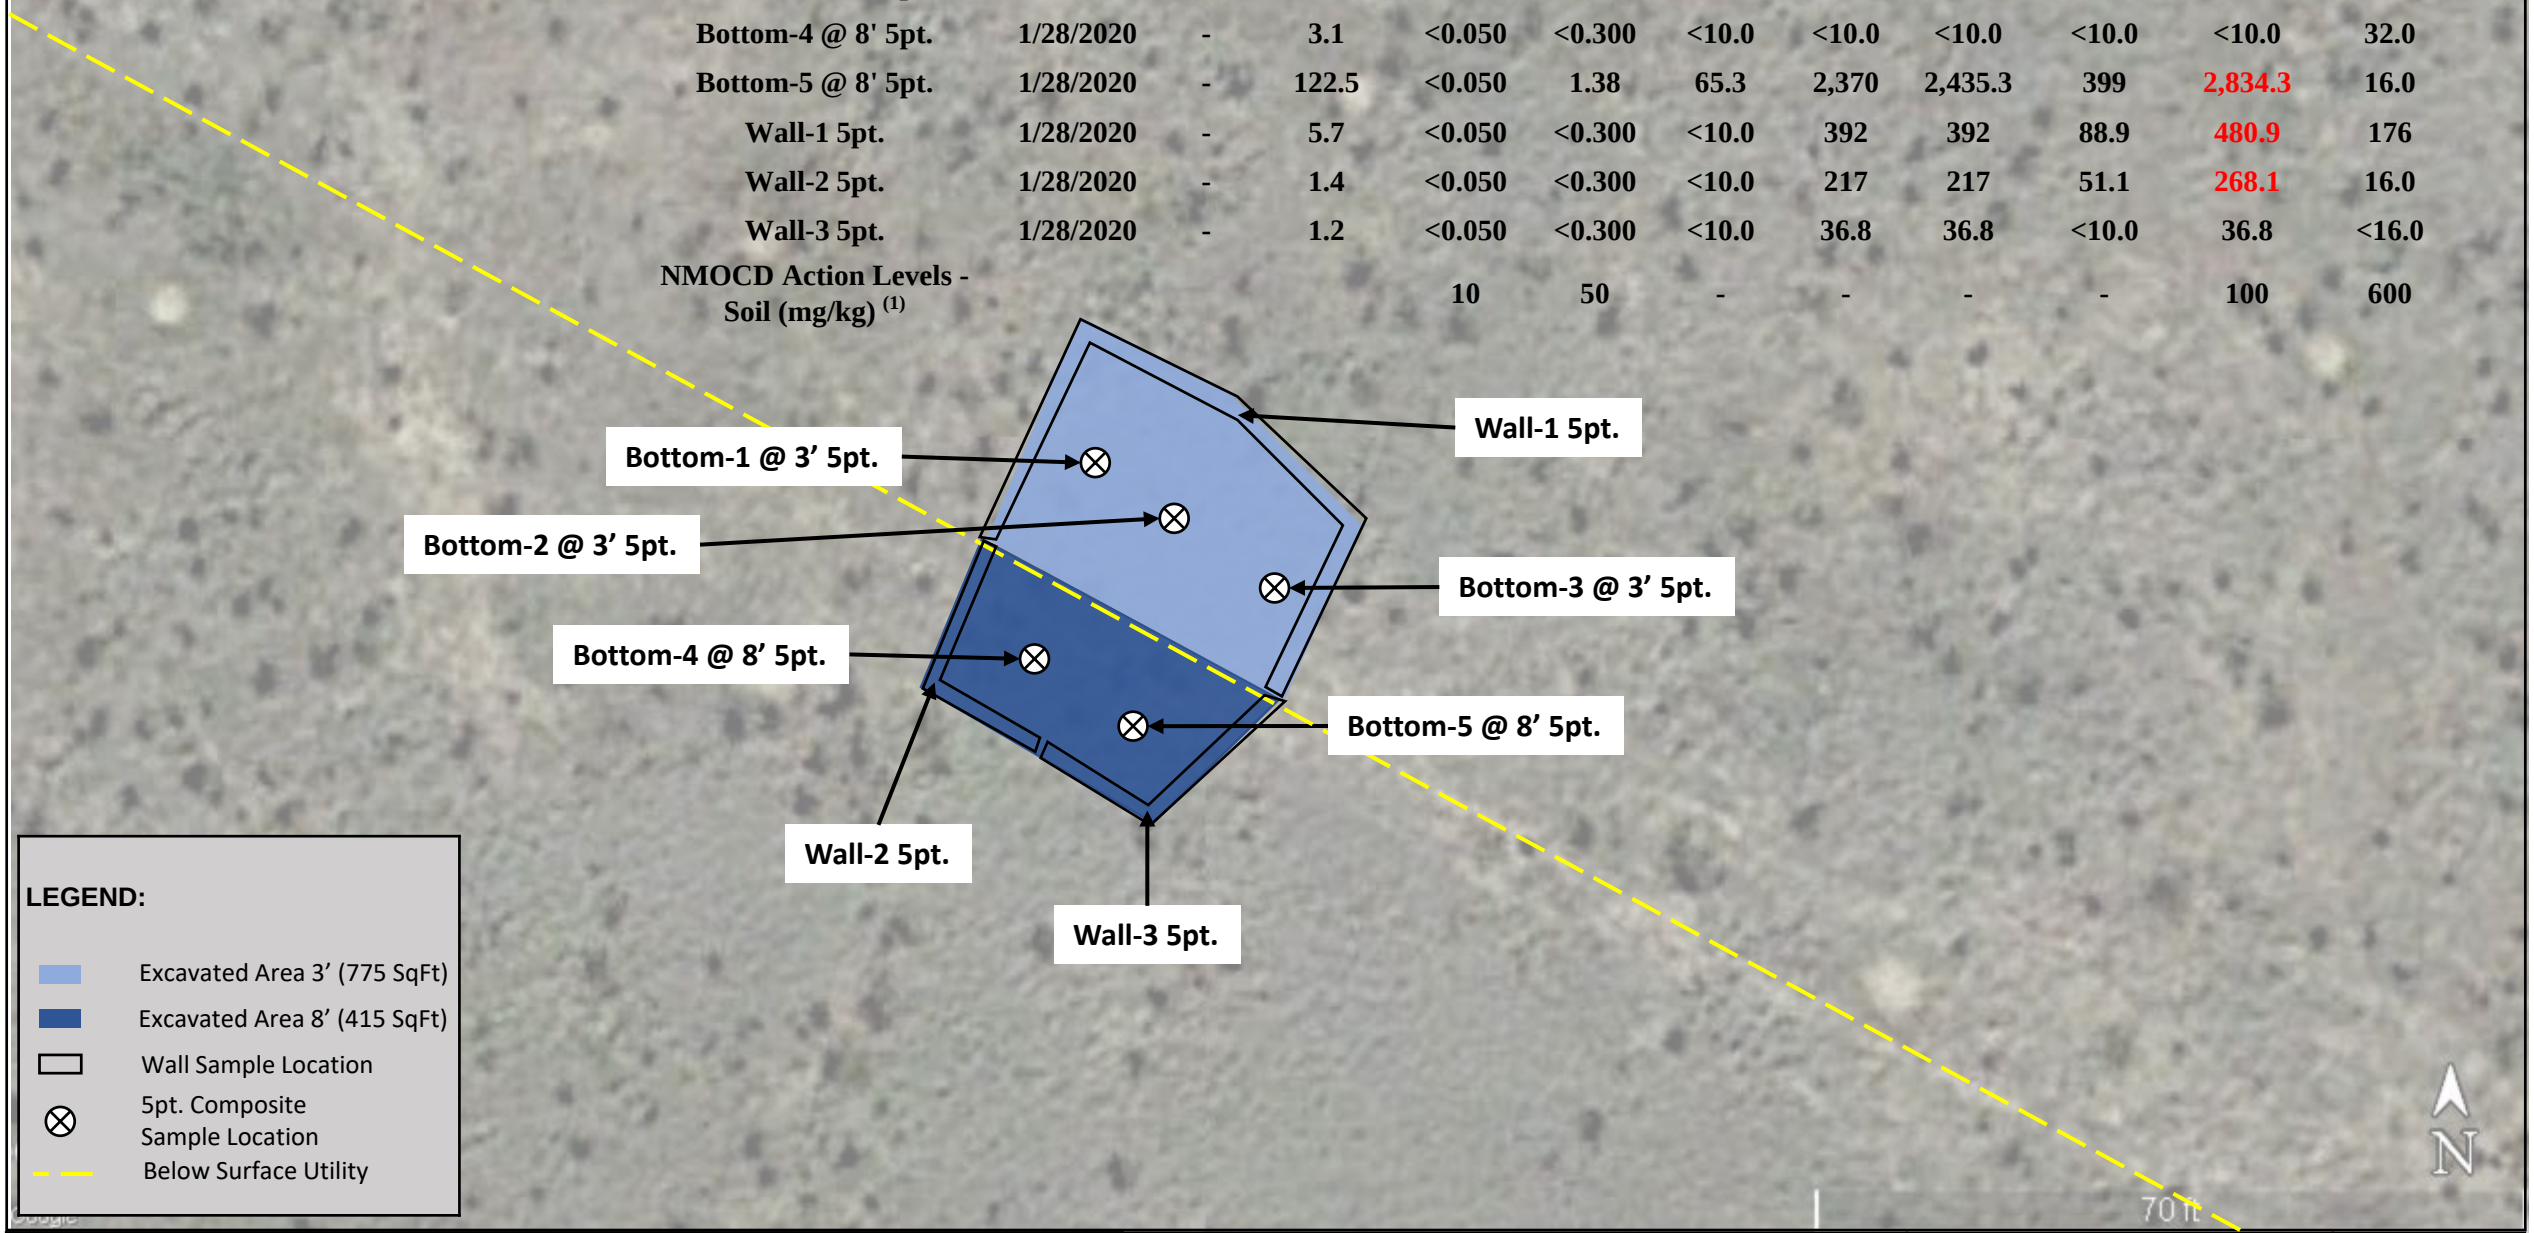
DATE: January 2020 DESIGNED BY: B. Cooper DRAWN BY: B. Cooper	TASMAN GEOSCIENCES *Tasman Geosciences, Inc.* *2620 W. Marland Blvd.* *Hobbs, NM 88240*	**DCP Midstream** **11117 Leak Location 1** GPS: 32.298043, -104.256508 Eddy County, New Mexico	Soil Impacts Map	**Figure 2**

From July 29, 2019 to July 31, 2019 Tasman personnel conducted oversight on initial remediation activities. Oversight included management of impacted soil within the relevant pipeline right-of-way that was previously excavated by DCP maintenance crew during line repair activities. A total of approximately 120 cubic yards of material was hauled, under manifest, to a NMOCD-approved disposal facility. Three (3) 5-point composite samples were taken from the base and sidewalls of the excavated area and submitted to the laboratory for analysis of total petroleum hydrocarbons (TPH) and chloride (Cl-) concentrations. Laboratory analytical results indicated that TPH and/or Cl- concentrations from the collected soil samples were above applicable NMOCD Closure Criteria (Table I).

Between October 22, 2019 and January 28, 2020, Tasman personnel revisited the Release Site three (3) additional times in an effort to complete additional site characterization, excavate identified hydrocarbon impacted soil, collect confirmation soil samples and transport/dispose of excavated soil to a NMOCD-approved disposal facility. During the assessment, eight (8) composite method soil samples were collected from the base and sidewalls of the open excavation and submitted to an NMOCD-approved laboratory for analysis of TPH, BTEX, and/or Chloride. Based on the remediation activities described above, the confirmation soil sample analytical results indicate that BTEX and Cl- concentrations are below the NMOCD Closure Criteria and are no longer a constituent of concern. TPH still remains above the NMOCD Closure Criteria of 100 ppm. A table summarizing laboratory analytical results from soil samples collected during the January 28,2020 site assessment is provided below.

A " Site Overview Map" is provided as Figure 2 (Attachment 2). Field Data, if applicable, is provided as Attachment #4. Laboratory analytical reports are provided as Attachment #7.

•Utilizing mechanical equipment, advance excavation vertically and horizontally in the areas exceeding a Total TPH of 100 mg/kg until laboratory analytical results from excavation confirmation soil samples indicate concentrations of TPH are below the NMOCD Closure Criteria.
• Excavated soil will be temporarily stockpiled on-site, atop a poly liner, pending transportation under manifest to an NMOCD-approved disposal facility.
• Upon receiving laboratory analytical results from confirmation soil samples below the NMOCD Closure Criteria, excavated areas will be backfilled with locally sourced, non-impacted "like" material. The affected area will be contoured and/or compacted to achieve erosion control, stability and preservation of surface water flow to the extent practicable.

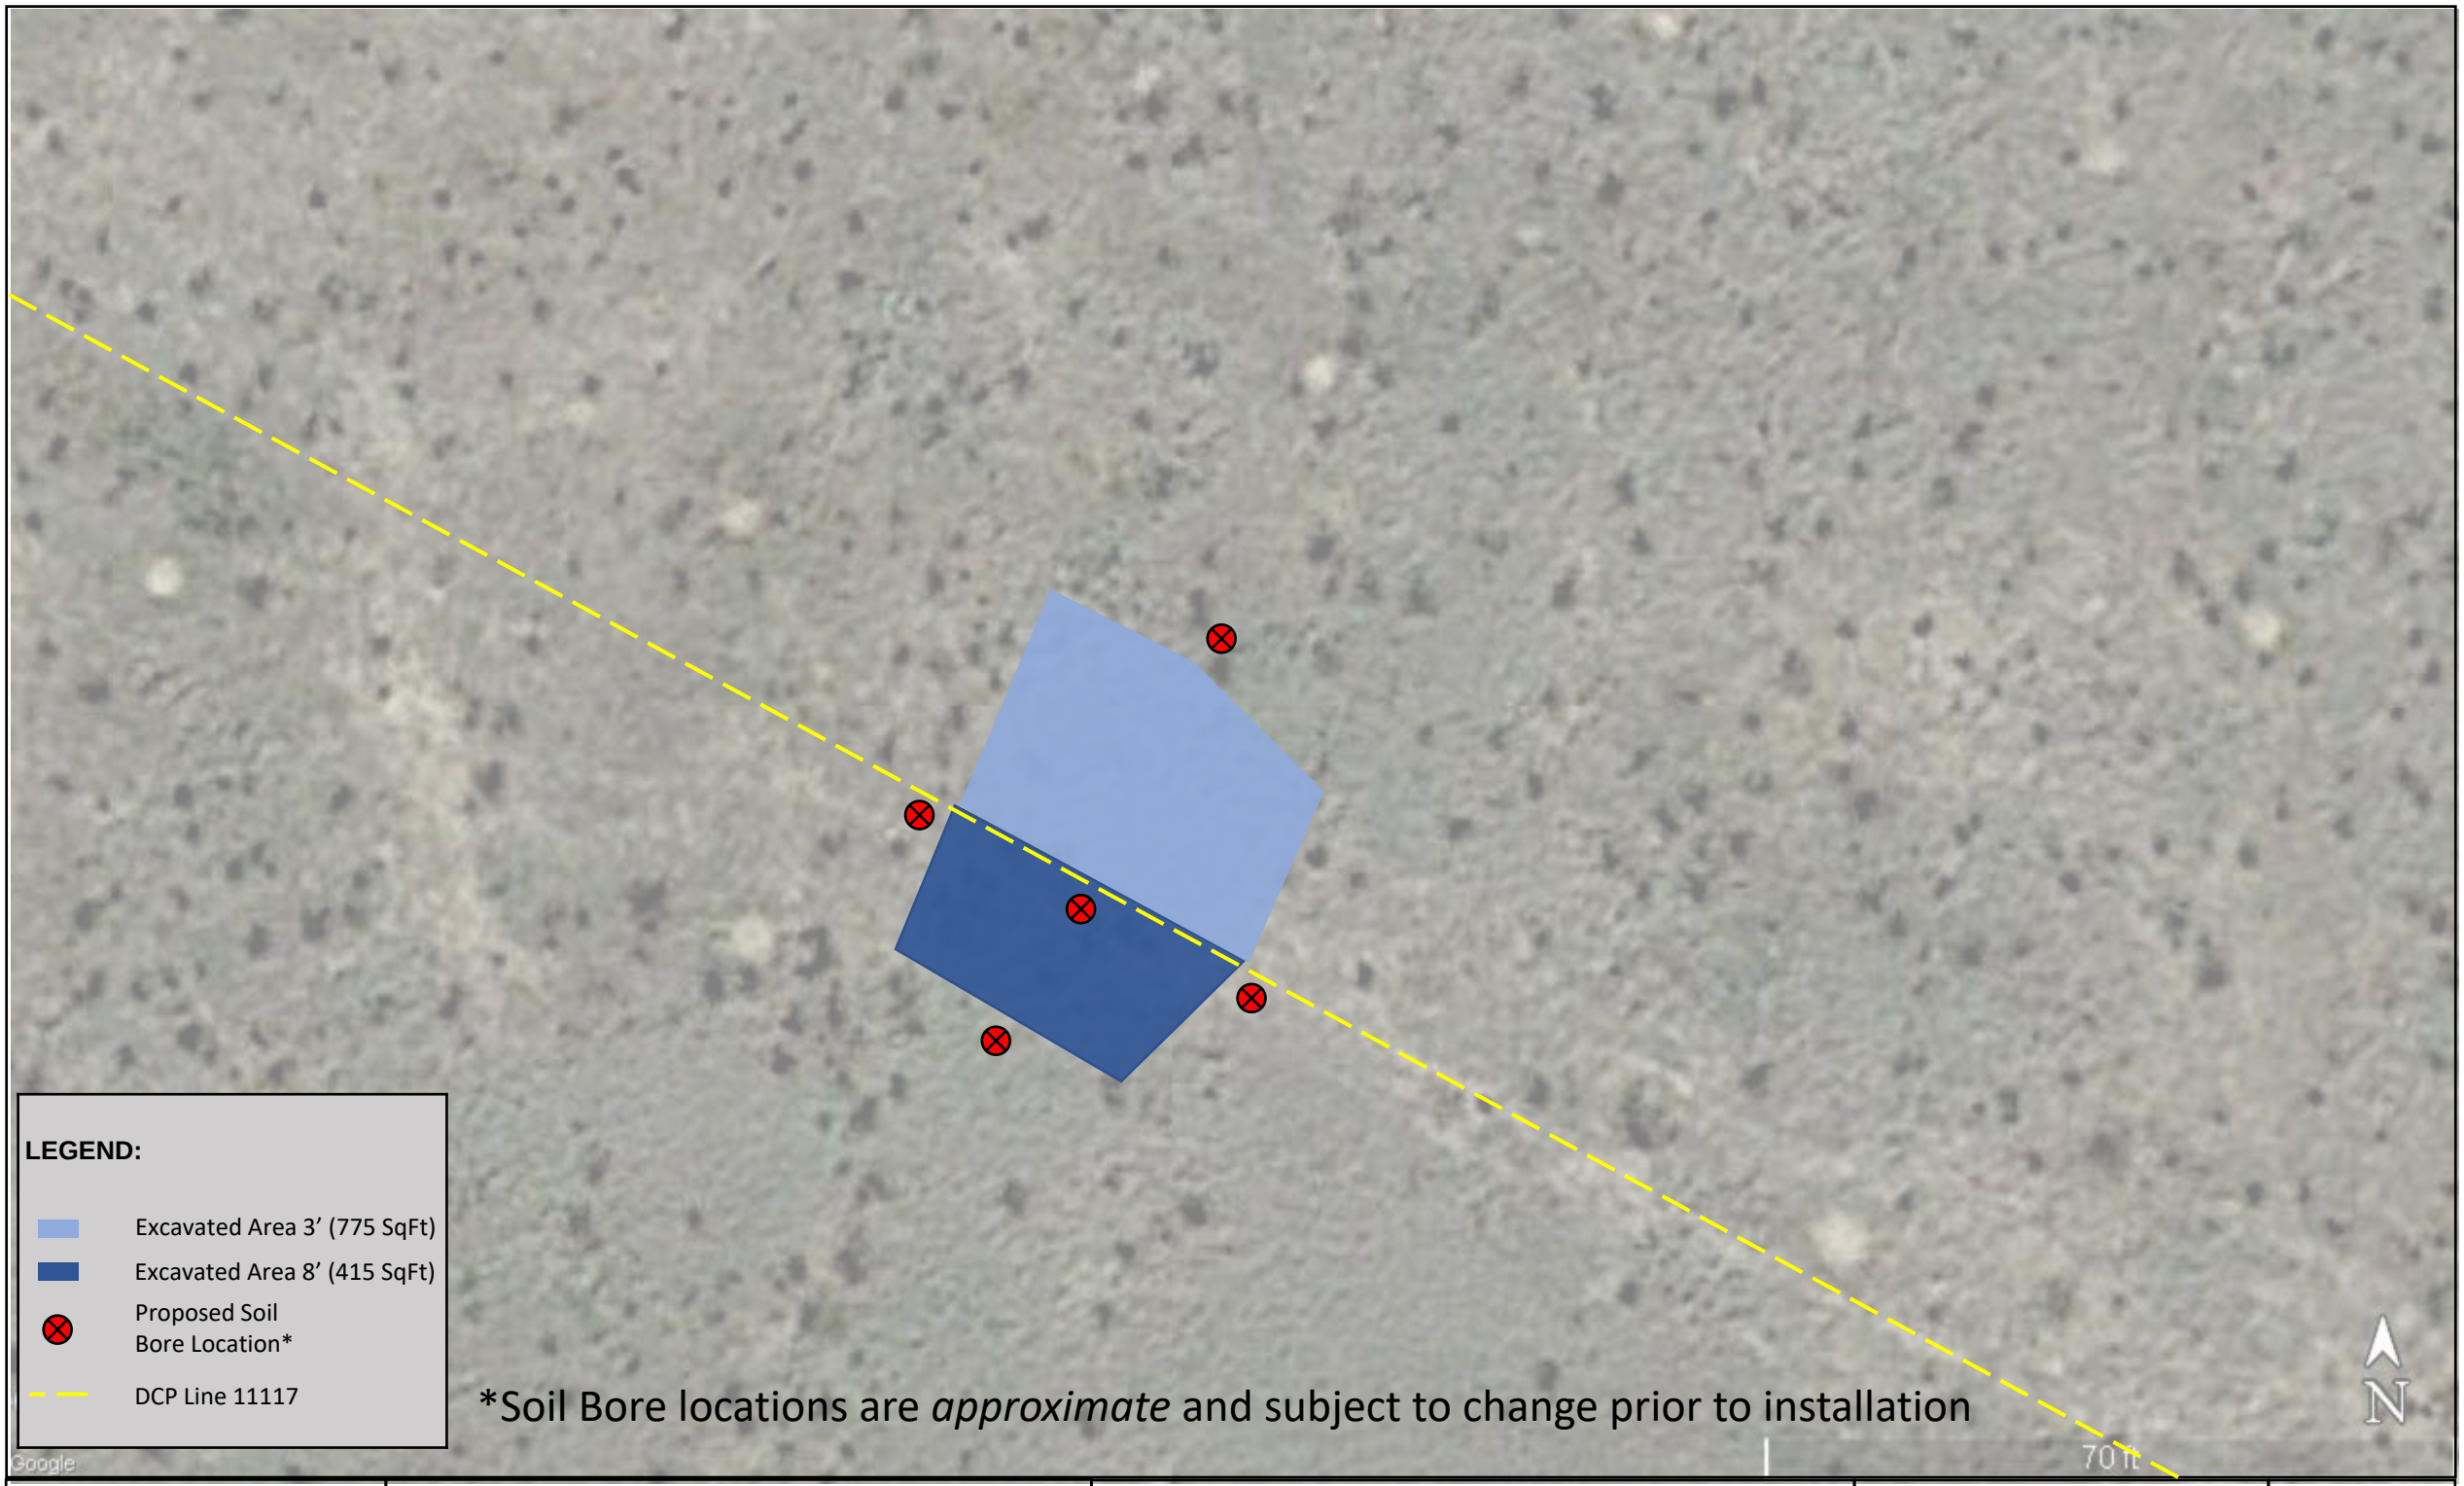
DATE: March 2020 DESIGNED BY: B. Cooper DRAWN BY: B. Cooper	TASMAN GEOSCIENCES *Tasman Geosciences, Inc.* *2620 W. Marland Blvd.* *Hobbs, NM 88240*	**DCP Midstream** **11117 Leak Location 1** GPS: 32.298043, -104.256508 Eddy County, New Mexico	Proposed Soil Bore Location Map	**Figure 3**

In an effort to determine the vertical and horizontal extent of soil impacts, DCP proposes to install five (5) soil bores utilizing an air rotary drilling rig. Soil samples will be collected at equal intervals and field screened for chlorides and

hydrocarbons. Representative soil samples from each soil bore will be submitted to an NMOCD-approved laboratory for analysis of TPH.

A "Proposed Soil Bore Location Map" is provided as Figure 3 (Attachment 3).
