Re: Site Assessment Summary and Remediation Plan
Natural Gas Gathering Line #11117 Leak Location 3
GPS: Latitude 32.297579 Longitude -104.255423
UL "P", Sec. 14, T23S, R26E
Eddy County, NM
NMOCD Ref. No. NRM2016955206

Tasman Geosciences, Inc. (Tasman), on behalf of DCP Operating Company, LP (DCP), has prepared this Site Assessment Summary and Remediation Plan for the condensate and natural gas Release Site known as the Natural Gas Gathering Line #11117 Leak Location 3. Details of the release are summarized below:

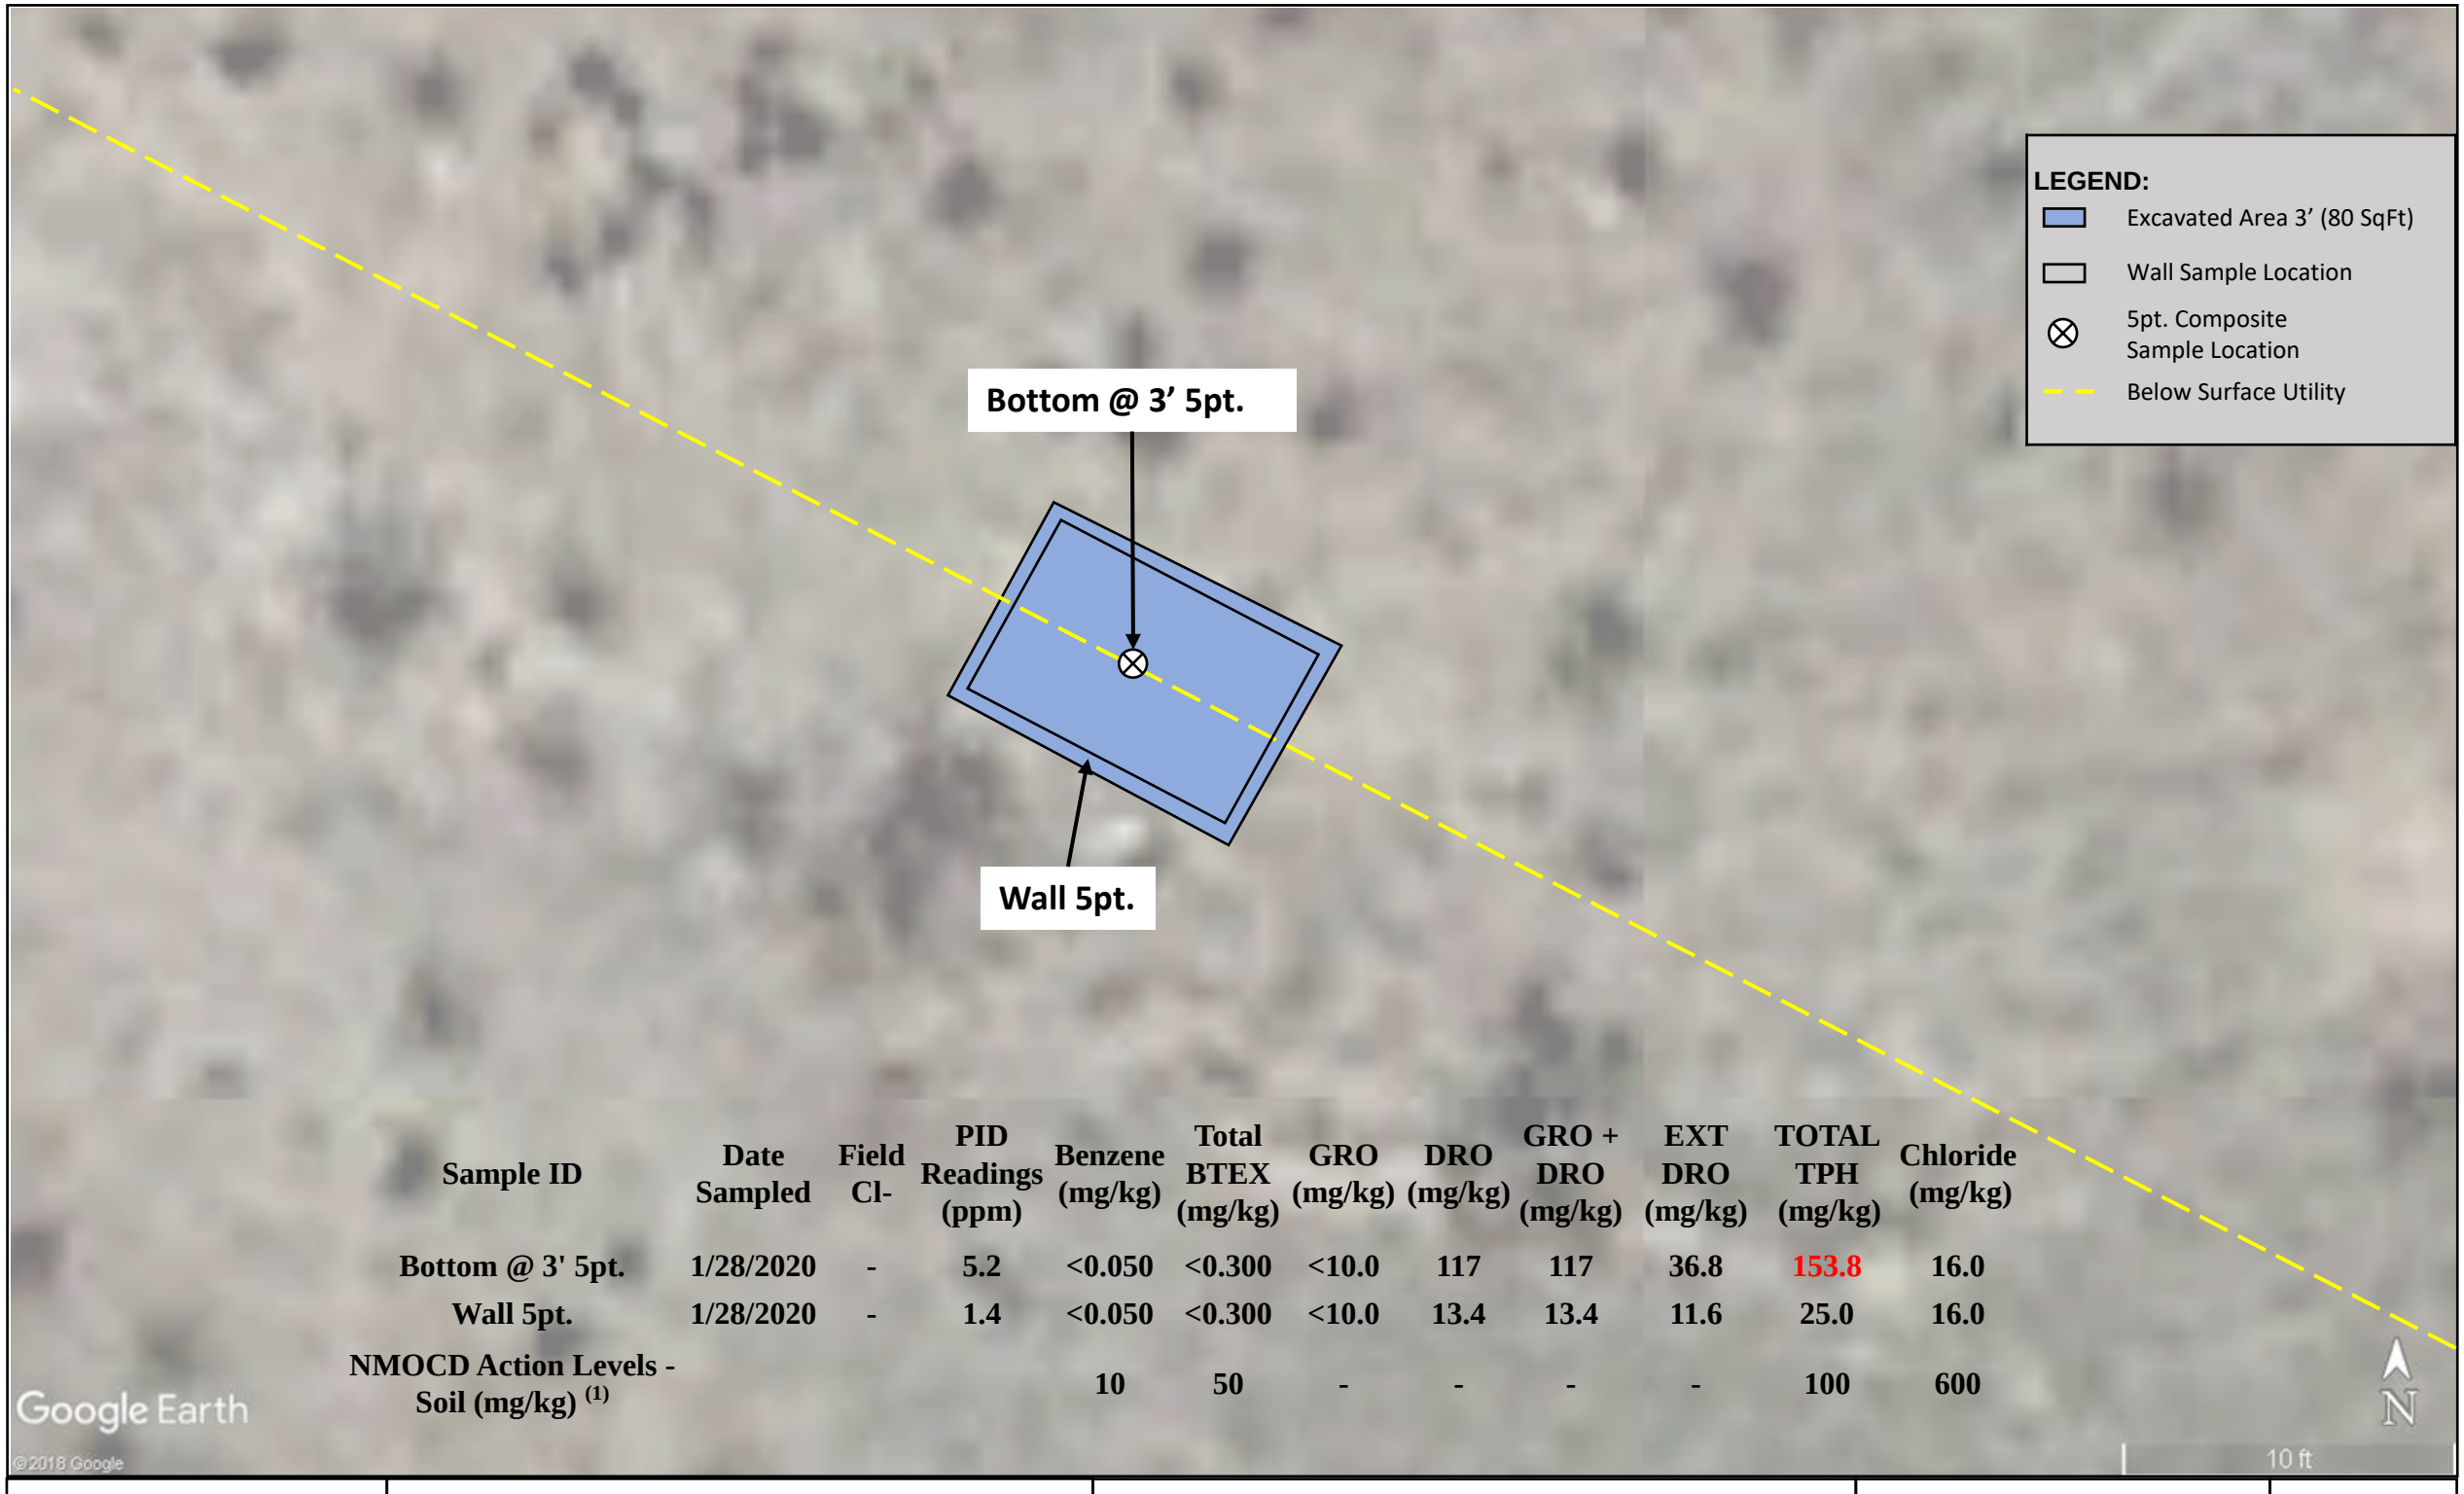
DATE: February 2020 DESIGNED BY: B. Cooper DRAWN BY: B. Cooper	TASMAN GEOSCIENCES *Tasman Geosciences, Inc.* *2620 W. Marland Blvd.* *Hobbs, NM 88240*	**DCP Midstream** **11117 Leak Location 3** GPS: 32.297579, -104.255423 Eddy County, New Mexico	Soil Impacts Map	**Figure 2**

From July 29, 2019 to July 31, 2019 Tasman personnel conducted oversight on initial remediation activities. Oversight included management of impacted soil within the relevant pipeline right-of-way that was previously excavated by DCP maintenance crew during line repair activities. A total of approximately 24 cubic yards of material was hauled, under manifest, to a NMOCD-approved disposal facility. Two (2) 5-point composite samples were taken from the base and sidewalls of the excavated area and submitted to the laboratory for analysis of total petroleum hydrocarbons (TPH) and chloride (Cl-) concentrations. Laboratory analytical results indicated that TPH and/or Cl- concentrations from the collected soil samples were above applicable NMOCD Closure Criteria (Table I).

Between October 22, 2019 and January 28, 2020, Tasman personnel revisited the Release Site three (3) additional times in an effort to complete additional site characterization, excavate identified hydrocarbon impacted soil, collect confirmation soil samples and transport/dispose of excavated soil to a NMOCD-approved disposal facility. During the assessment, two (2) composite method soil samples were collected from the base and sidewalls of the open excavation and submitted to an NMOCD-approved laboratory for analysis of TPH, BTEX, and/or Chloride. Based on the remediation activities described above, the confirmation soil sample analytical results indicate that BTEX and Cl- concentrations are below the NMOCD Closure Criteria and are no longer a constituent of concern. TPH still remains above the NMOCD Closure Criteria of 100 ppm. A table summarizing laboratory analytical results from soil samples collected during the January 28,2020 site assessment is provided below.

Sample ID	Date Sampled	Field Cl-	PID Readings (ppm)	Benzene (mg/kg)	Total BTEX (mg/kg)	GRO (mg/kg)	DRO (mg/kg)	GRO + DRO (mg/kg)	EXT DRO (mg/kg)	TOTAL TPH (mg/kg)	Chloride (mg/kg)
Bottom @ 3' 5pt.	1/28/2020	-	5.2	<0.050	<0.300	<10.0	117	117	36.8	153.8	16.0
Wall 5pt.	1/28/2020	-	1.4	<0.050	<0.300	<10.0	13.4	13.4	11.6	25.0	16.0
NMOCD Action Levels - Soil (mg/kg) (1)				10	50	-	-	-	-	100	600

•Utilizing mechanical equipment, advance excavation vertically and horizontally in the areas exceeding a Total TPH of 100 mg/kg until laboratory analytical results from excavation confirmation soil samples indicate concentrations of TPH are below the NMOCD Closure Criteria.
• Excavated soil will be temporarily stockpiled on-site, atop a poly liner, pending transportation under manifest to an NMOCD-approved disposal facility.
• Upon receiving laboratory analytical results from confirmation soil samples below the NMOCD Closure Criteria, excavated areas will be backfilled with locally sourced, non-impacted "like" material. The affected area will be contoured and/or compacted to achieve erosion control, stability and preservation of surface water flow to the extent practicable.

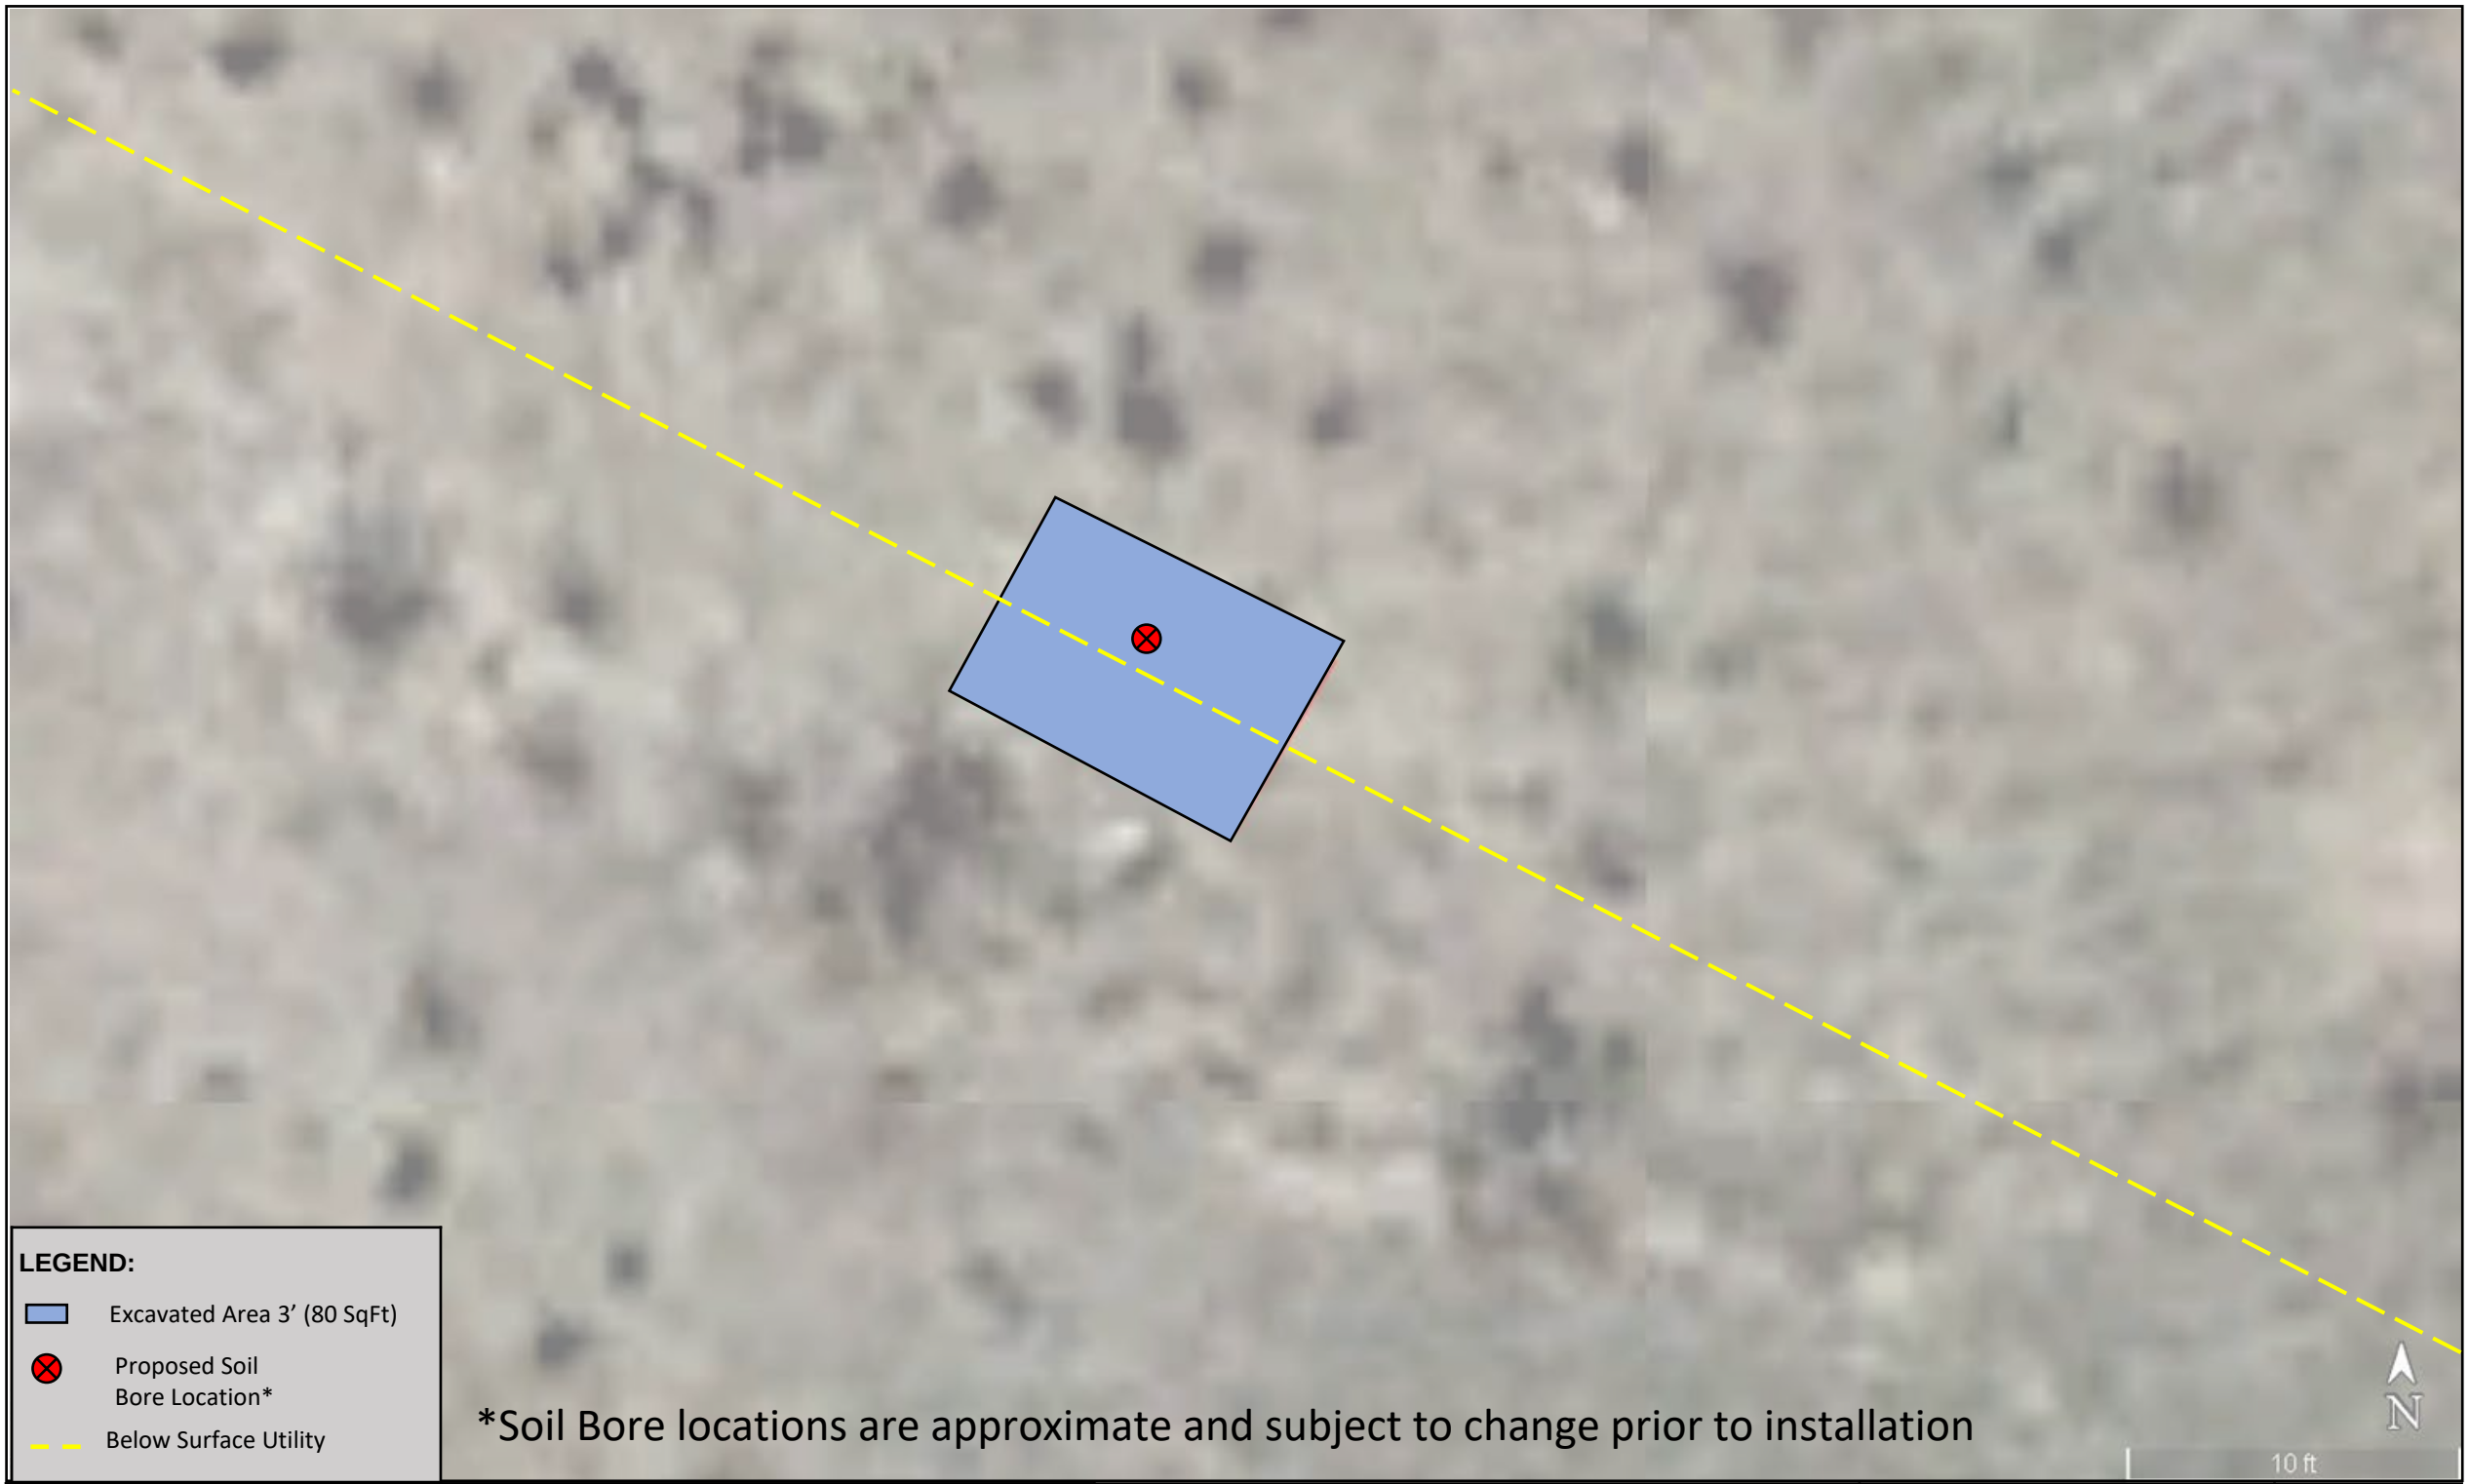
DATE: February 2020 DESIGNED BY: B. Cooper DRAWN BY: B. Cooper	TASMAN GEOSCIENCES *Tasman Geosciences, Inc.* *2620 W. Marland Blvd.* *Hobbs, NM 88240*	**DCP Midstream** **11117 Leak Location 3** GPS: 32.297579, -104.255423 Eddy County, New Mexico	Proposed Soil Bore Location Map	**Figure 3**

In an effort to determine the vertical and horizontal extent of soil impacts, DCP proposes to install one (1) soil bore utilizing an air rotary drilling rig. Soil samples will be collected at equal intervals and field screened for chlorides and hydrocarbons. Representative soil samples from soil bore will be submitted to an NMOCD-approved laboratory for analysis of TPH.
