Re: Closure Report
N-Line Leak 3
GPS: Latitude 32.734912 Longitude -103.772112
UL "F", Sec. 21, T18S, R32E
Lea County, NM
NMOCD Ref. No.

Tasman Geosciences (Tasman), on behalf of DCP Midstream (DCP), has prepared this *Closure Report* for the historical Release Site known as the **N-Line Leak 3.** Details of the release are summarized below:

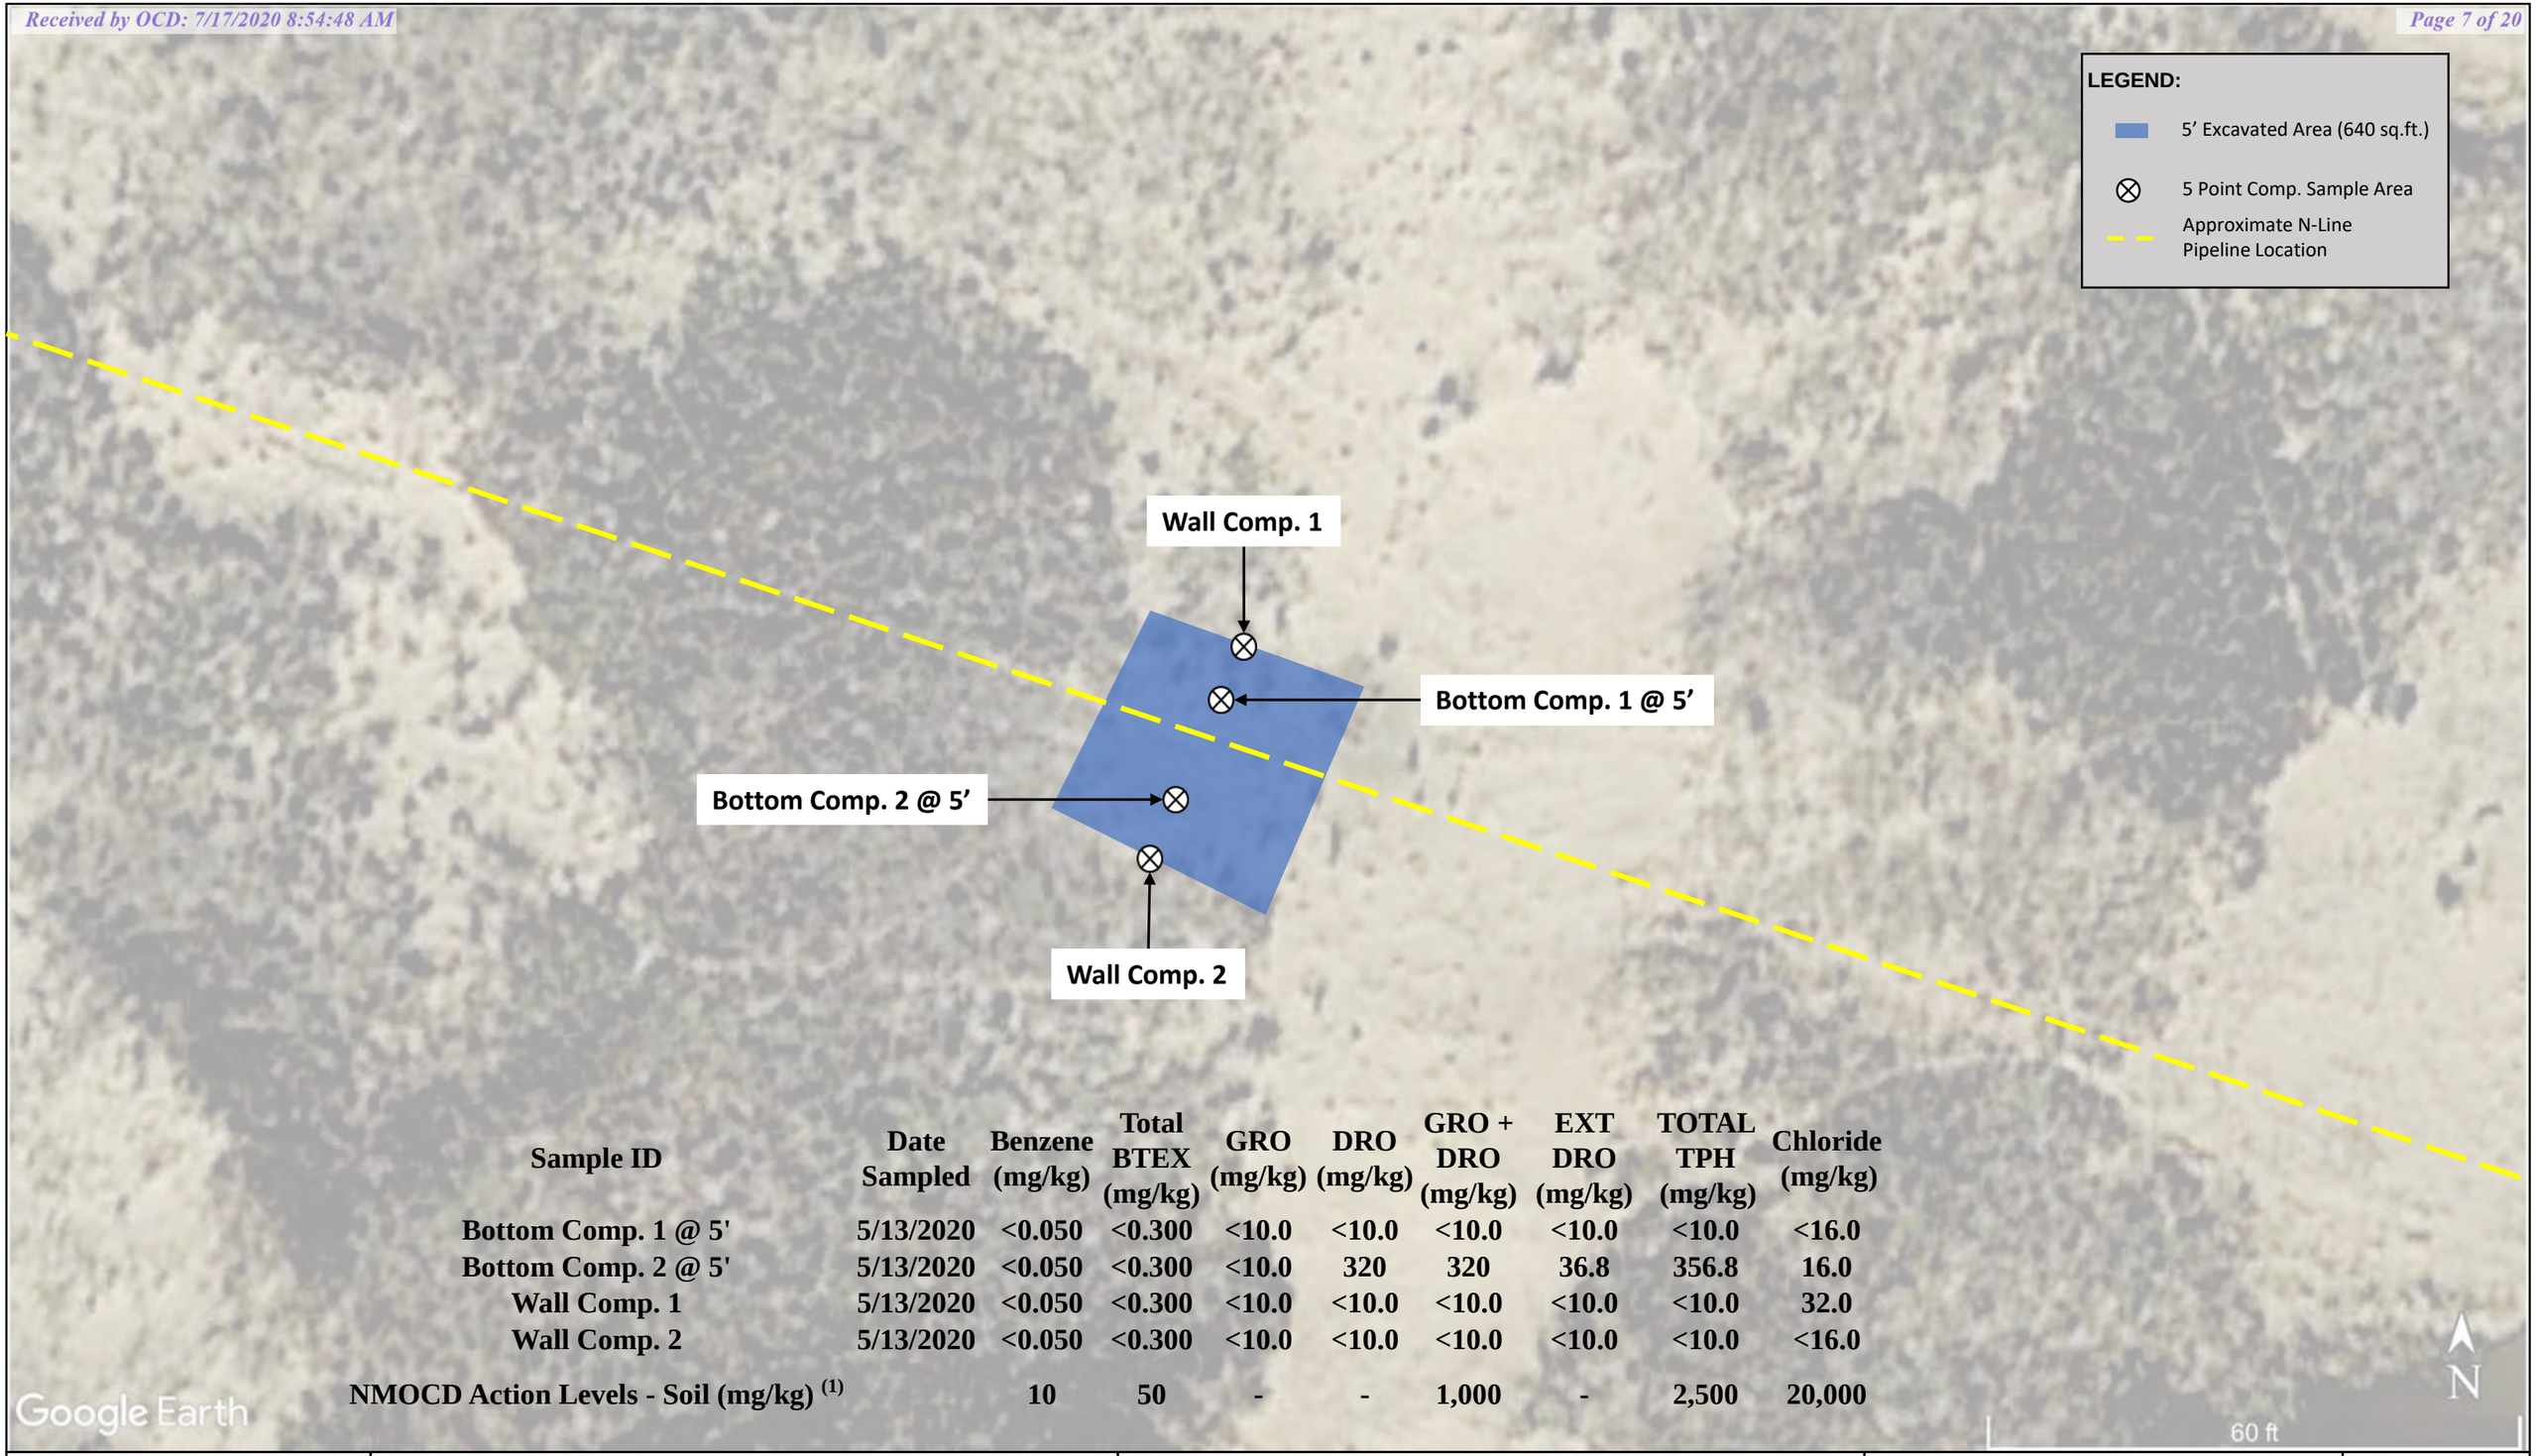
Figure 2

Site Sample Location Map

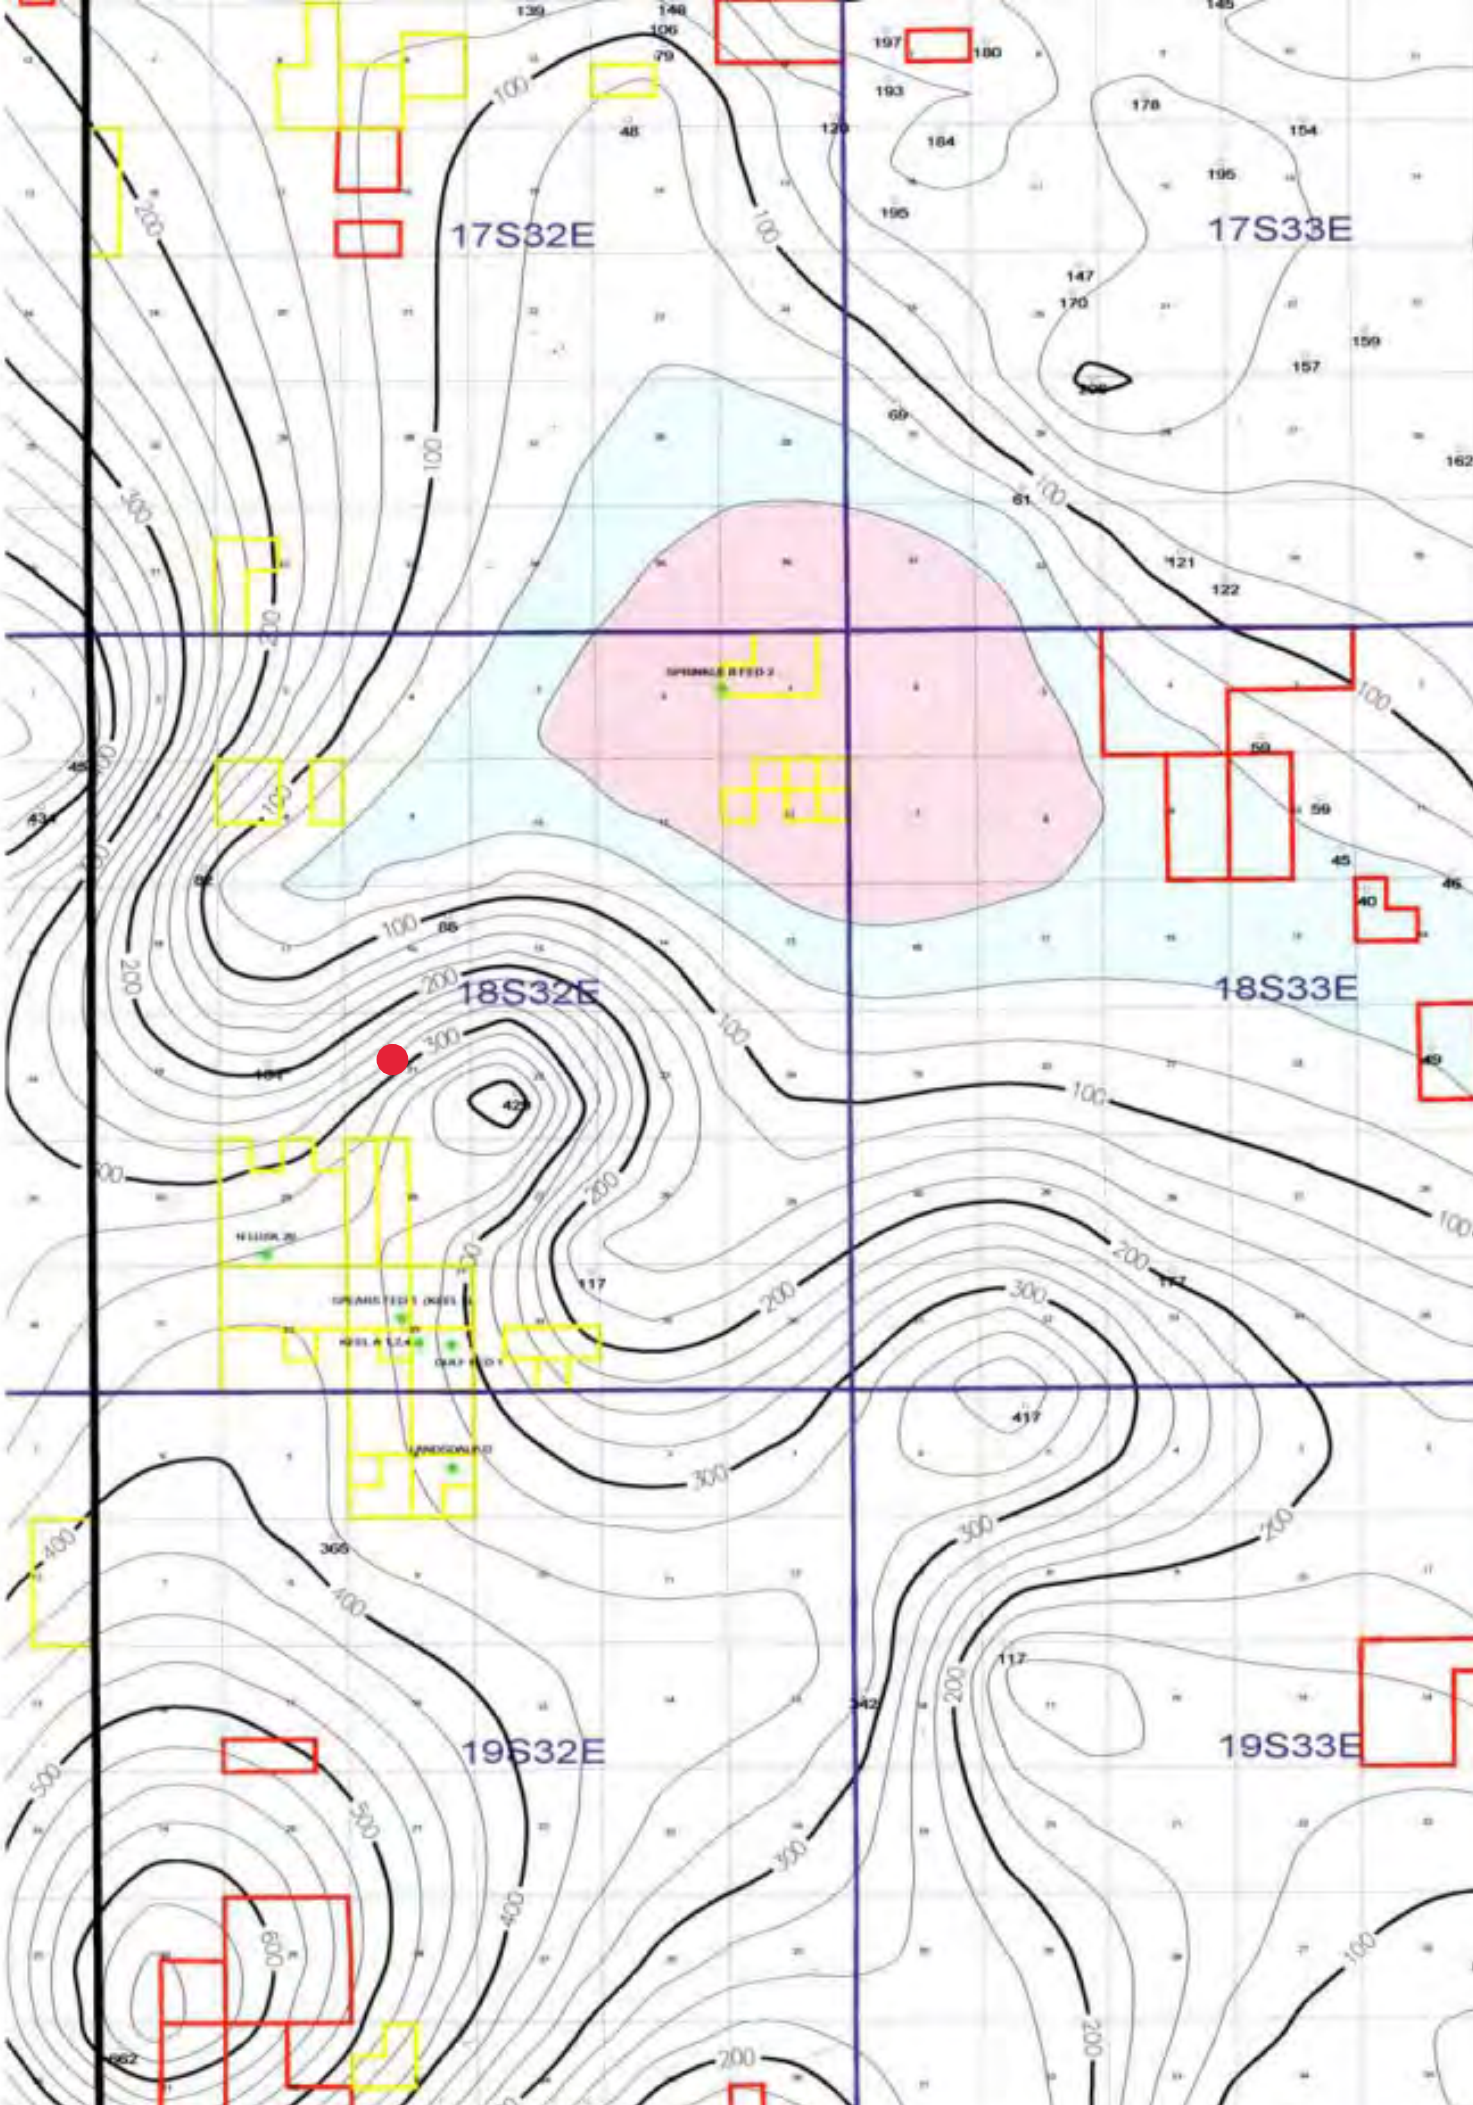
DCP N-Line leak 3
19 May 2020, 08:53:17
