Sample Data for Leak Delineation

Linn Skelly B Battery

UL/H, Sec 20, T17S R31E

Eddy County, NM

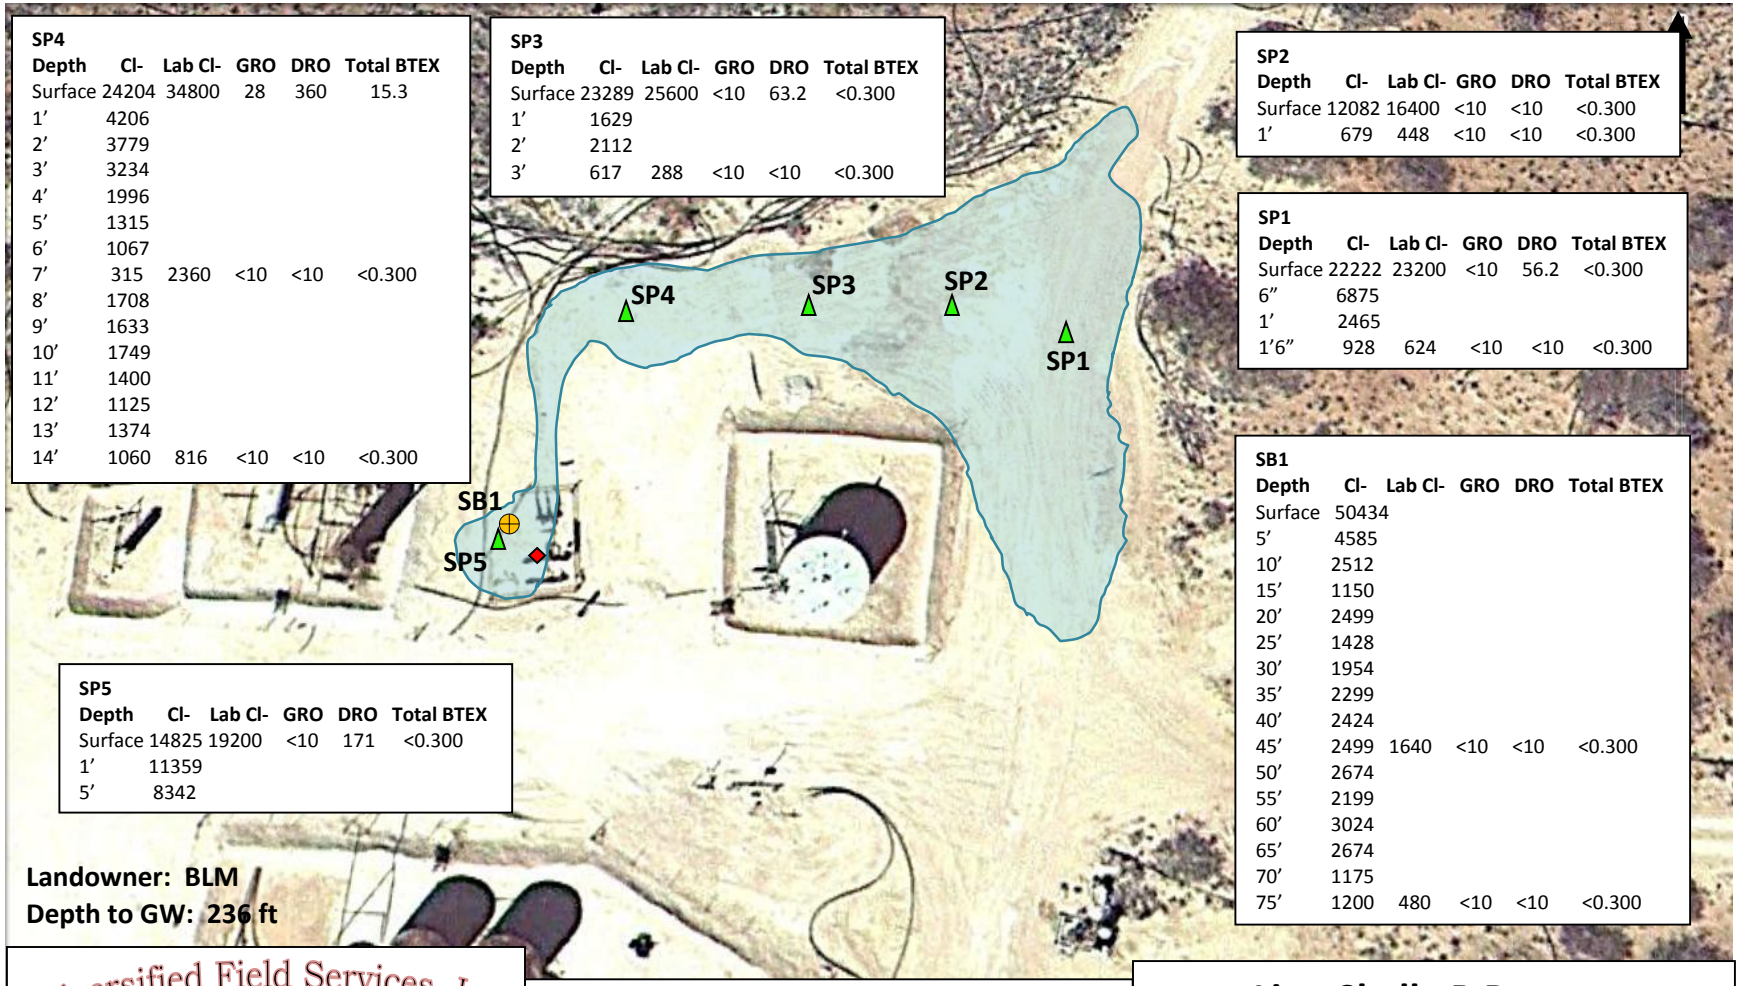
Depth	Cl-	Lab Cl-	GRO	DRO	Total BTEX
Surface	24204	34800	28	360	15.3
1’	4206				
2’	3779				
3’	3234				
4’	1996				
5’	1315				
6’	1067				
7’	315	2360	<10	<10	<0.300
8’	1708				
9’	1633				
10’	1749				
11’	1400				
12’	1125				
13’	1374				
14’	1060	816	<10	<10	<0.300

Depth	Cl-	Lab Cl-	GRO	DRO	Total BTEX
Surface	23289	25600	<10	63.2	<0.300
1’	1629				
2’	2112				
3’	617	288	<10	<10	<0.300

Depth	Cl-	Lab Cl-	GRO	DRO	Total BTEX
Surface	12082	16400	<10	<10	<0.300
1’	679	448	<10	<10	<0.300

Depth	Cl-	Lab Cl-	GRO	DRO	Total BTEX
Surface	22222	23200	<10	56.2	<0.300
6”	6875				
1’	2465				
1’6”	928	624	<10	<10	<0.300

Depth	Cl-	Lab Cl-	GRO	DRO	Total BTEX
Surface	50434				
5’	4585				
10’	2512				
15’	1150				
20’	2499				
25’	1428				
30’	1954				
35’	2299				
40’	2424				
45’	2499	1640	<10	<10	<0.300
50’	2674				
55’	2199				
60’	3024				
65’	2674				
70’	1175				
75’	1200	480	<10	<10	<0.300

Depth	Cl-	Lab Cl-	GRO	DRO	Total BTEX
Surface	14825	19200	<10	171	<0.300
1’	11359				
5’	8342

- Stained Area (total 12,455 ft²)
- Leak Source
- Sample Point
- Soil Bore
